Building Assessment & Master Plan

Ontario Museum of History & Art

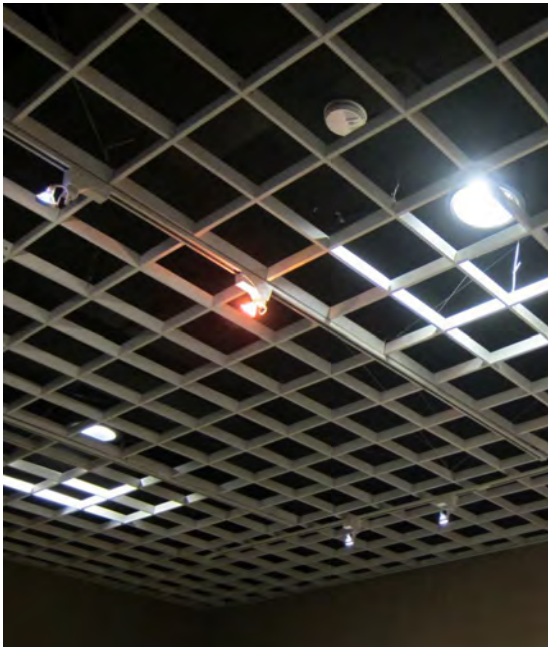
Typical grid ceiling in south galleries

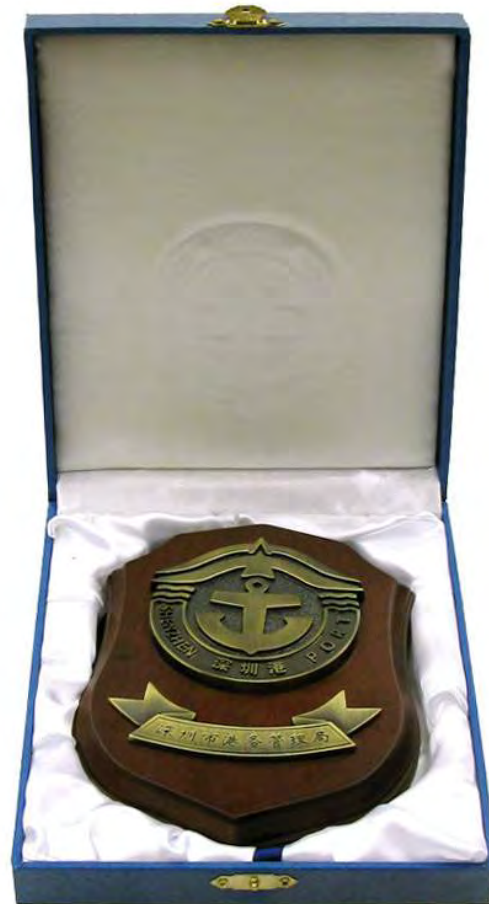
Space Optimization Recommendations

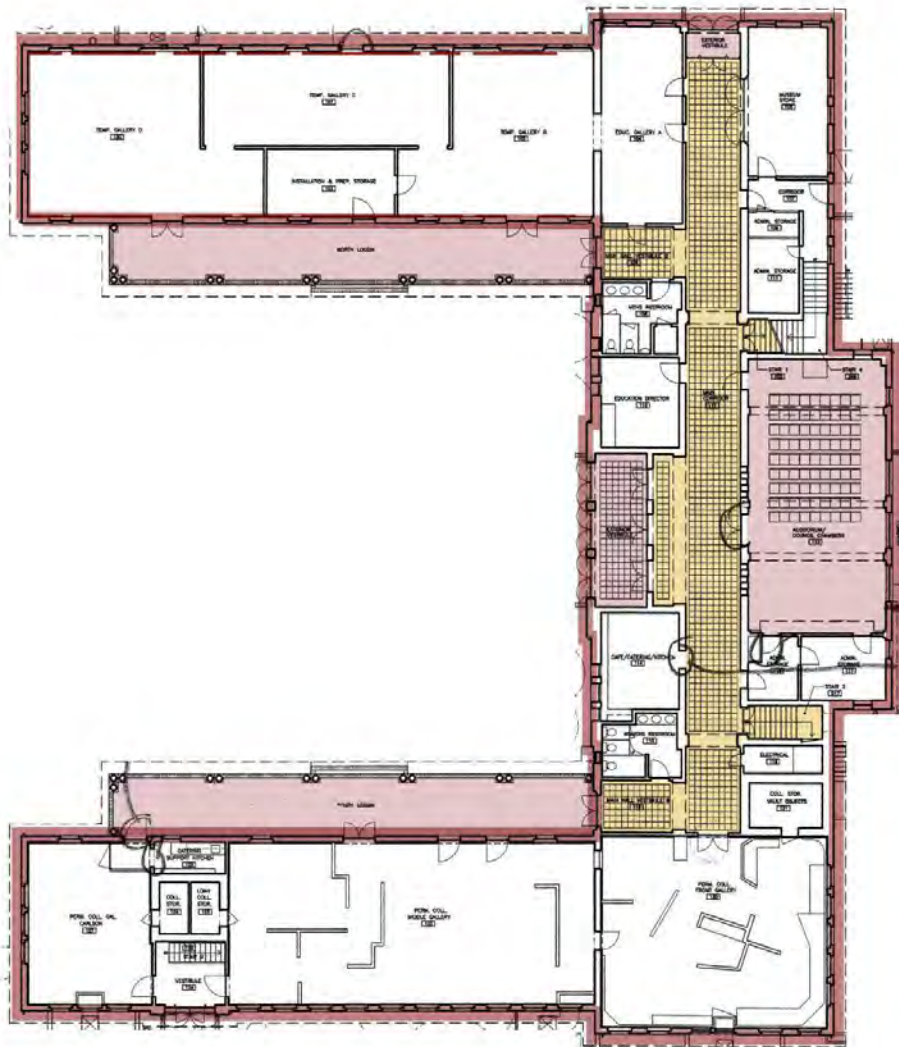
Building historic fabric priority

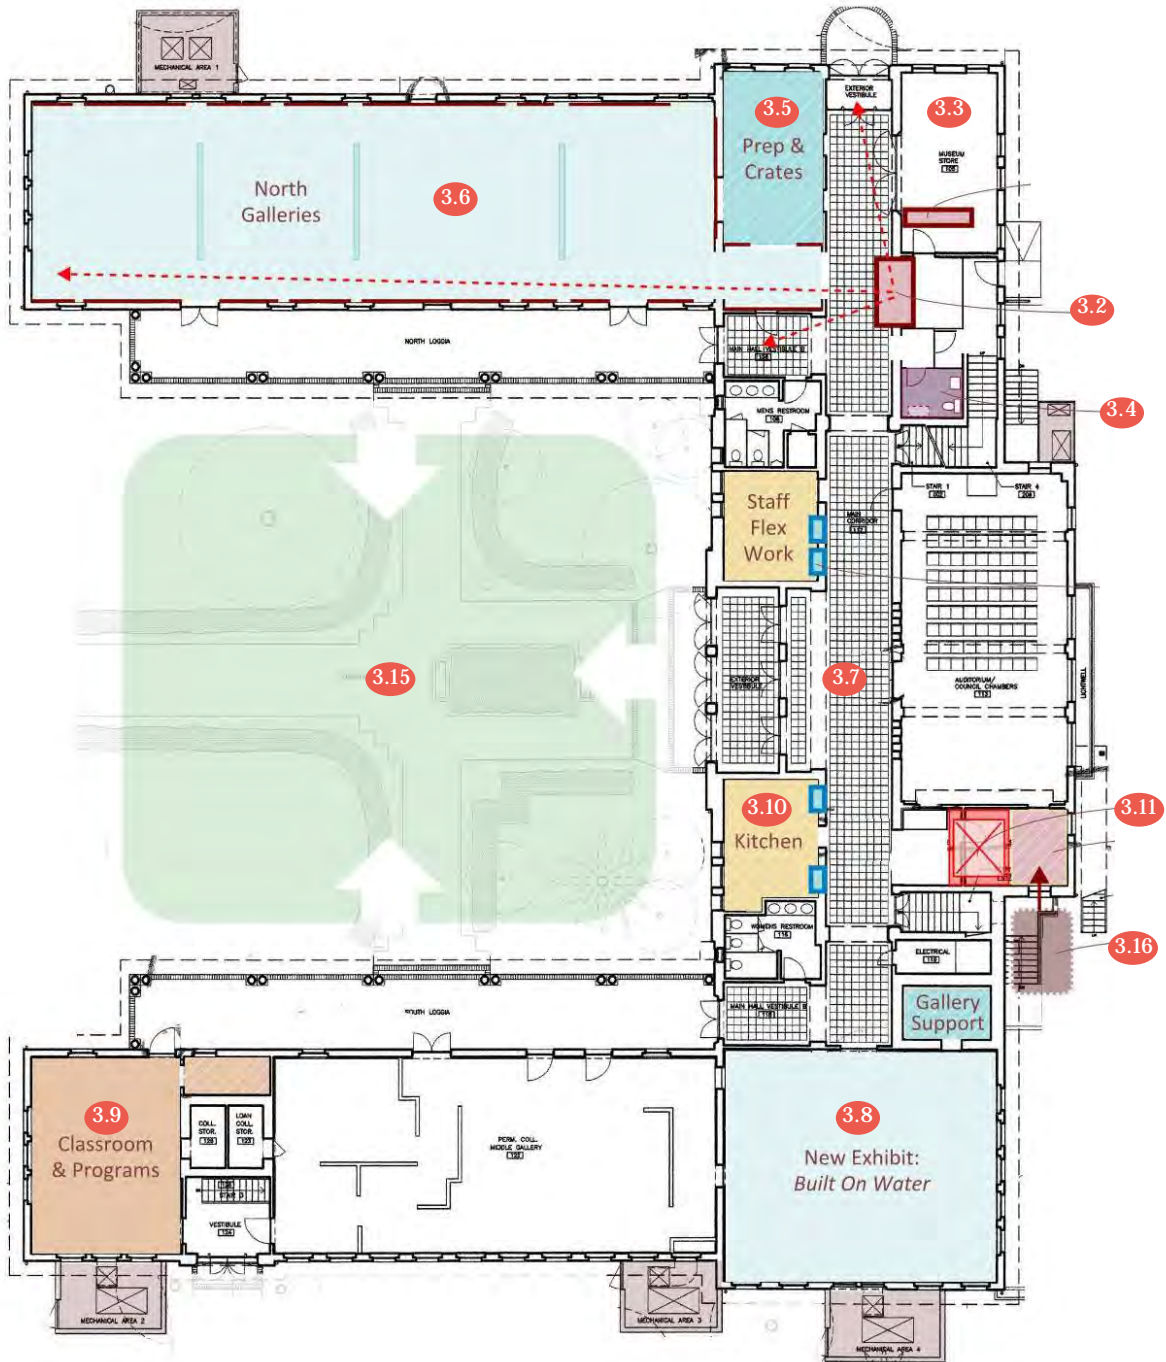
First floor concept plan

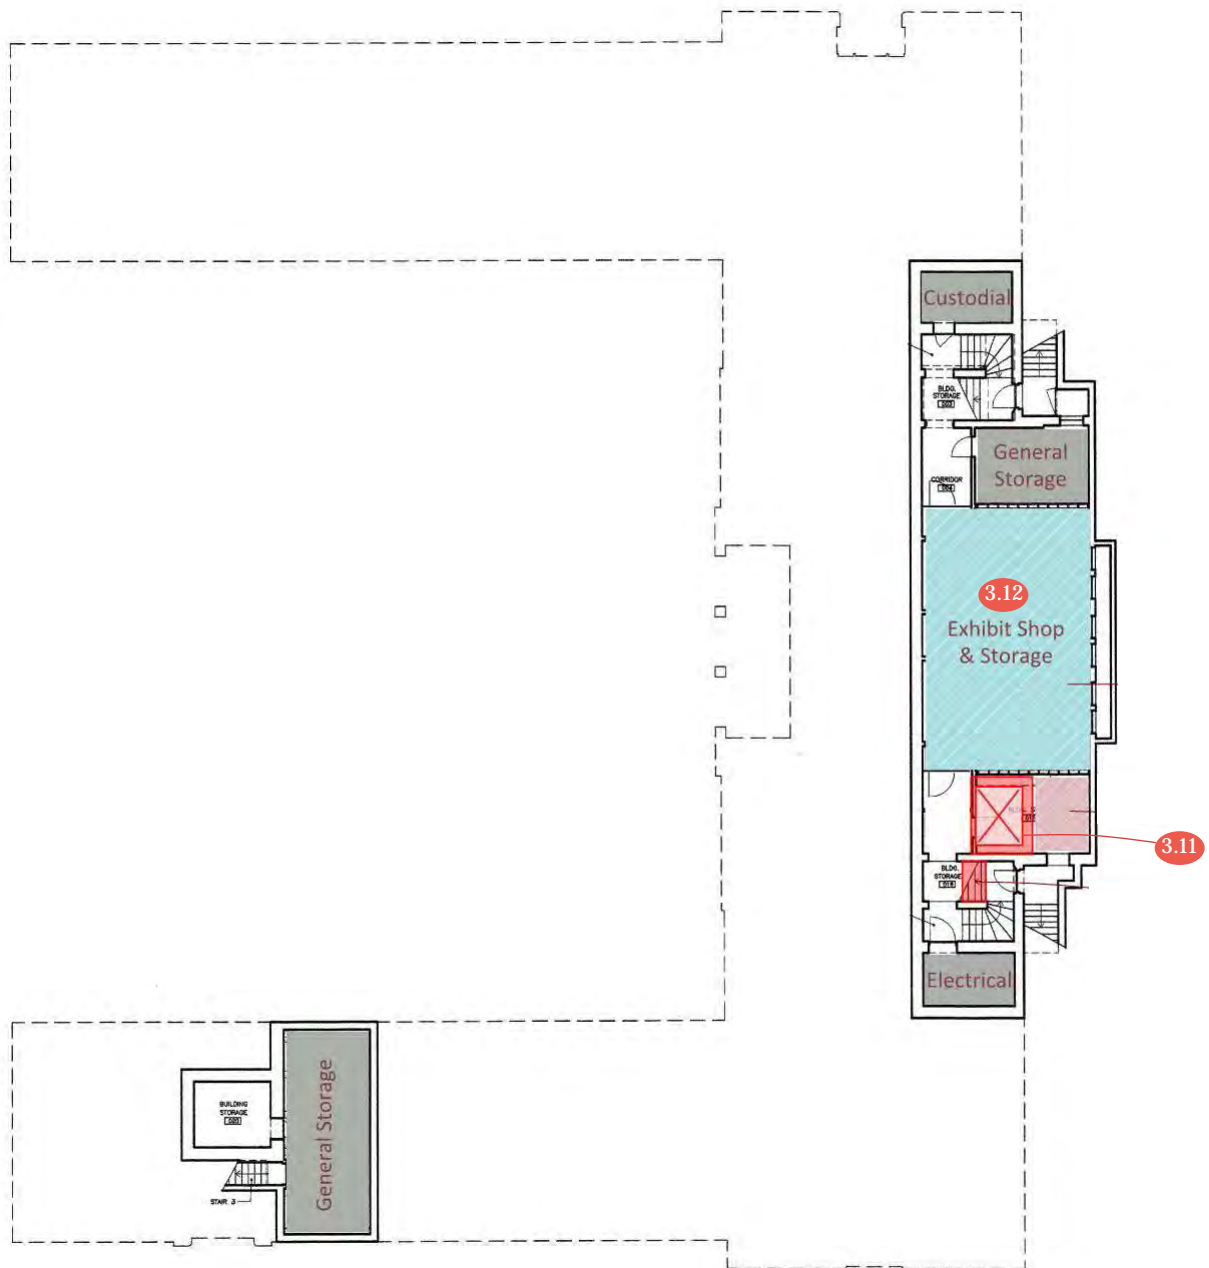
Basement concept plan

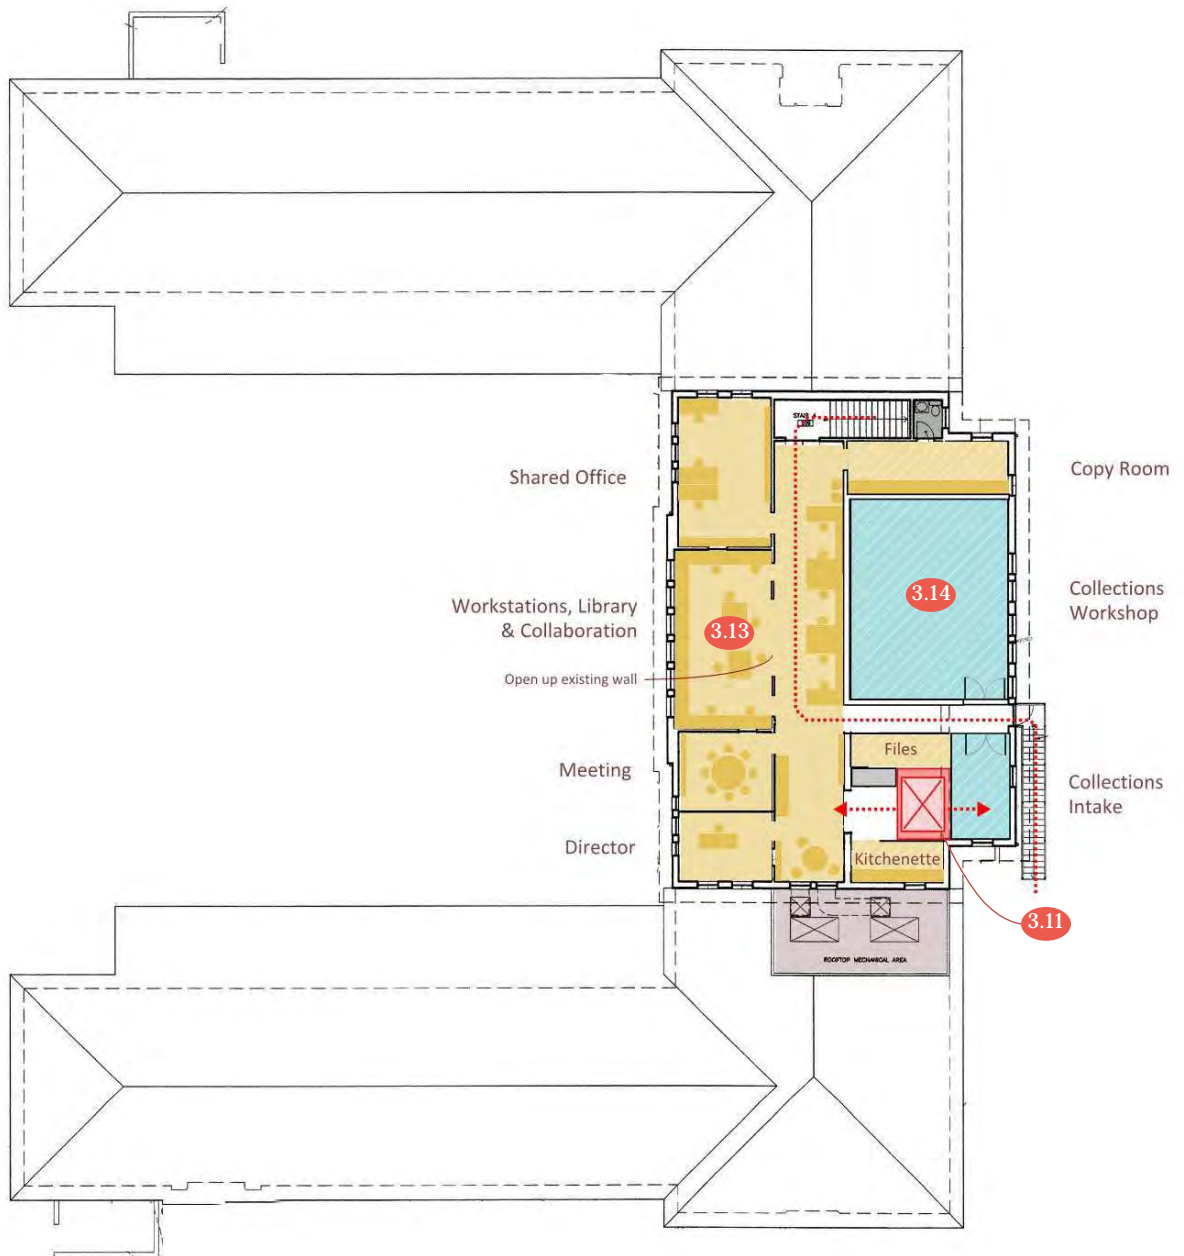
Second floor concept plan

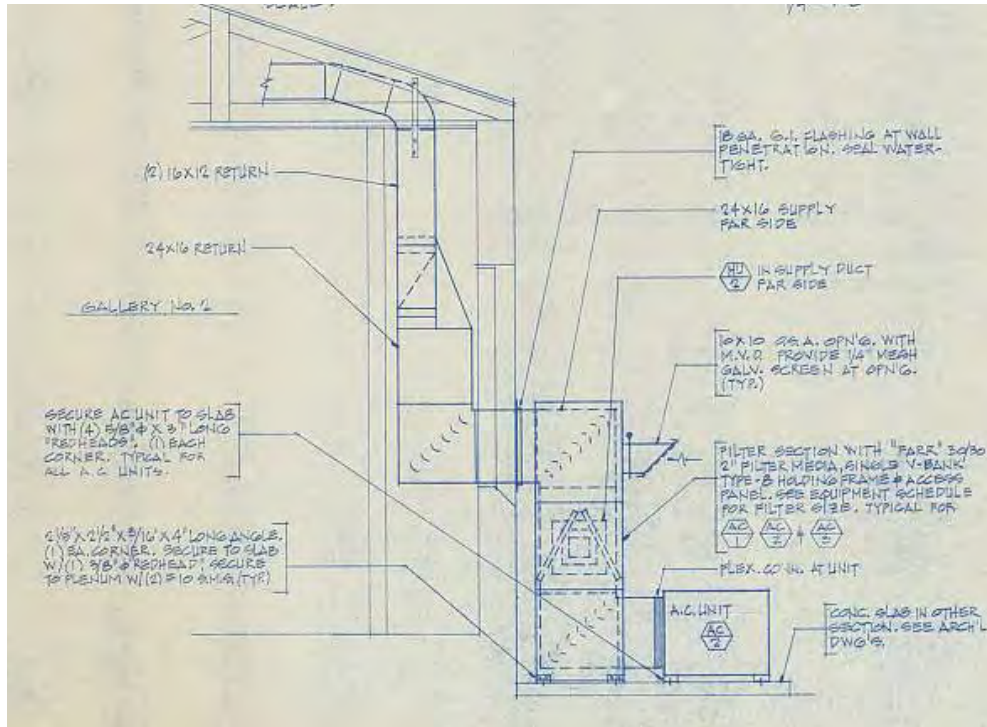
Section detail of existing hard-ducted condition showing undesirable impact on window and interior space

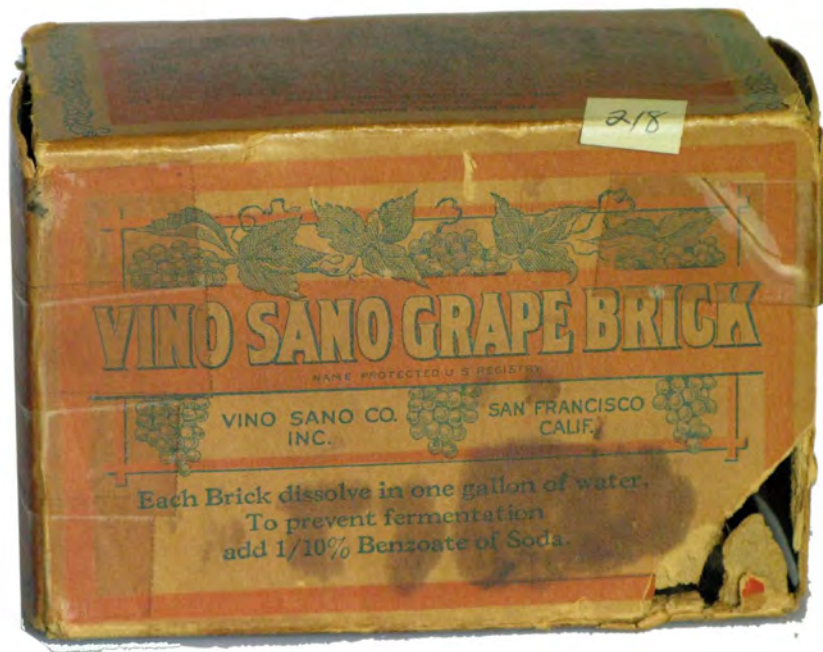
Building Conditions Assessment

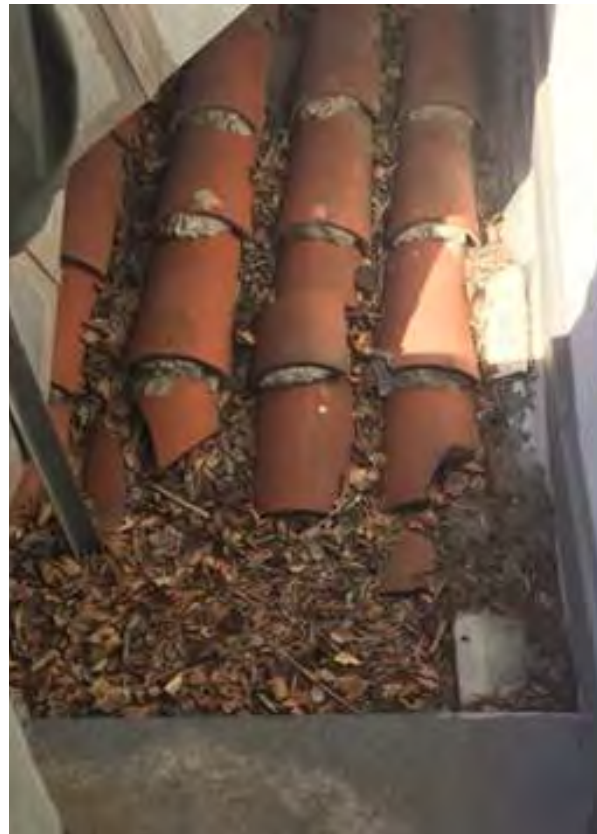
View from mechanical pad to clay tile roof at reported leak location. Note broken tile, heavy debris, and flashing.

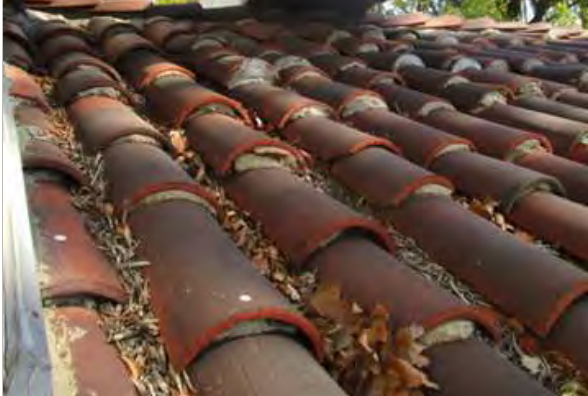
View of clay tile roofing from second floor window; note debris accumulation.

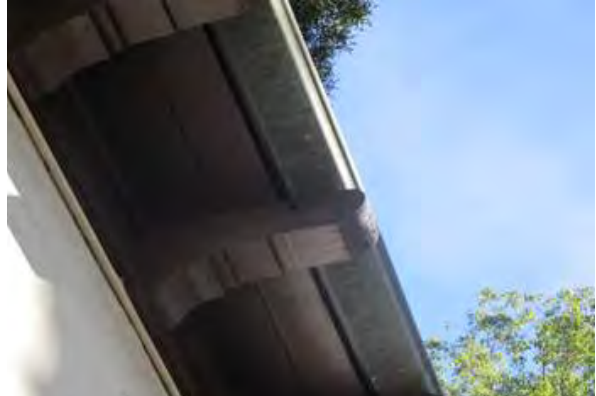
Typical eave condition showing overhang, decorative rafter tails, and copper gutter.

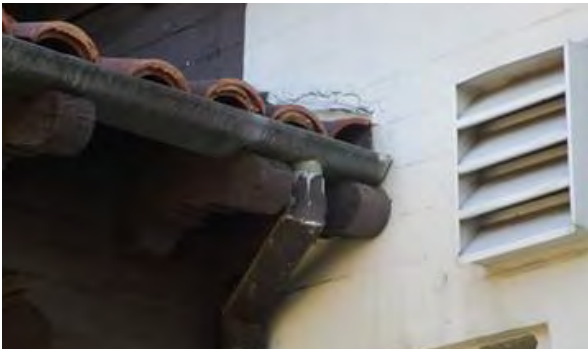
Gutter-to-downspout connection; note drip stains at loose fitting.

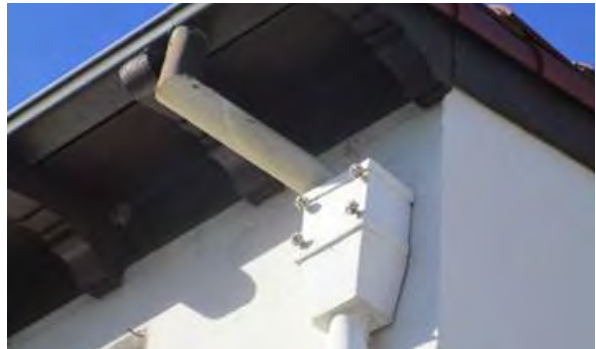
Typical painted downspout and conductor head.

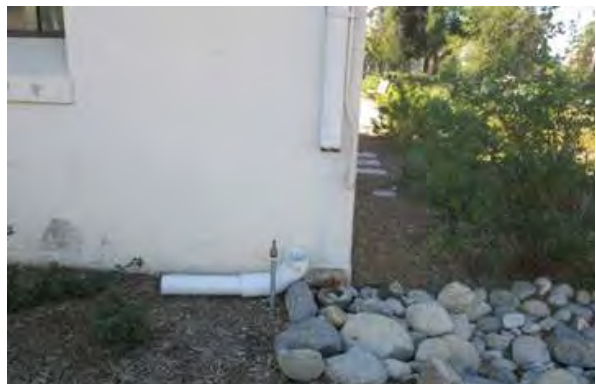
Replacement PVC extension disconnected from downspout at northwest corner of building.

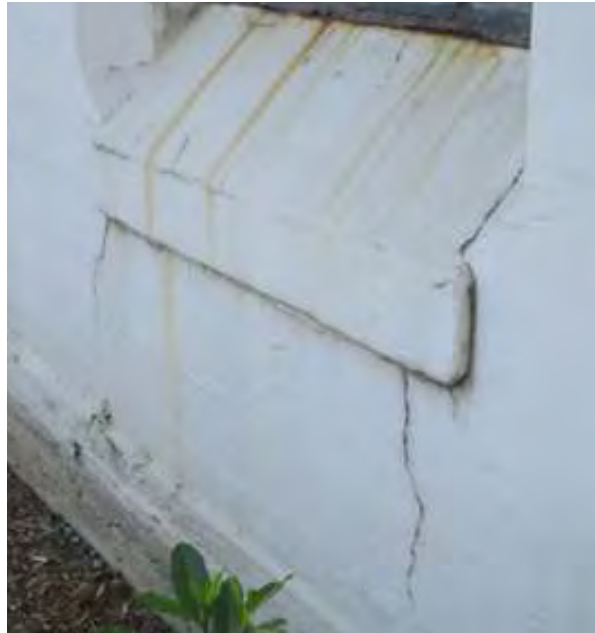
Cracks in concrete at west elevation.

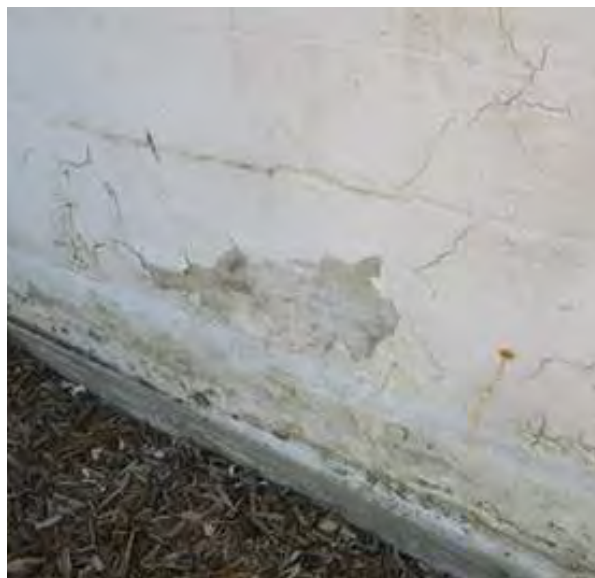
Peeled paint coating at base of wall, west elevation.

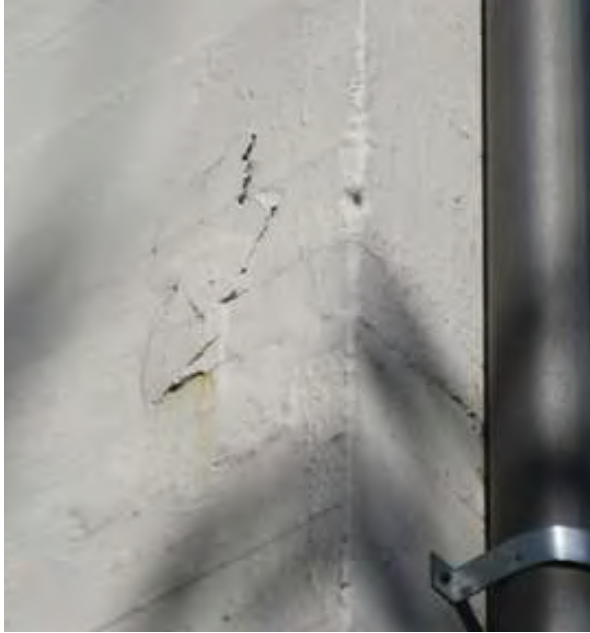
Spalled concrete at east elevation (south return).

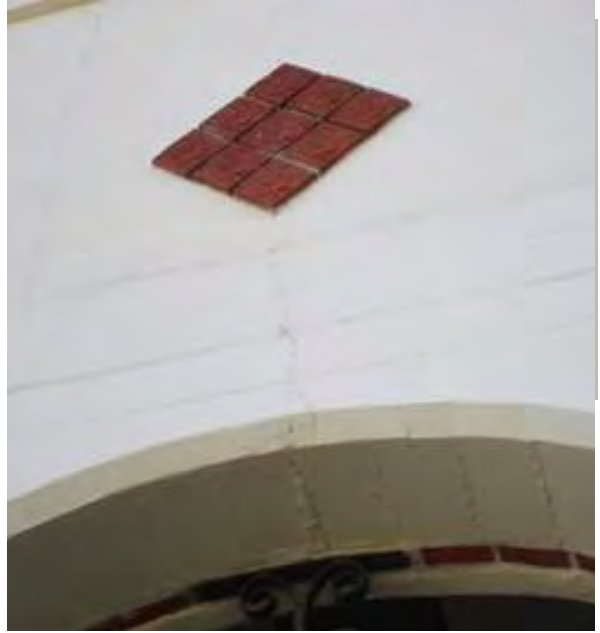
Terra cotta tile details at east courtyard elevation. Note crack at concrete wall and arch below.

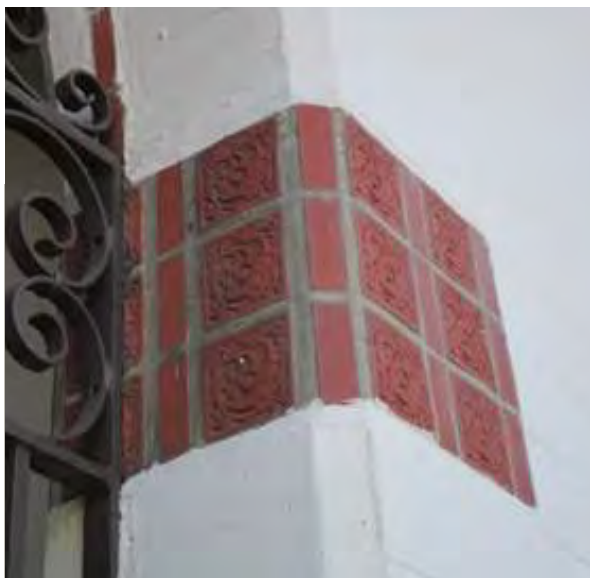
Typical terra cotta tile details flanking entrance bays at east courtyard elevation.

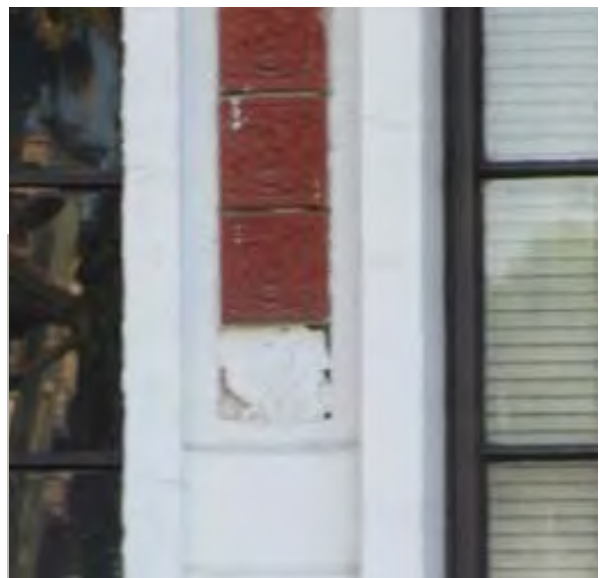
Missing tile between windows at east courtyard elevation.

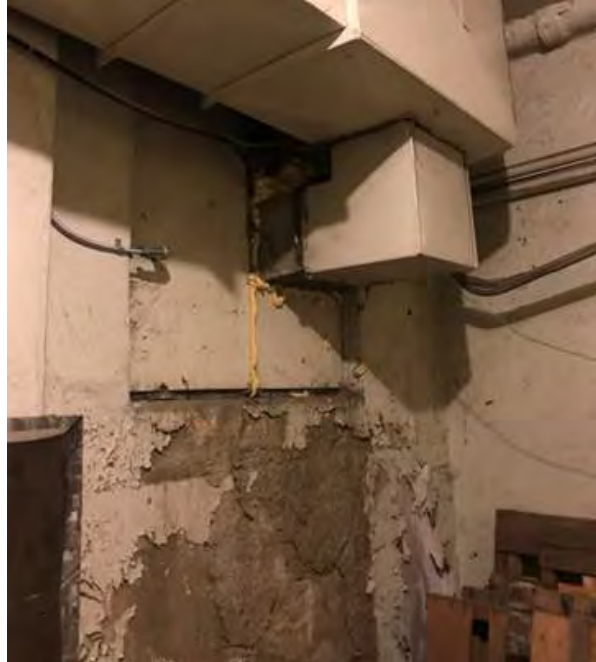
Ductwork installed in basement window opening. Note plywood infill, sealant, and heavy deterioration of wall below.

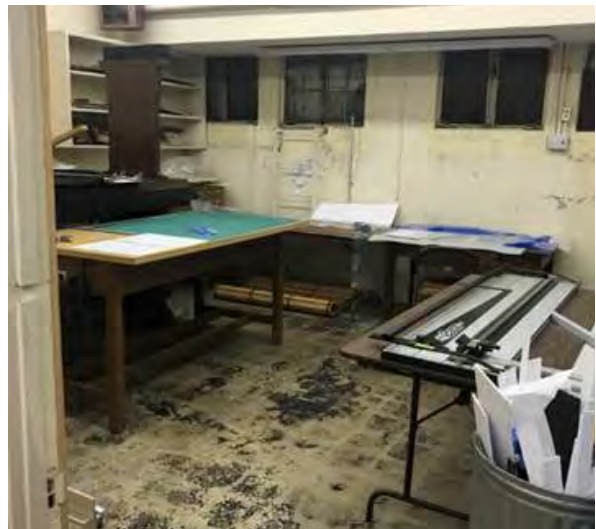
Basement workroom; note vinyl tile has been removed from concrete floor slab.

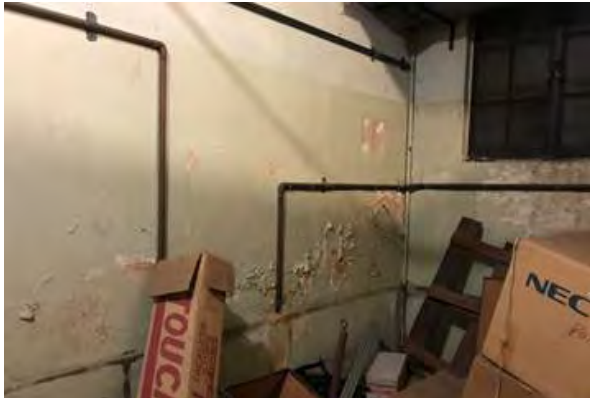
Peeling paint and deteriorated wall finishes at basement storage room.

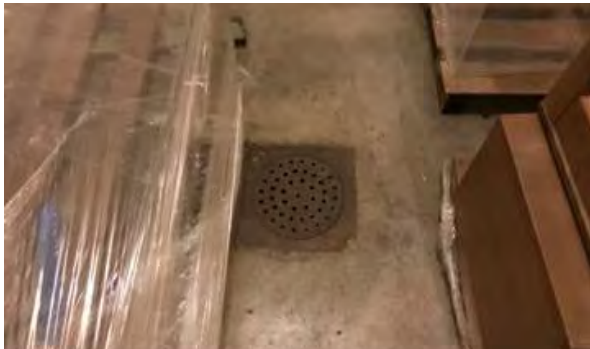
Typical floor drain at concrete floor slab in basement.

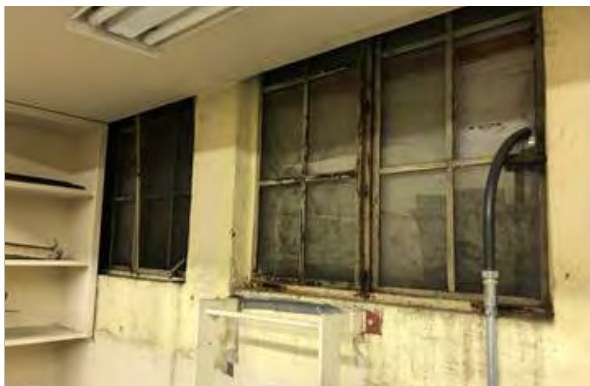
Deteriorated/damaged windows at basement. Windows covered with plywood at exterior.

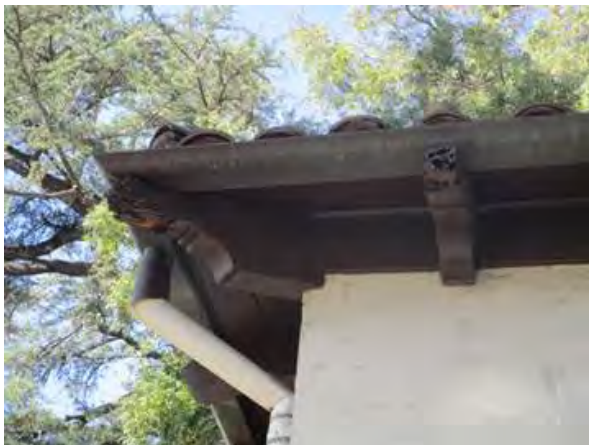
Typical decayed ends of exposed rafters. (northeast corner shown)

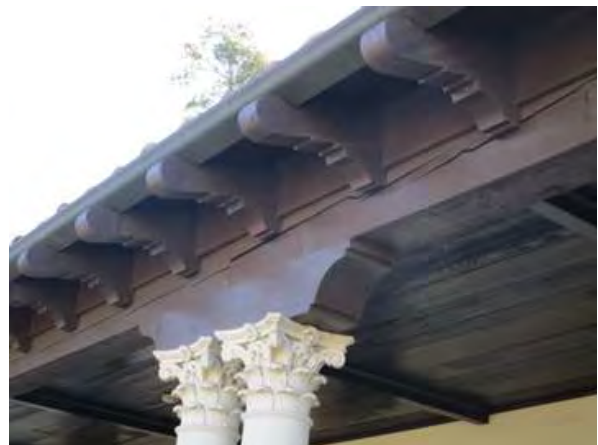
Typical deep checking/splits at veranda wood beams. (south courtyard elevation shown)

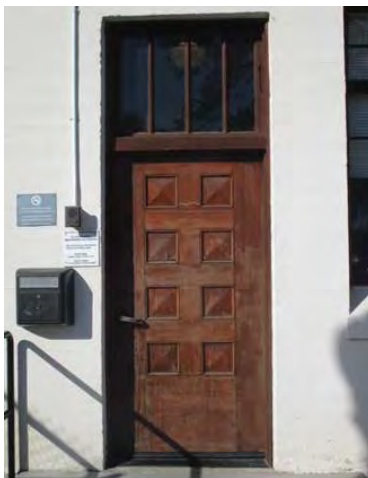
Door and transom at east elevation.

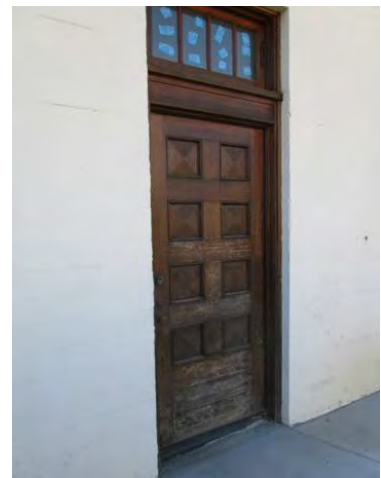
Door and transom at north elevation.

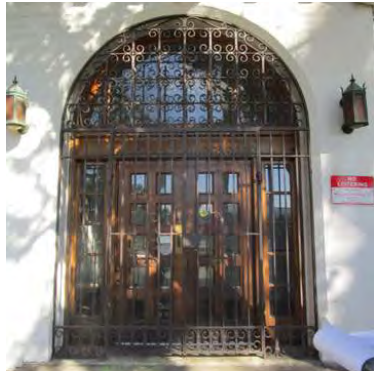
Door, sidelights and arched transom at south elevation.

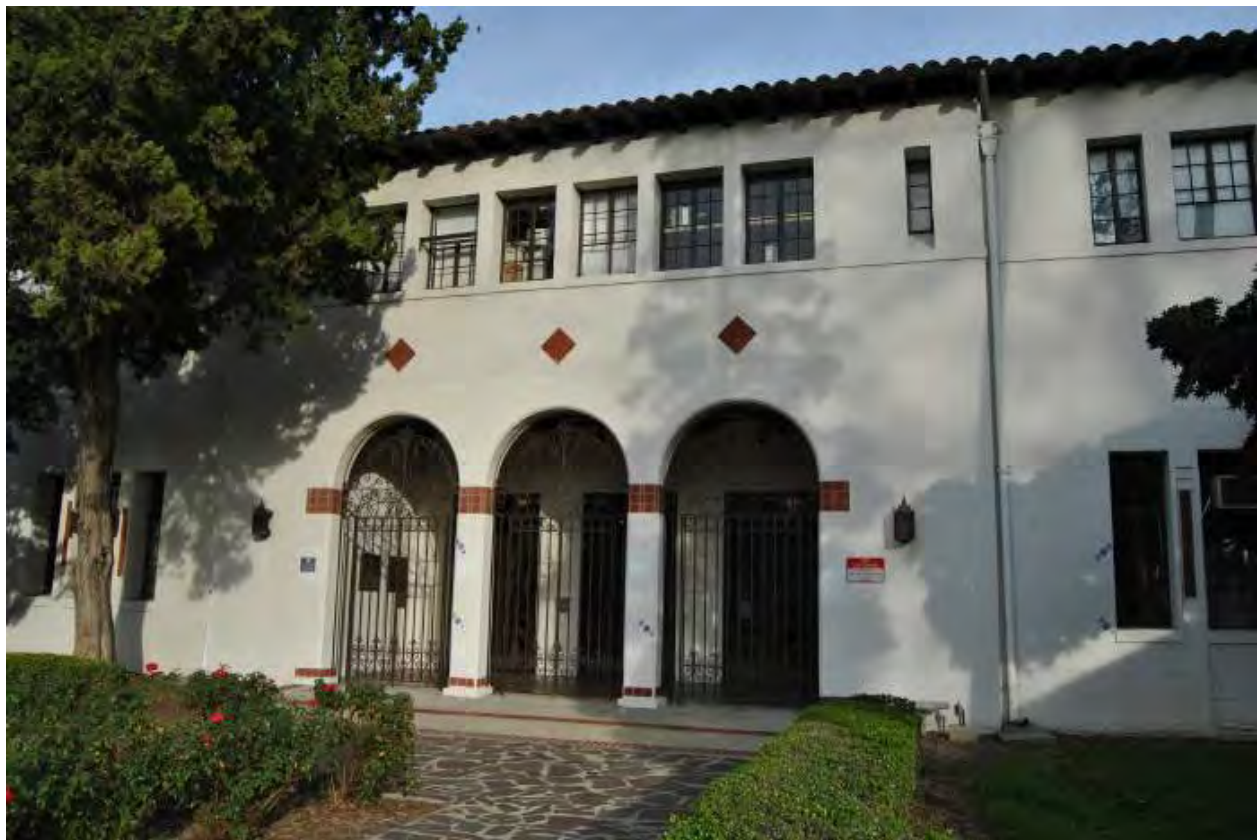
Three gates at west courtyard elevation.

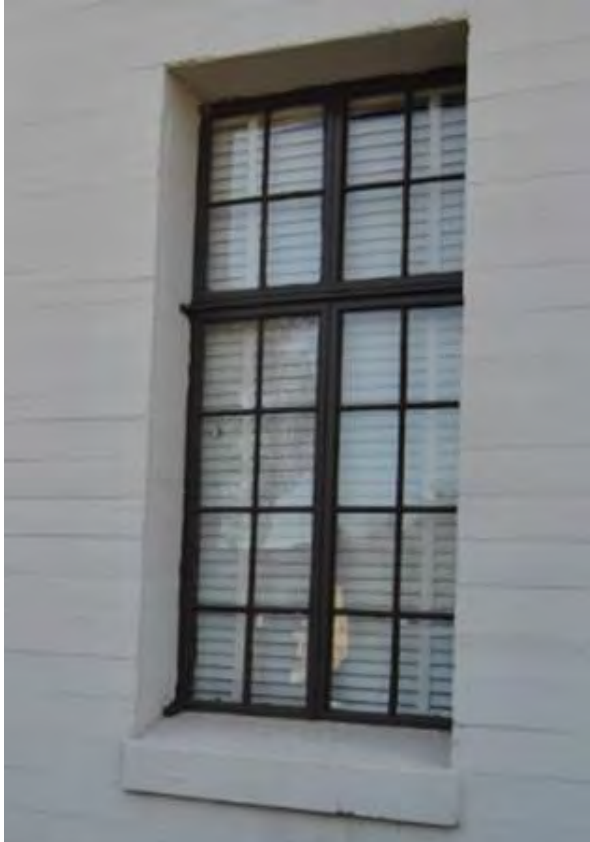
Typical window requiring basic maintenance only.

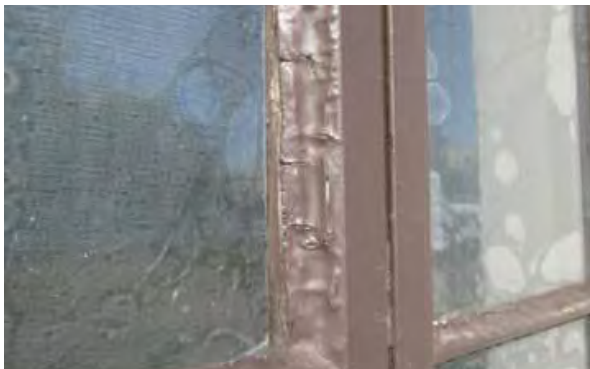
Typical condition at windows requiring basic maintenance; note cracked glazing putty.

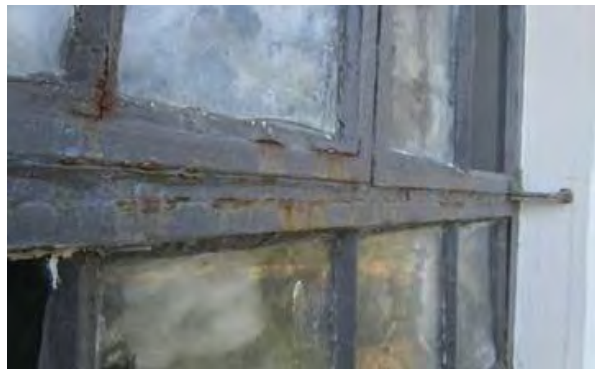
Typical condition at windows requiring more extensive repair; note corrosion of steel components.

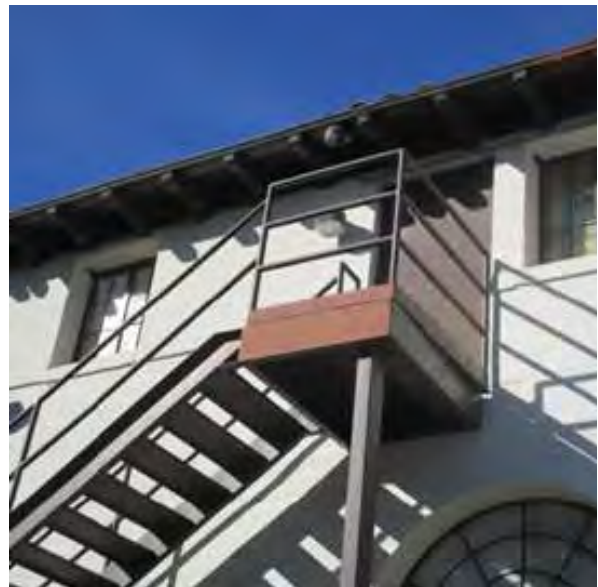
Exit stair at east elevation; note second floor landing and column support.

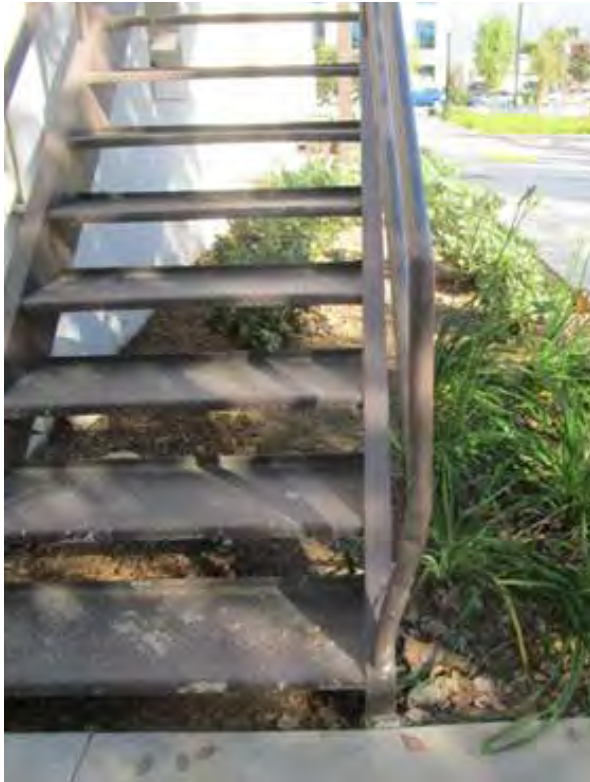
View of steel stair; note damaged rail post.

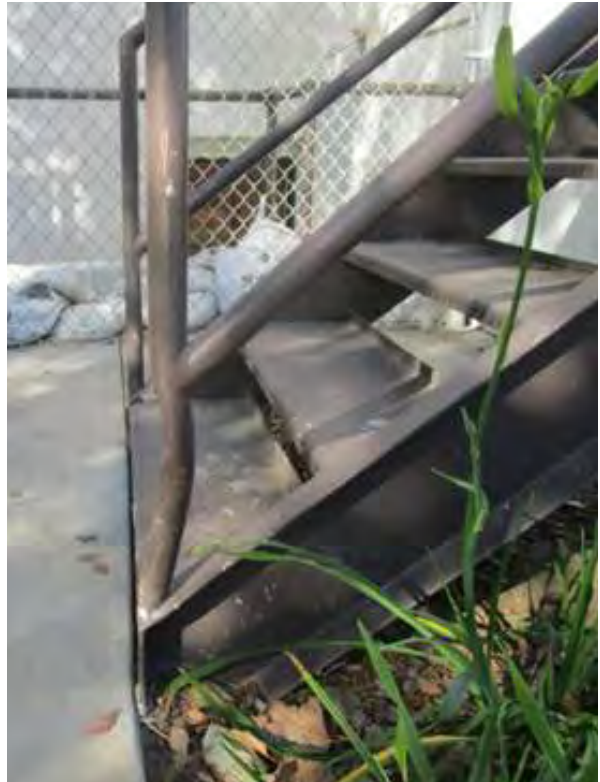
View of steel stair; note damaged rail post.

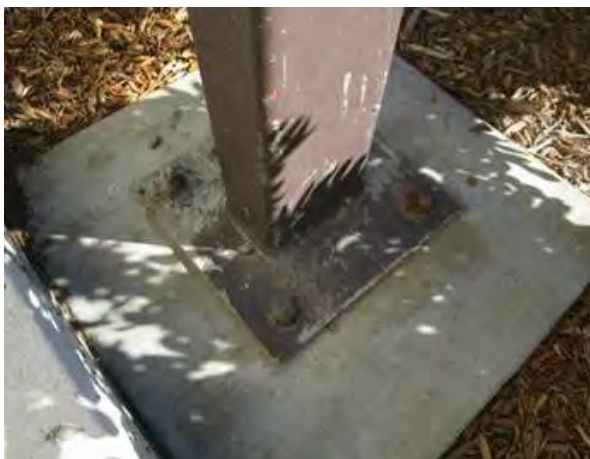
Base plate at steel column support; note corrosion at anchor bolts.

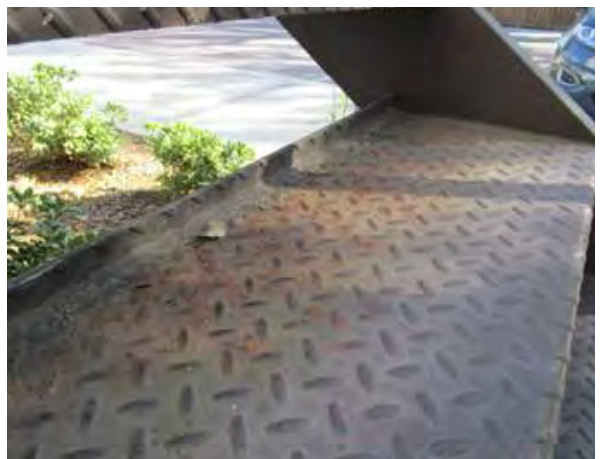
Checker-plate steel stair tread; note surface corrosion and peeling paint.

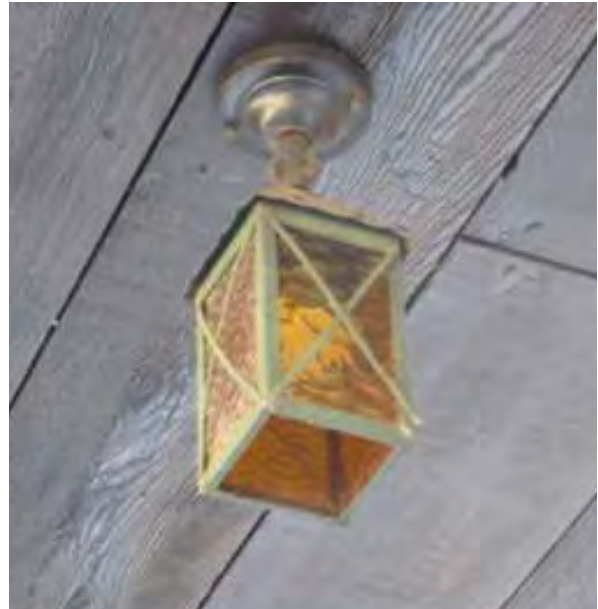
Typical bronze pendant fixture at courtyard veranda soffit.

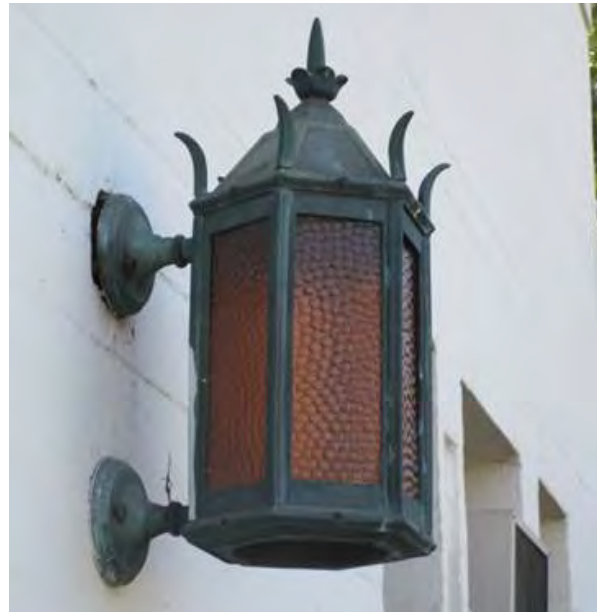
Bronze sconce at exterior entrance, east courtyard elevation; note missing lens at bottom, missing fasteners and localized corrosion products (green).

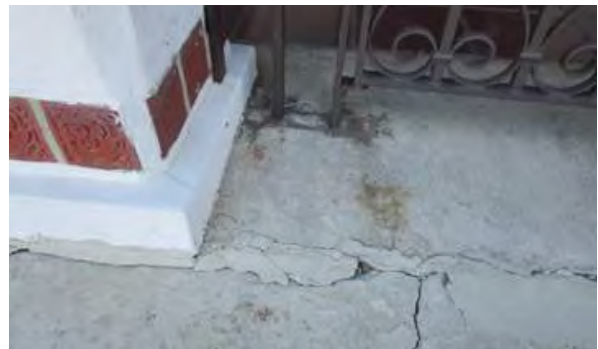
Detail view of damaged concrete.

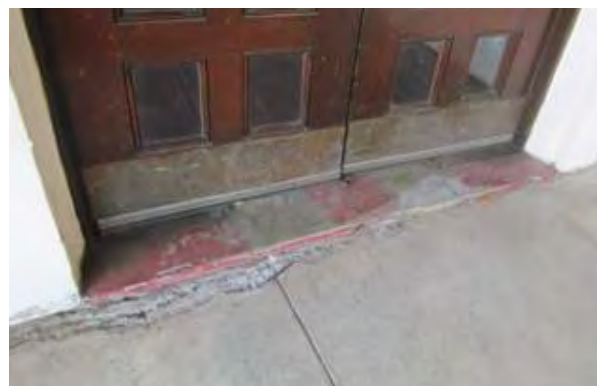
Typical concrete spalling at entrance thresholds, north and south courtyard elevations.

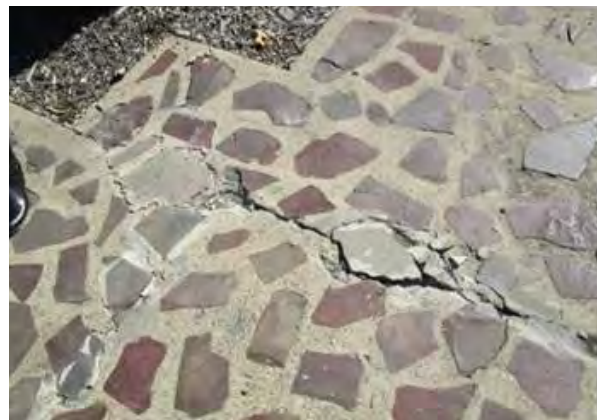
Cracking and spalling at slate paver walkway.

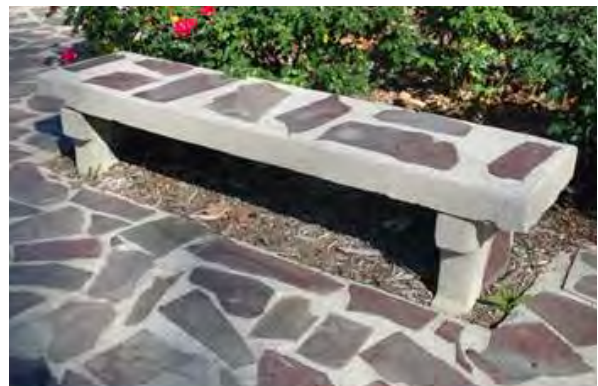
Courtyard bench. (Photo taken Feb. 2016, prior to relocation).

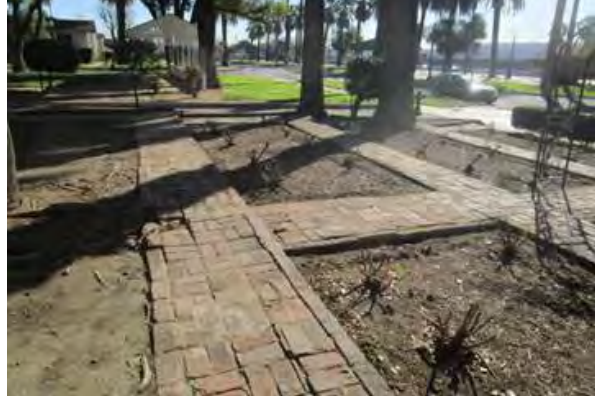
Damaged brick pavers at rose garden.

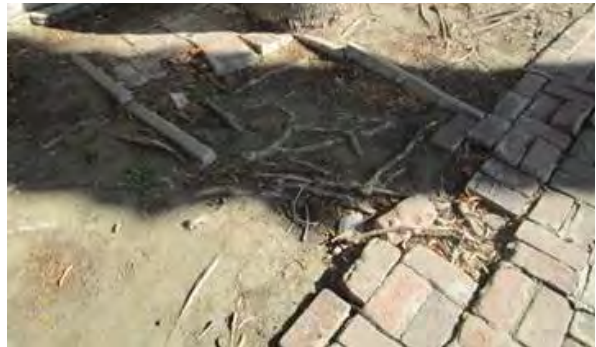
Walkway extension with missing brick pavers and tree root damage.

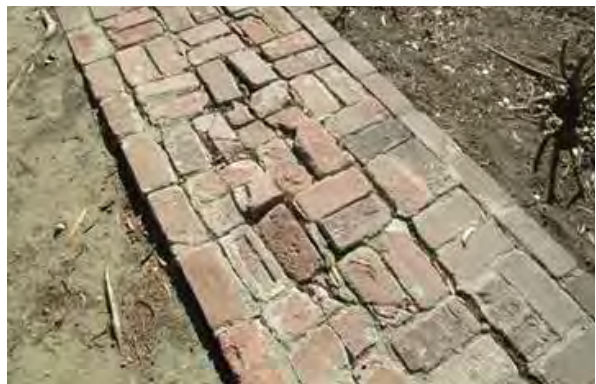
Uneven/deteriorated brick pavers and mortar joints.

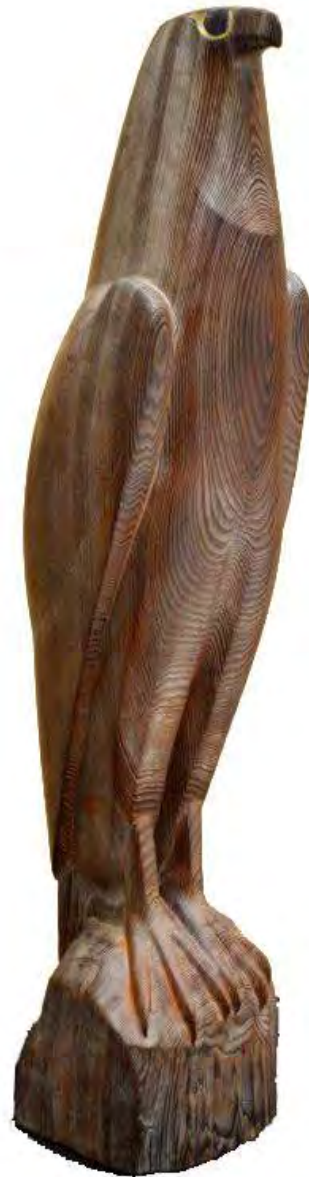
Building Treatment Recommendations

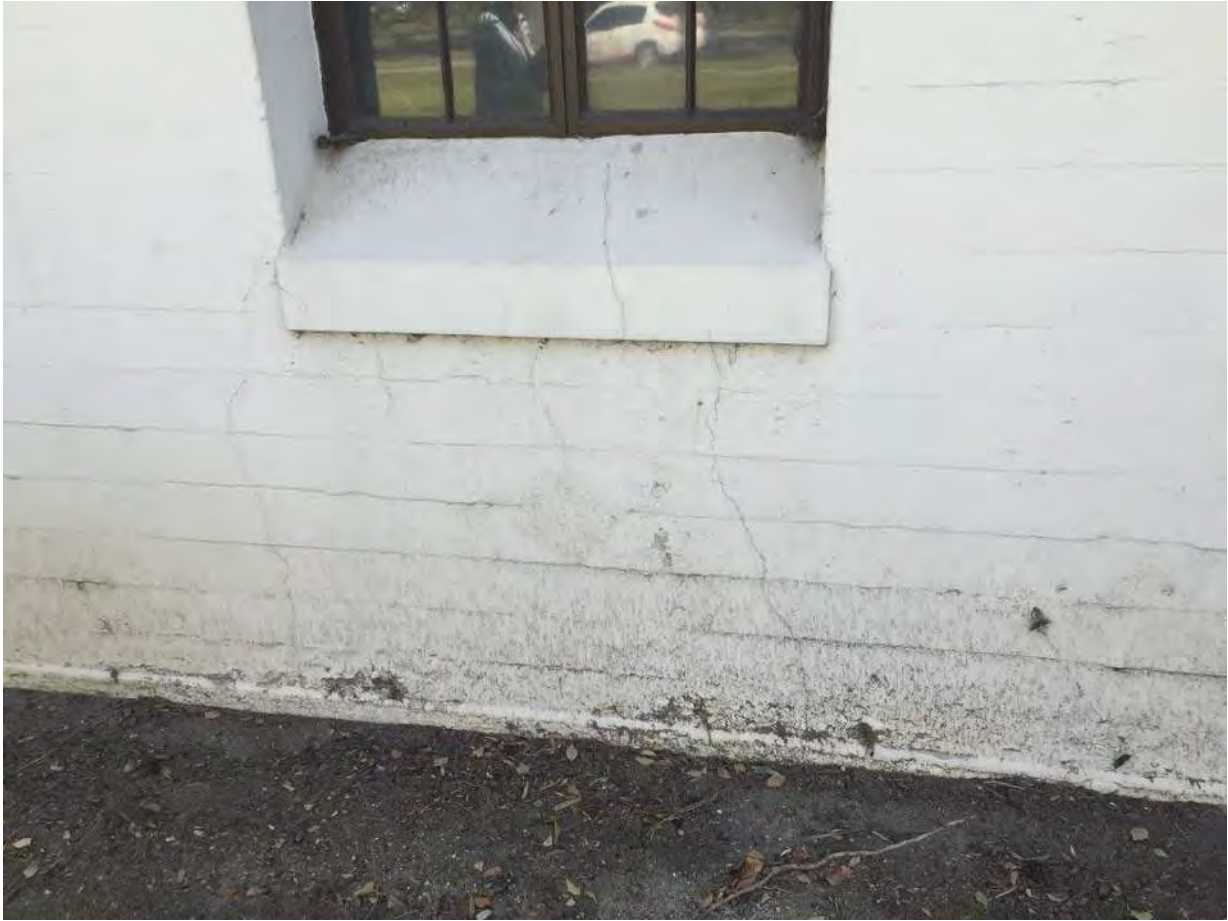
Image 6. Common crack pattern below exterior window.
