Building Assessment & Master Plan

Ontario Museum of History & Art

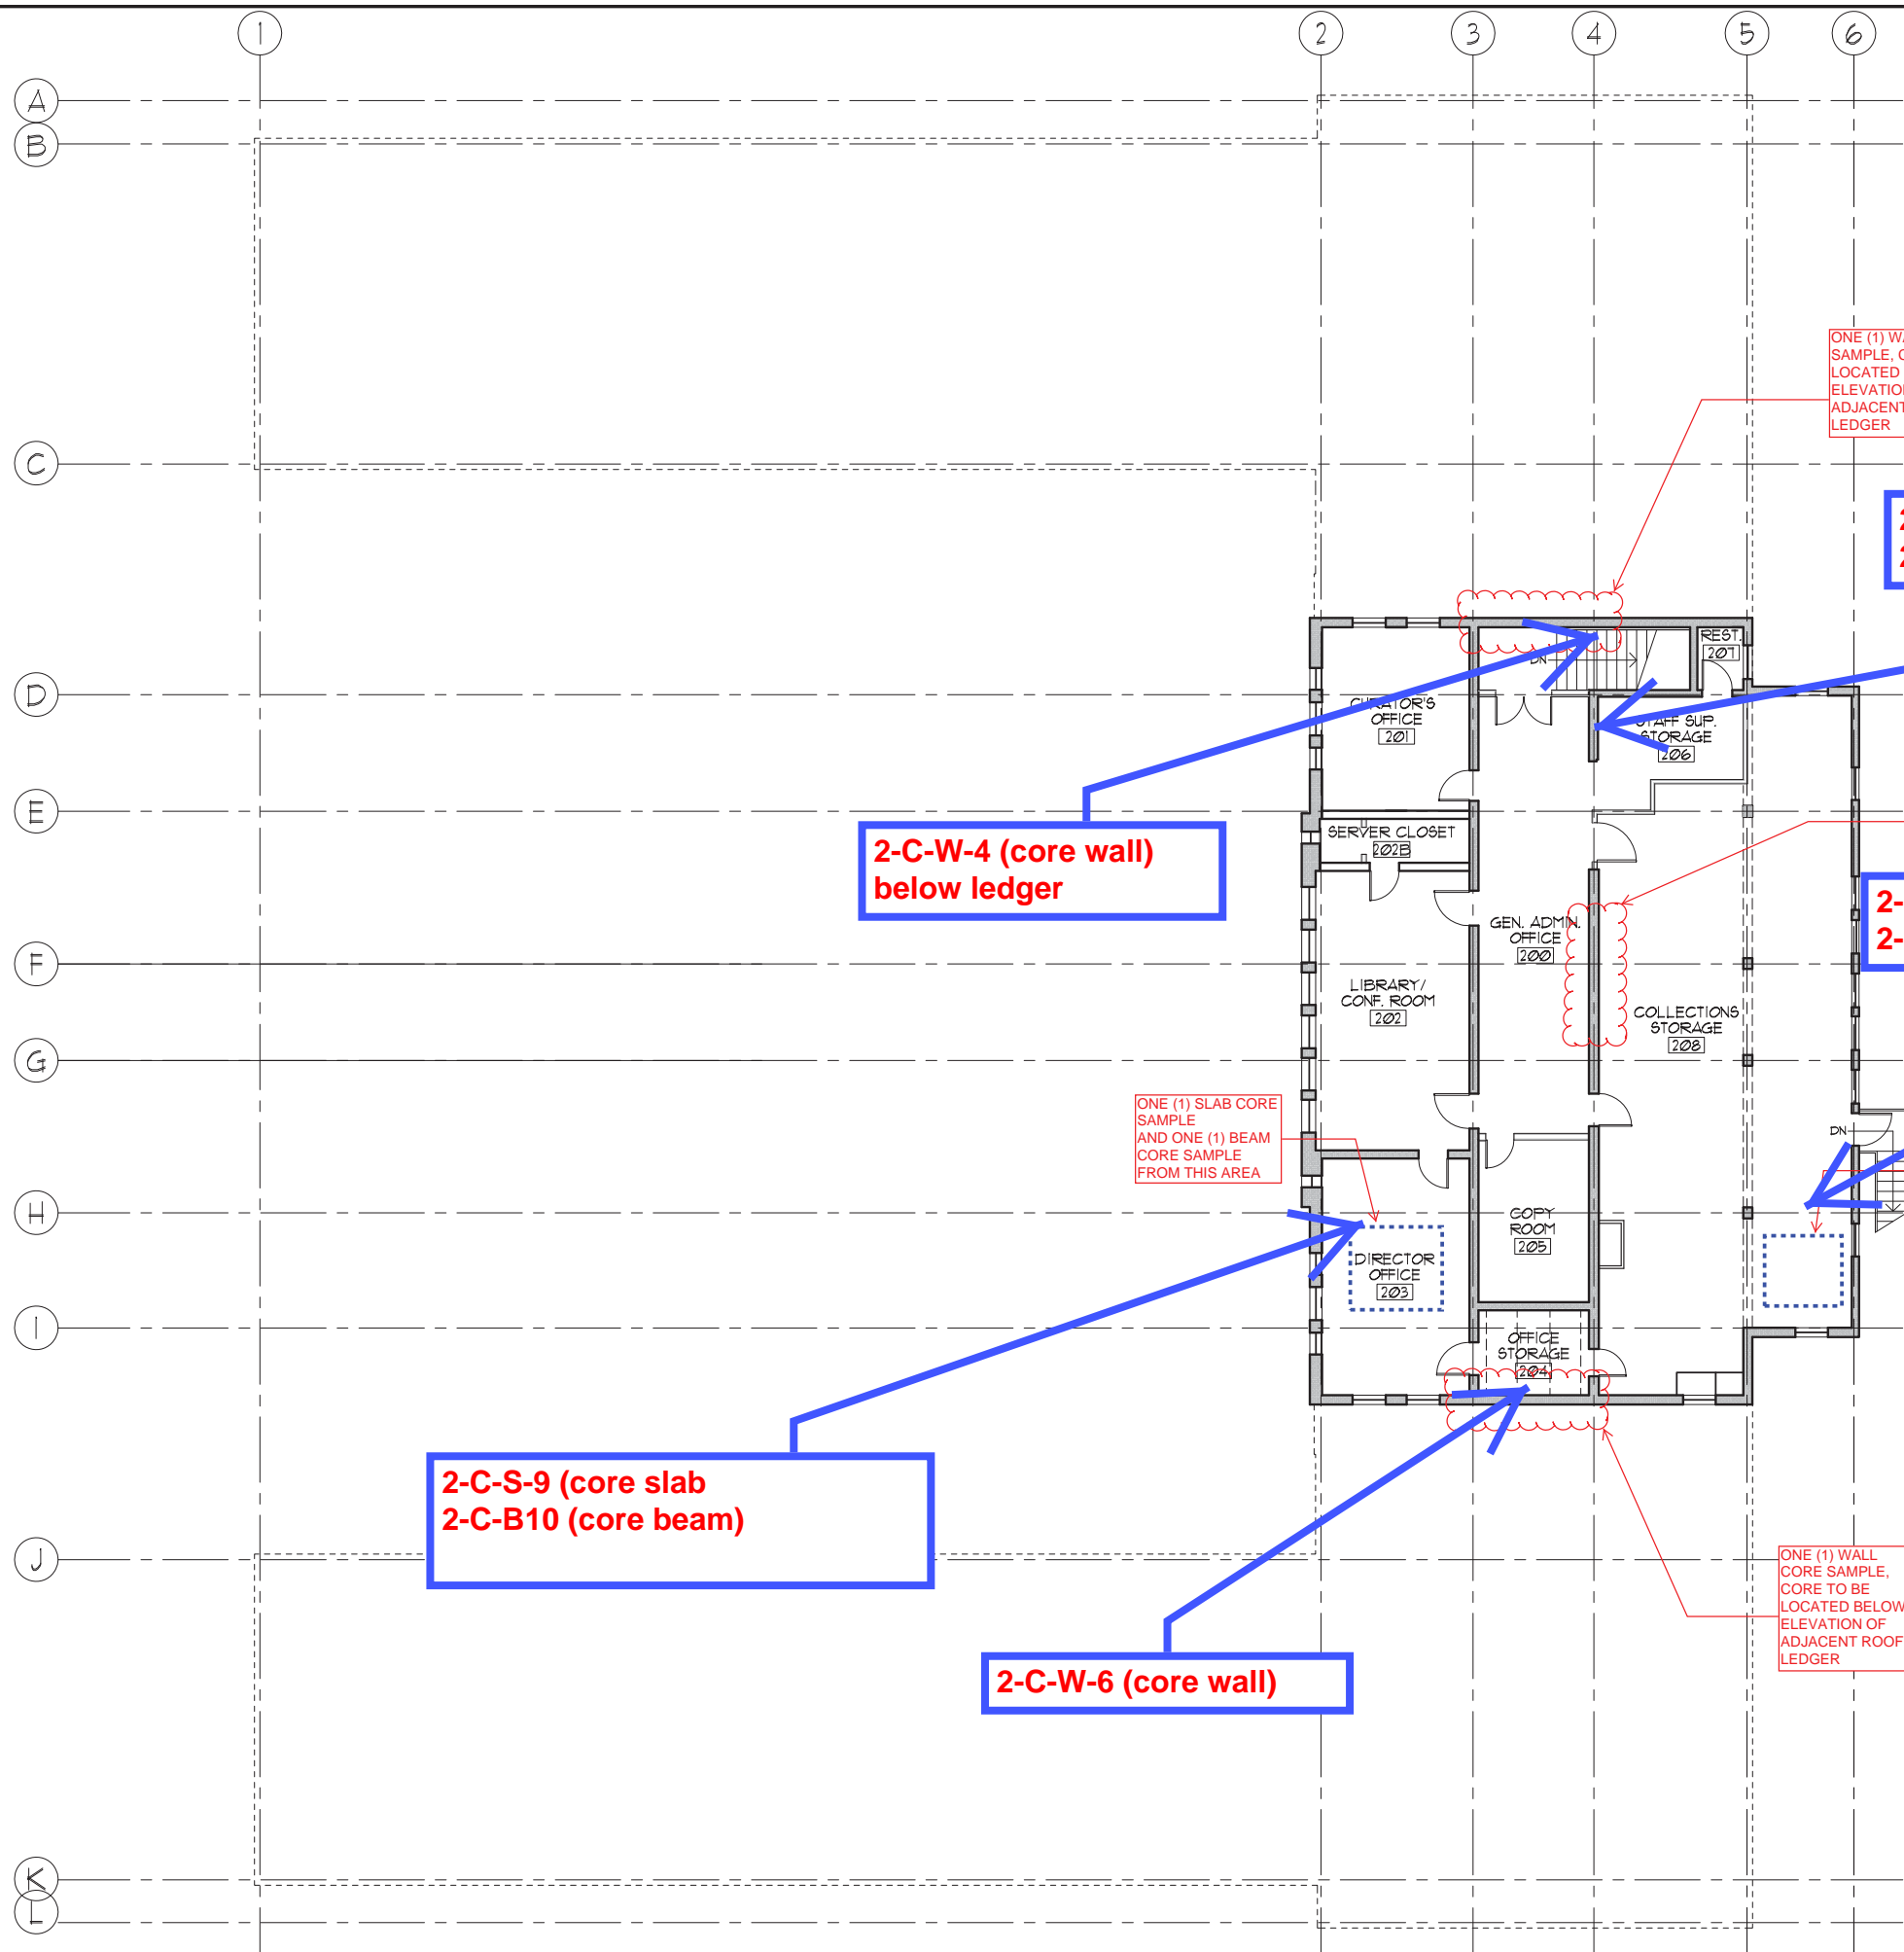
ONE (1) WALL CORE SAMPLE, CORE TO BE LOCATED BELOW ELEVATION OF ADJACENT ROOF LEDGER

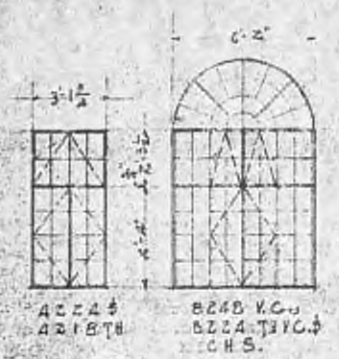
ONTARIO CITY HALL
 FOUNDATION PLAN
 DETAILS OF FOOTINGS
 SCALE 1/8" = 1'-0"
 DENITT MITCHELL ARCHT. ENGRS.
 615 - D. ST. SAN DIEGO, CALIF.

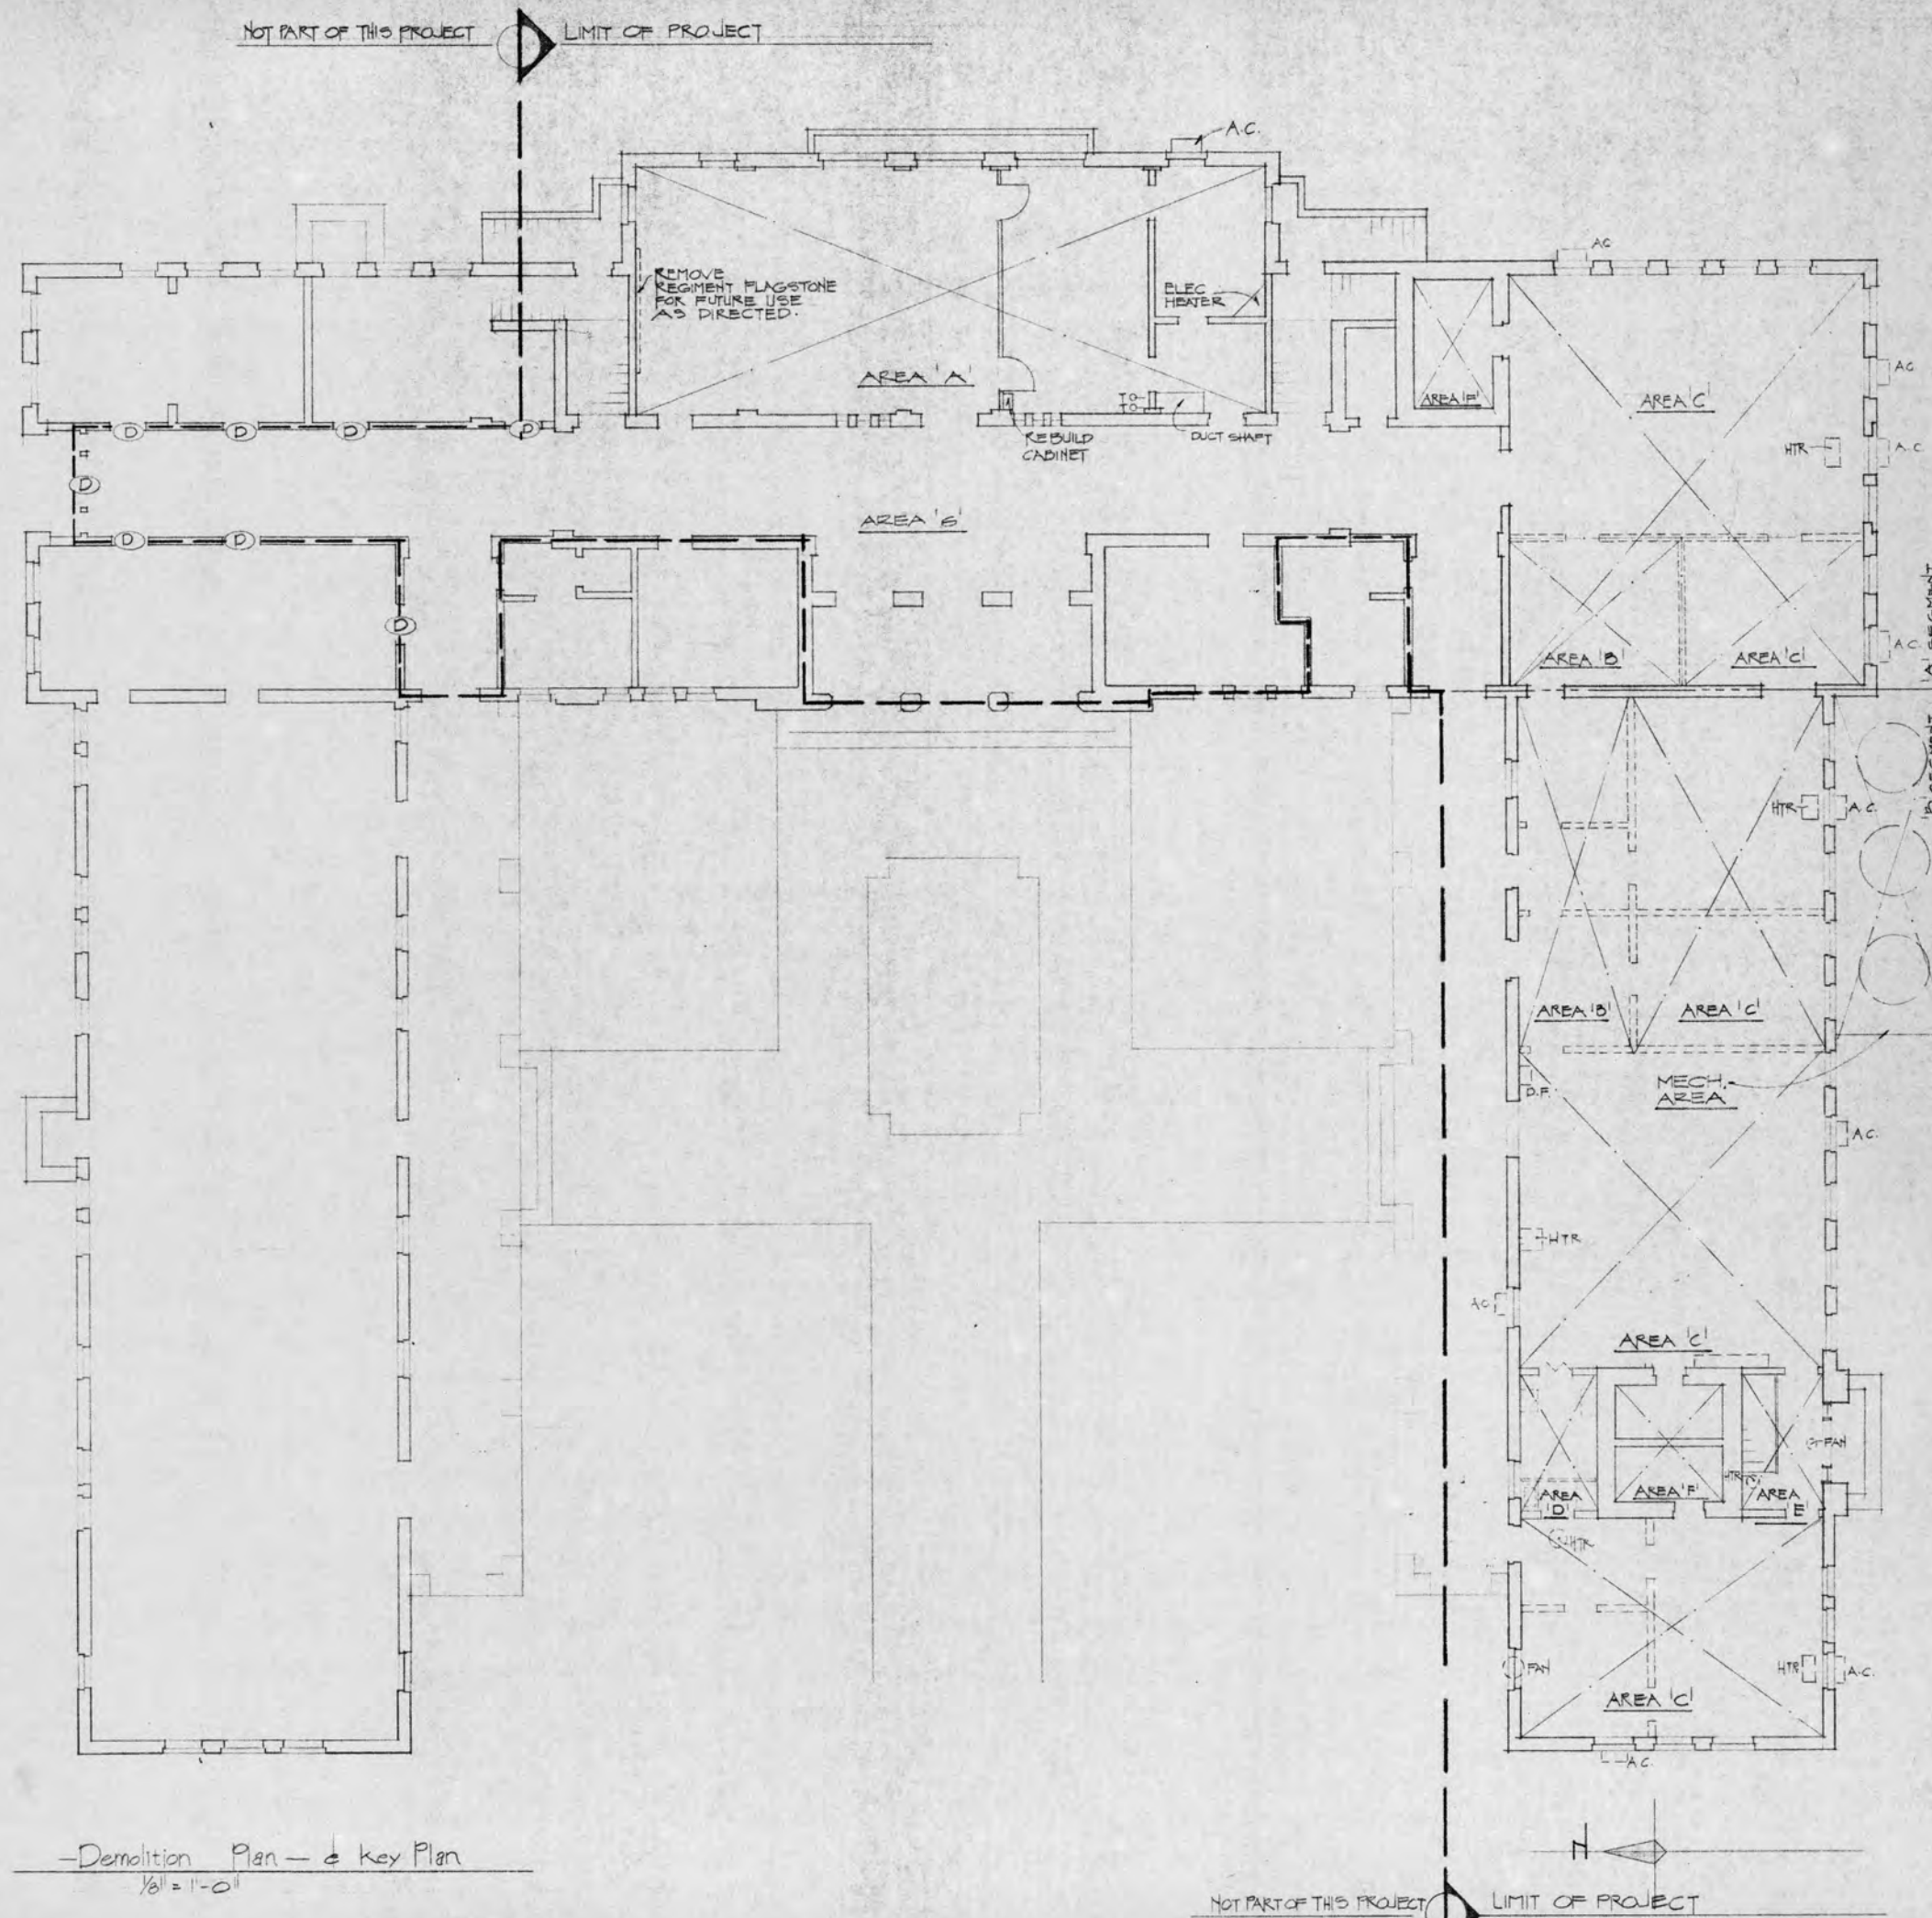
AREA	DEMO REQUIRED
A)	1. REMOVE EXIST'G LIGHT FIXTURES. 2. REMOVE EXIST'G A/C TILE (GLUE UP TYPE). 3. REMOVE DAMAGED WOOD TRIM @ DOORS & WINDOWS. 4. REMOVE EXIST'G DOORS & HRTAKE - RAIL & GATES. 5. REMOVE EXIST'G CARPET, PAD ETC. W/ DAMAGED WOOD BASE. 6. SCRAPE & CLEAN EXIST'G WALL FINISH PATCH AS REQ'D TO MATCH EXIST'G. 7. REMOVE LEAD & WOOD INSERTS FROM WALL OPENINGS. 8. REMOVE EXIST'G A.C. UNITS & ELEC. HEATER.

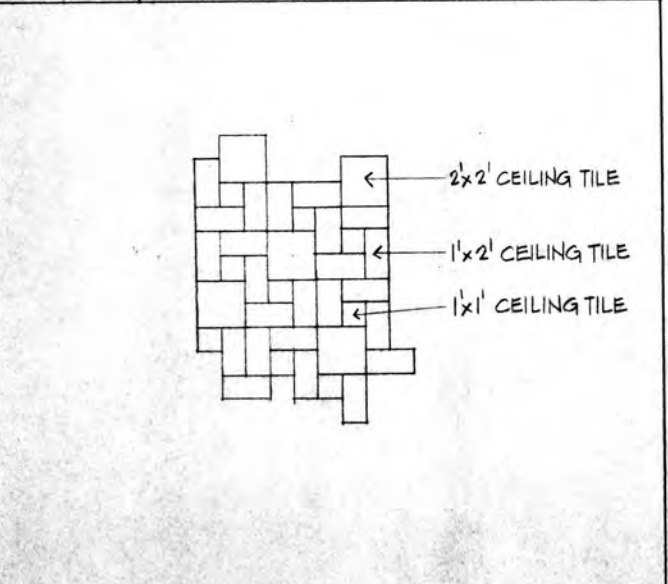
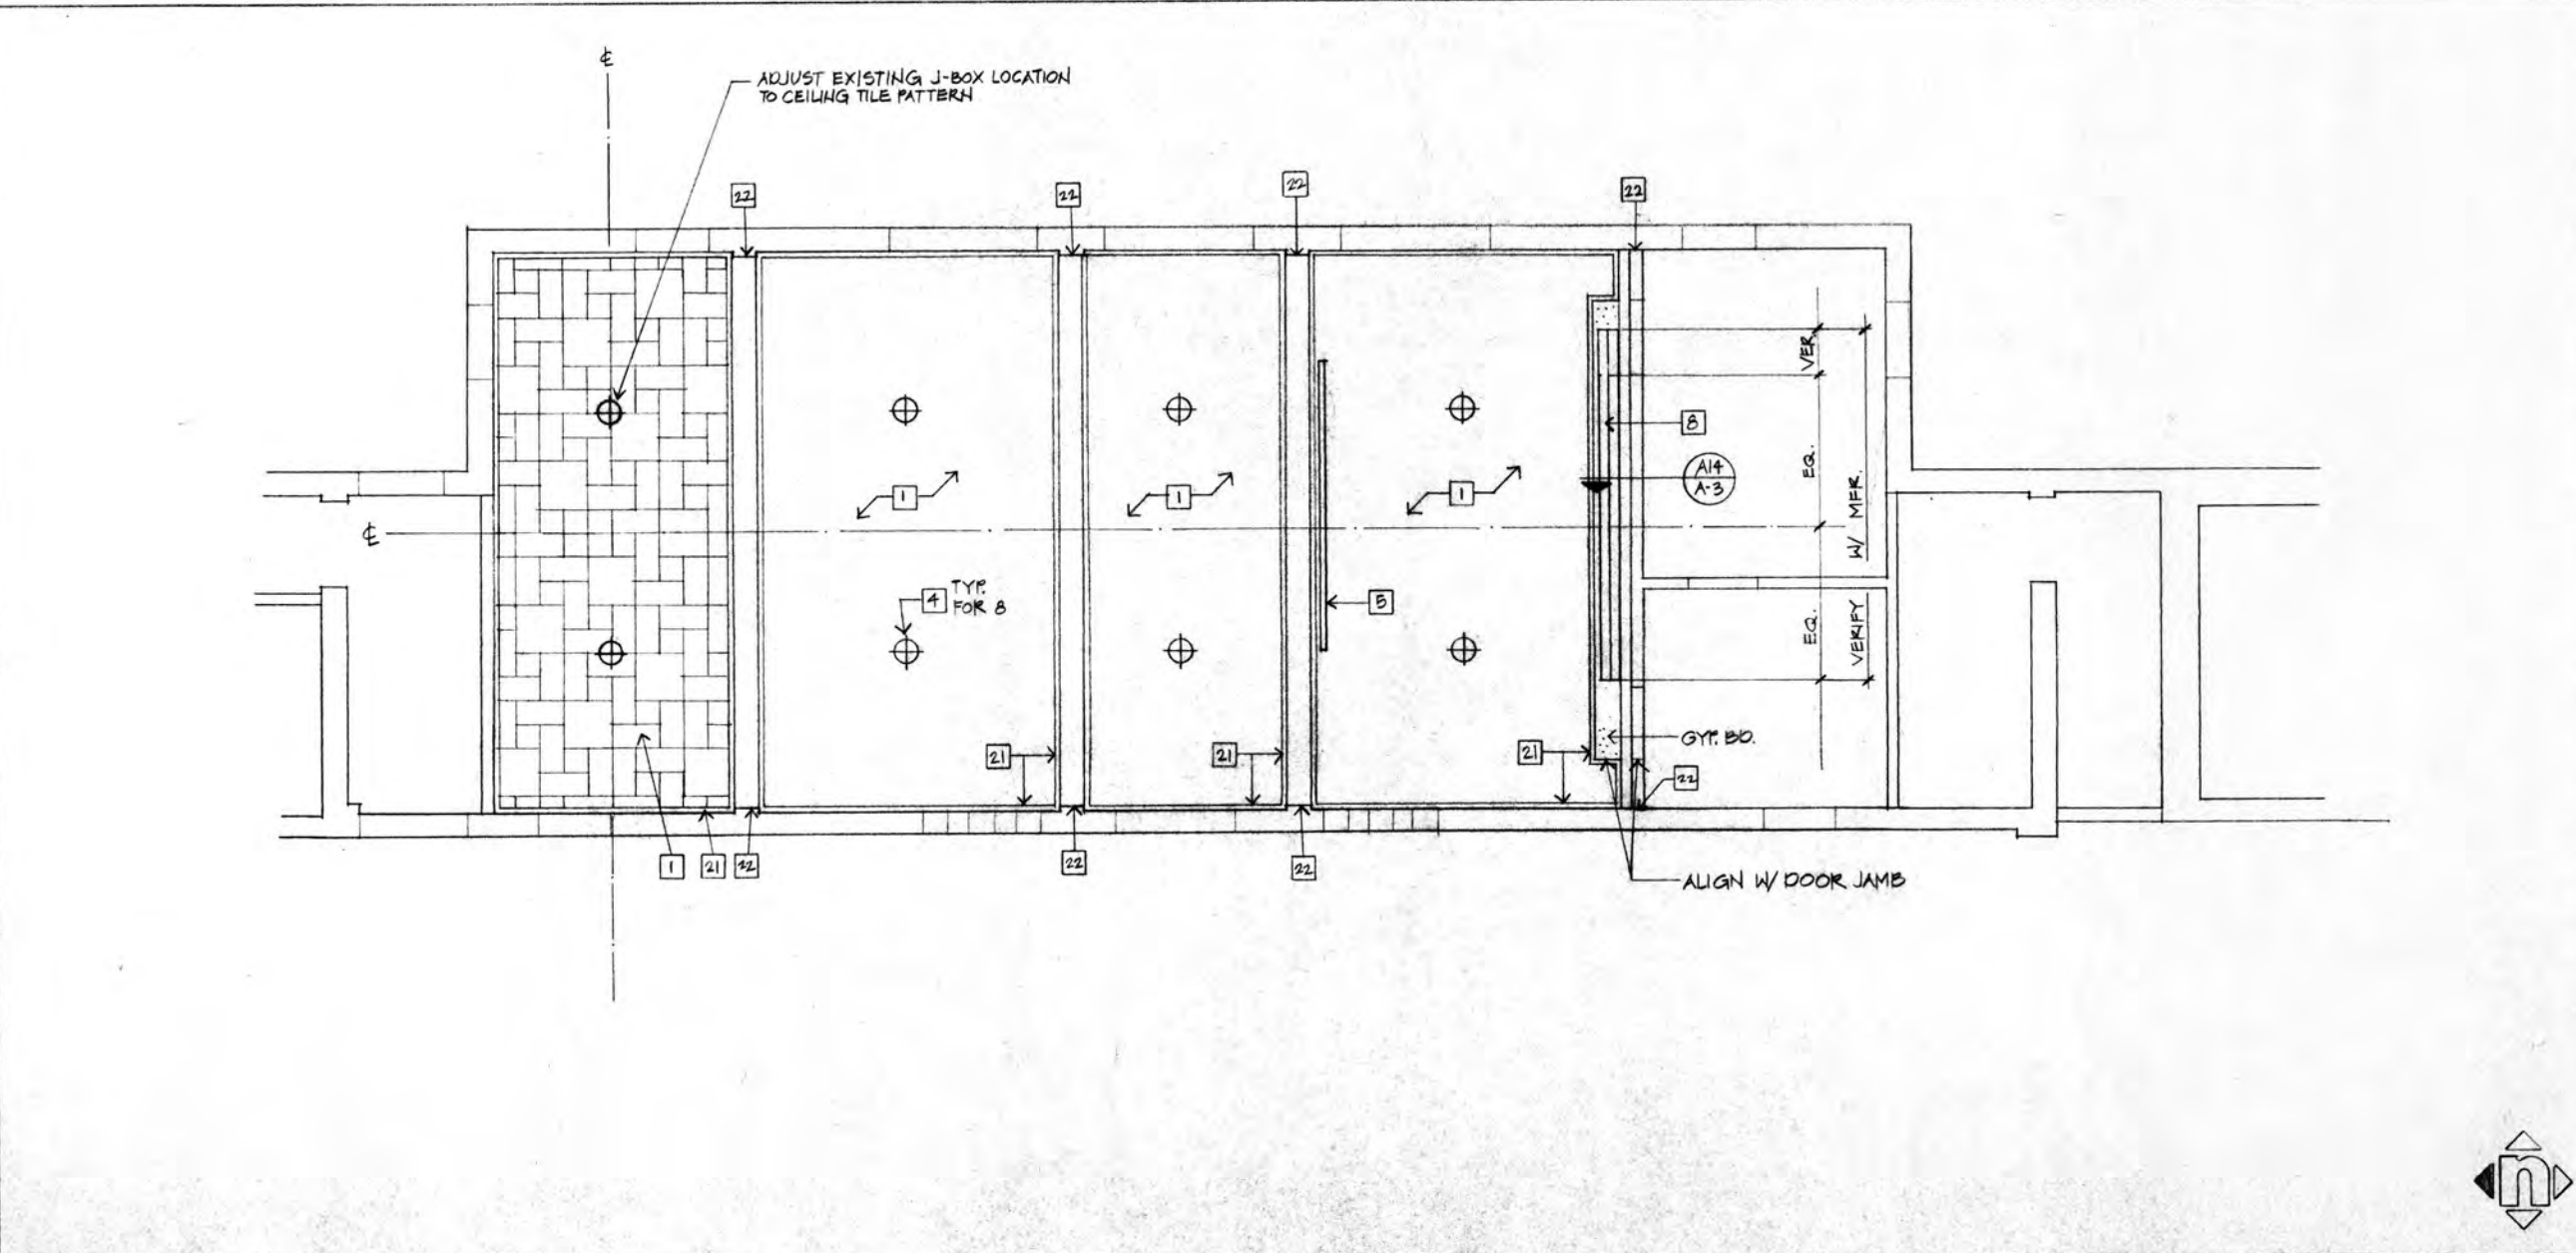
- NOTE:**
- SHEET LINOLEUM BASE BID IS PER NOTE #3 ABOVE
 - SHEET LINOLEUM ALT BID #1 (ADDITIVE) PROVIDE CARPET TILES OVER THE EXISTING (PROVIDE BID ALLOWANCE OF \$322 SQYD.)
 - SHEET LINOLEUM ALT BID #2 (ADDITIVE) REMOVE EXISTING SHEET LINOLEUM AND REPLACE WITH NEW SHEET LINOLEUM. (SEE SHEET A1 FOR ADDITIONAL WORK.)
 - INSTALL MISSING WOOD TRIM. FINISH TO MATCH (E) ADJACENT WOOD TRIM.

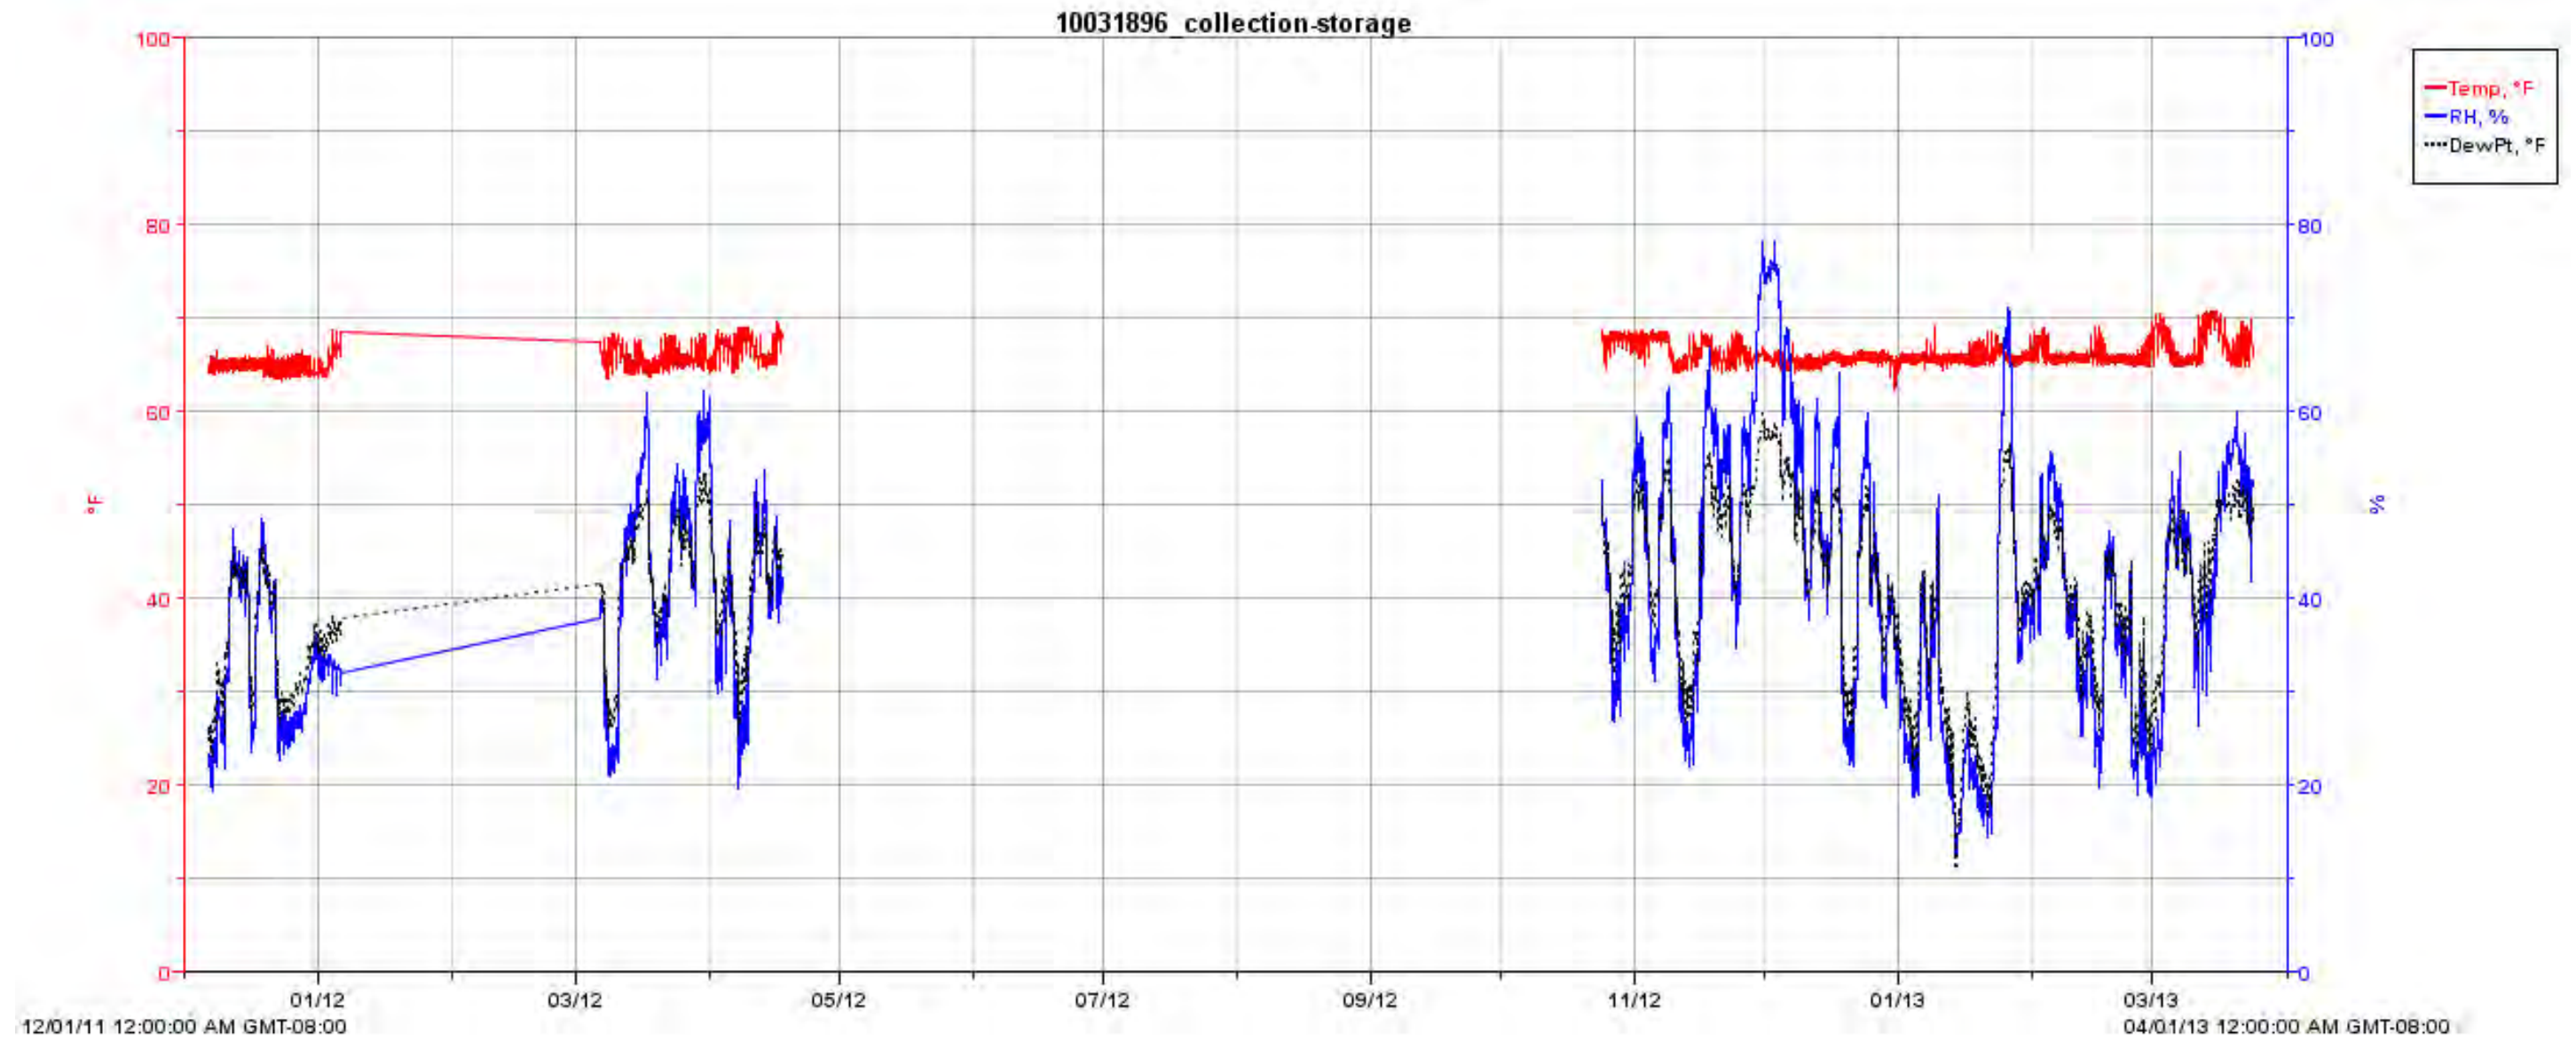
Ontario Museum MEP Condition Assessment Report

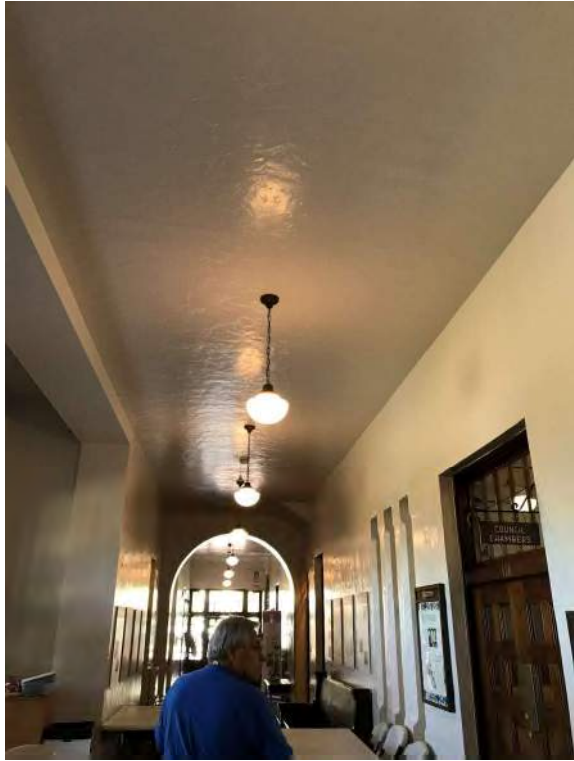
Figure 1 - 1st Floor Corridor Lighting

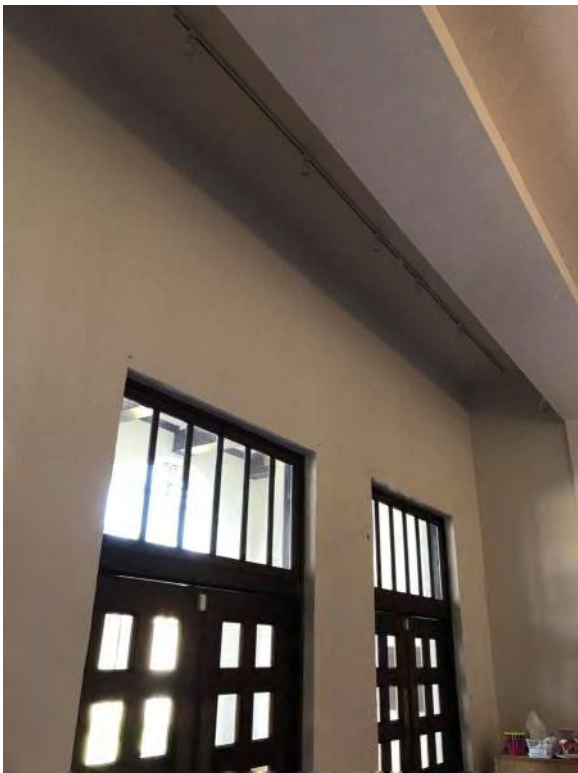
Figure 3 - Sample Missing Exit Sign/Emergency Fixture

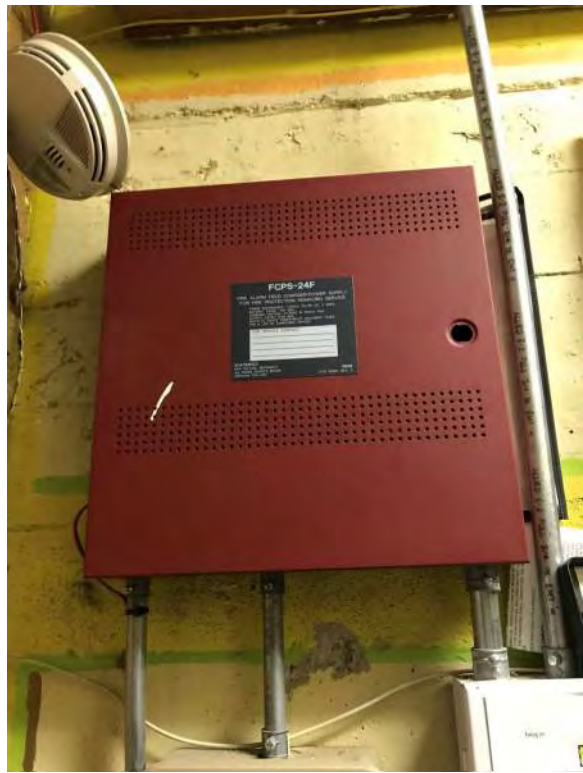
Figure 4 - Missing Fire Alarm Control Panel
