ARBORIST REPORT BY DANE SHOTA, APRIL 2011

TREE ASSESSMENTS FOR GUAISTI WINERY

Dane S. Shota Certified Arborist
16835 Algonquin Street # 172
Huntington Beach, CA 92649-3825
Office (714) 377-1181, Fax (714) 846-8848

April 2011

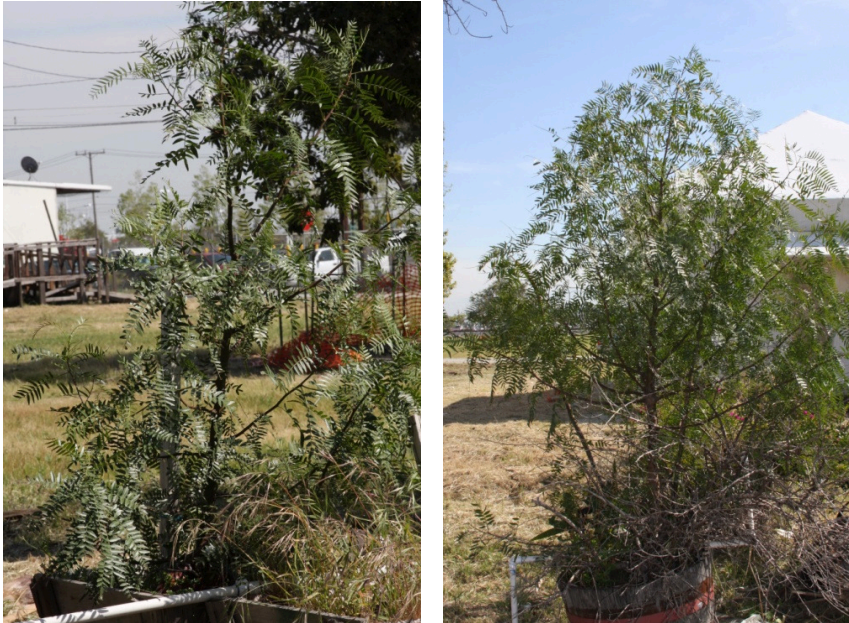
Schinus molle has an inherent trait of heart rot when they get to an older stage. These trees may look pleasant, however when they get older they are not structurally sound. Many of these trees have failure (fallen limbs or trunks).

Schinus molles has been put on the do not plant list because they are invasive. Here are two trees (pictured above) that planted themselves by birds or wind in the Guasti tree nursery; this shows how invasive they are.

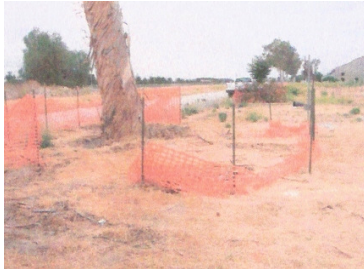
Diagram A

Plastic construction fencing (diagram A) is easily moved, deteriorates, or destroyed by construction activities and therefore not recommended unless it is hung and interwoven from heavy gauge wire attached between sturdy posts with plastic fencing materials changed out when deteriorated. A better method, often specified by municipalities, is the installation of chain link, wire mesh fence or wood fence (see Diagram b). The fencing should ideally be 4 to 6 feet (1.2 to 1.8 m) tall or higher and solidly anchored into the ground. In all cases, fencing should meet or exceed local ordinances. Root systems from trees on adjacent properties may also need to be fenced on the construction site side.
