Appendix E1 Biological Resources Report

Biological Technical Report for the Ontario Regional Sports Complex Project

San Bernardino County, California

March 2024

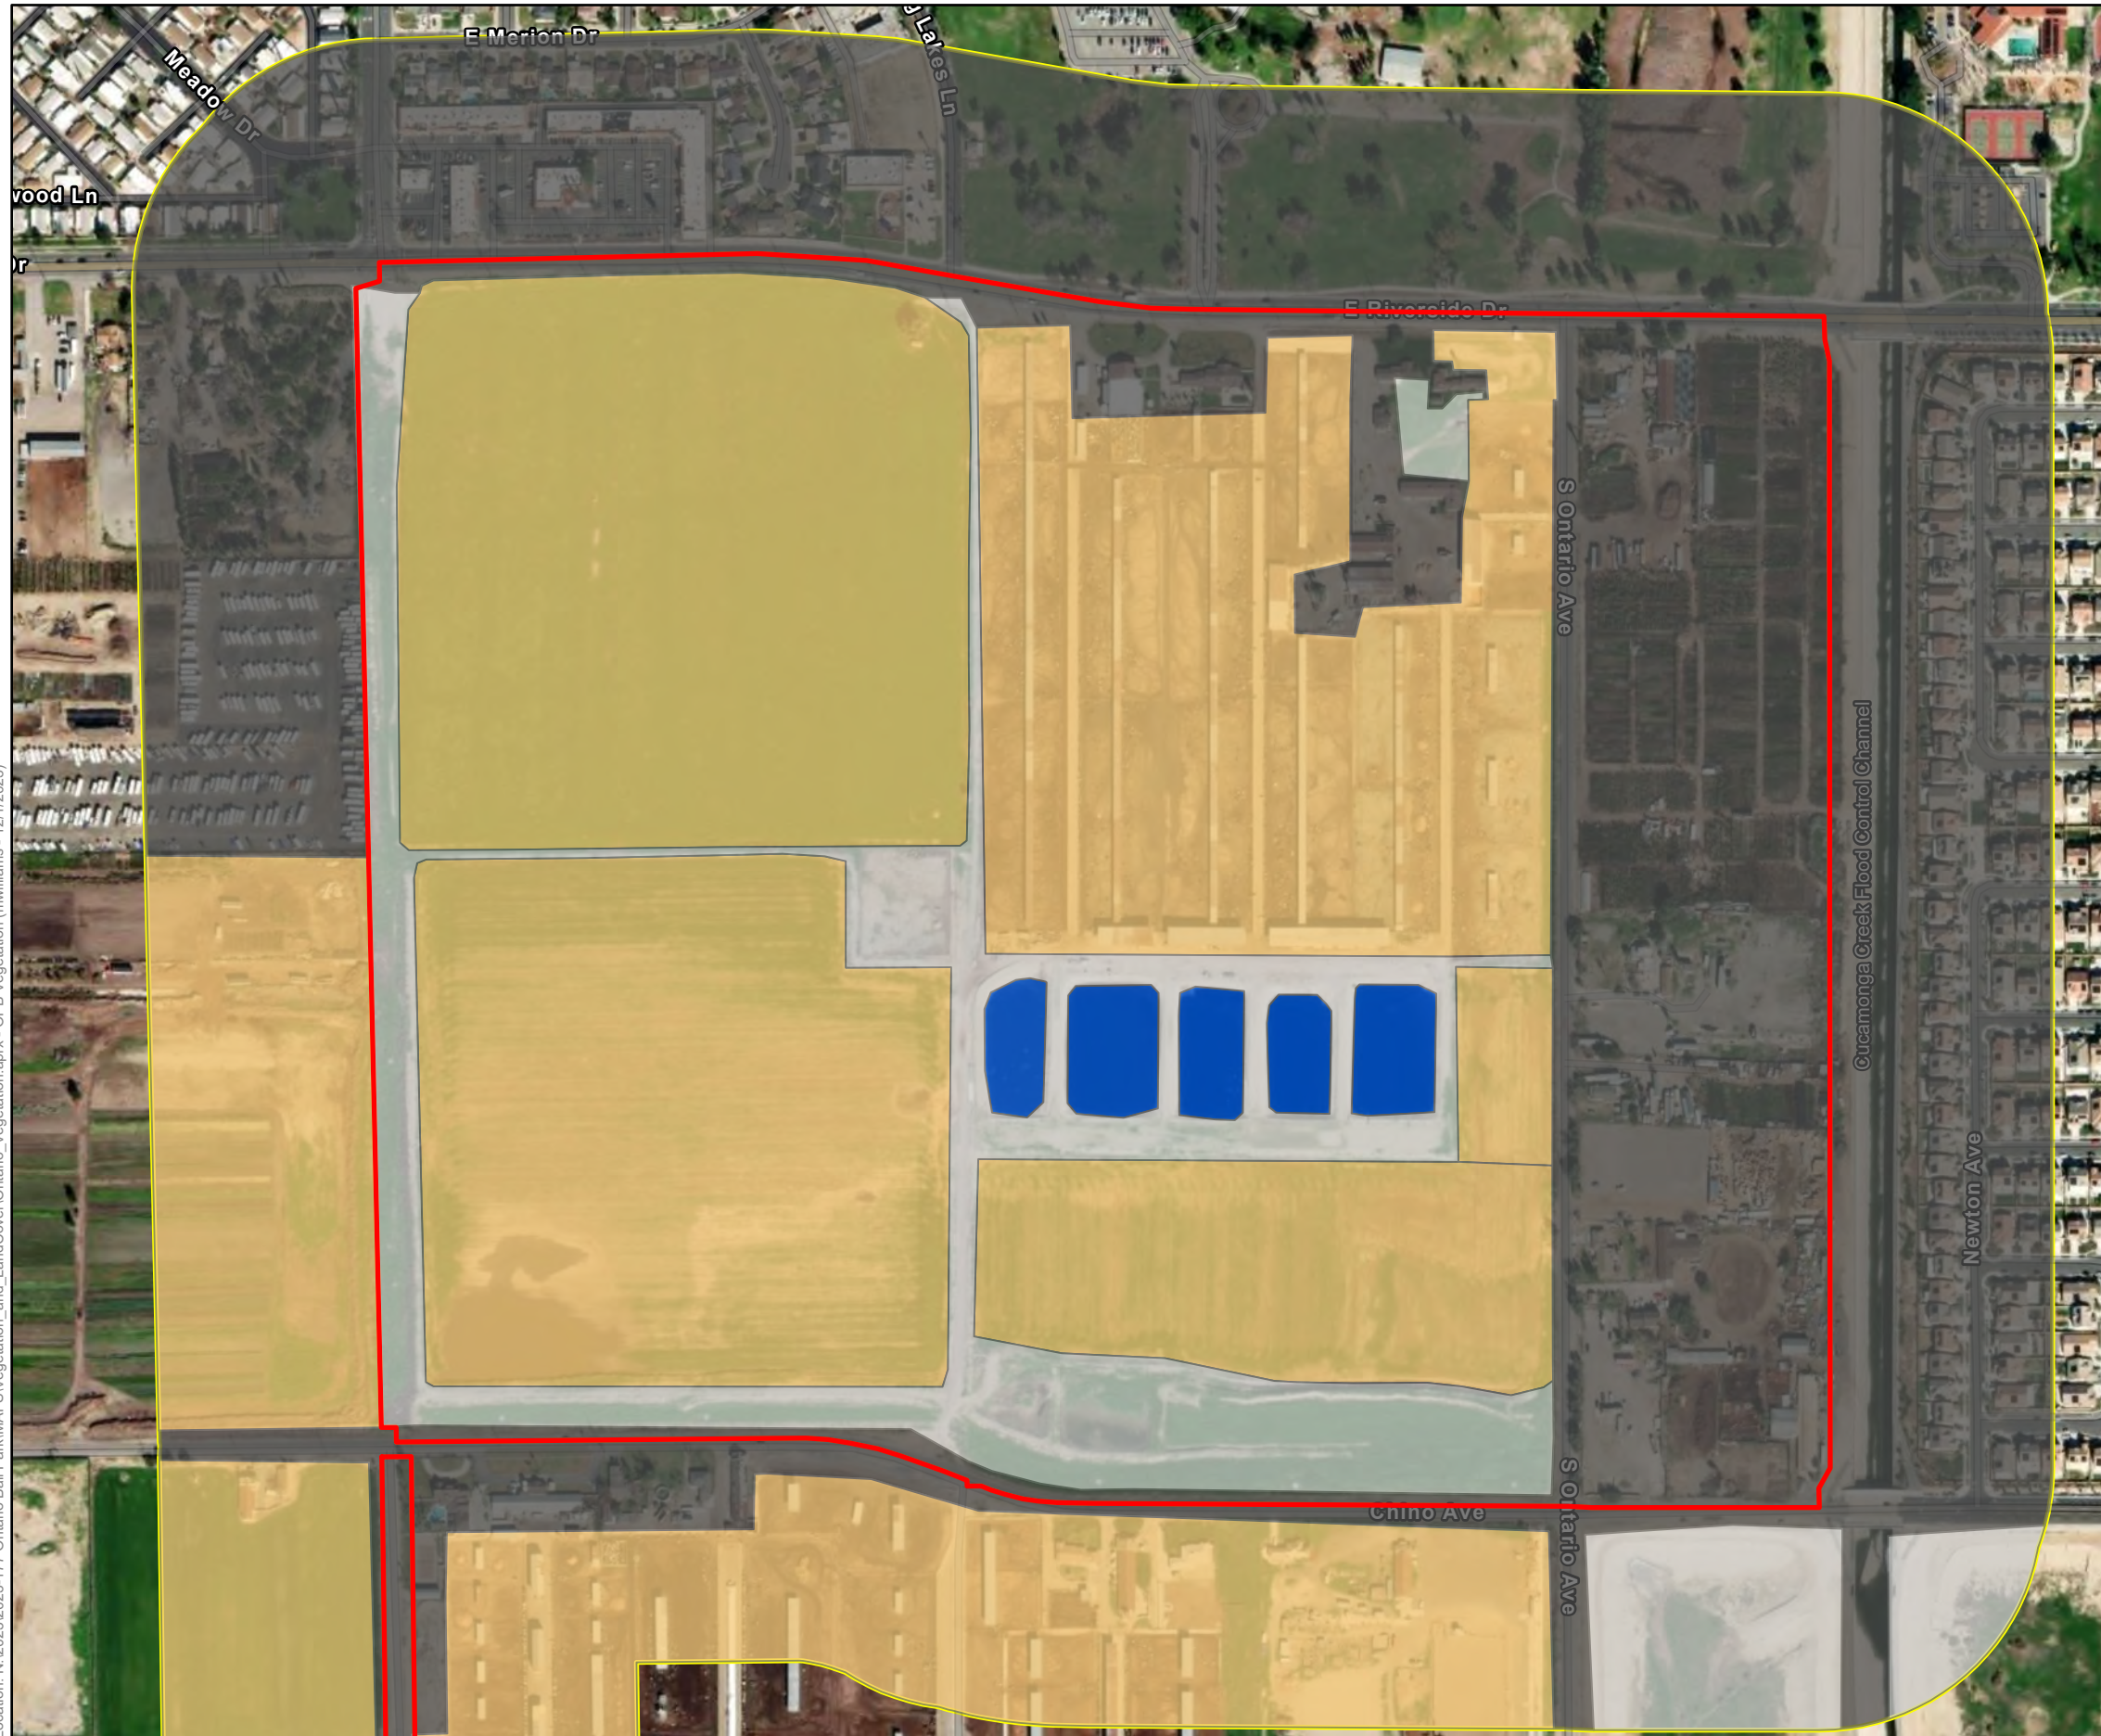
- Map Contents**
- Project Area
 - 500ft Buffer
- Vegetation**
- Agriculture
 - Developed
 - Disturbed
 - Open Water

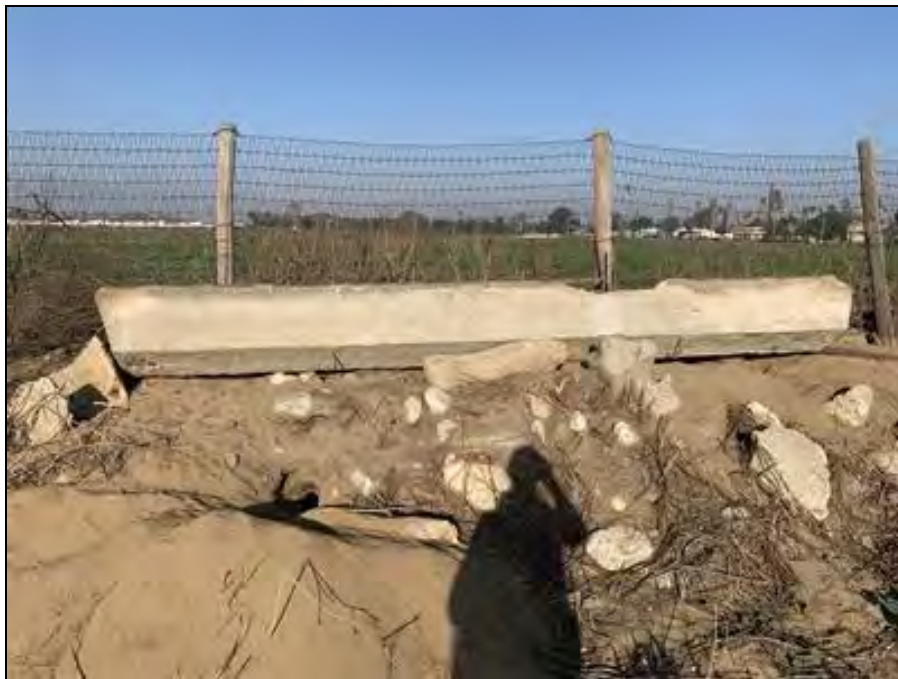
Photo 2. Debris Pile- Suitable for Burrowing Owl Refugia Located in the Northeast Portion of the Project Area. Facing west.

The low-growing vegetation present throughout the Project Area and the presence of friable soils, California ground squirrel burrows, and debris piles offer suitable burrow and refugia habitat for burrowing owls. Although only one live burrowing owl was observed during the biological survey, due to the mobile nature of the burrowing owl, it is possible for burrowing owls to move onto or off of the site throughout the year.

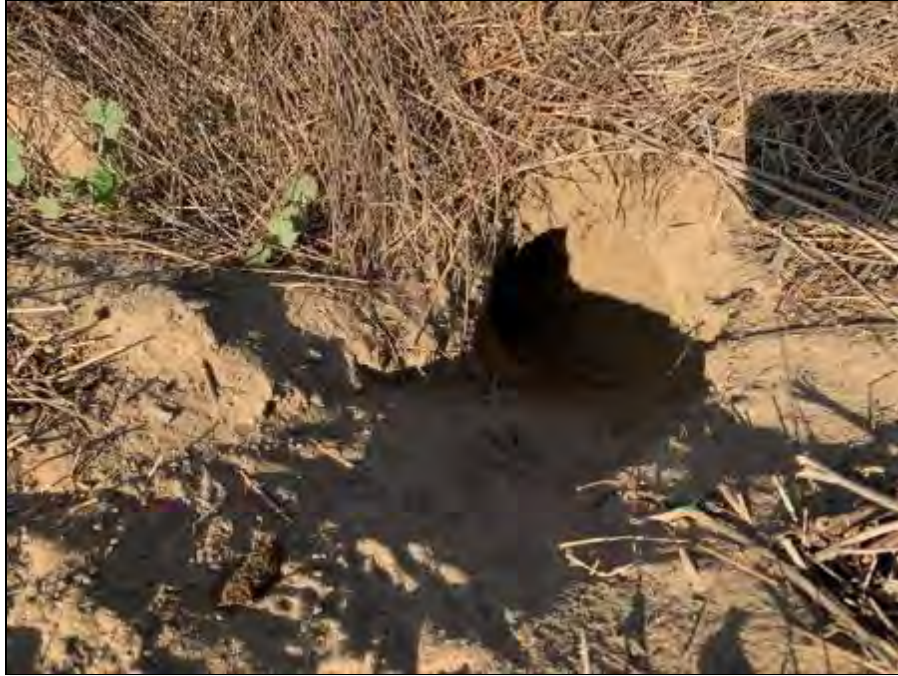
Photo 3. Occupied Burrowing Owl Burrow with Sign (i.e., Pellet and Live Owl) Located Near the Active Dairy Farm in the Northeast Portion of the Project Area. Facing west.

The Project Area provides suitable burrowing owl habitat and, at the time of the biological reconnaissance survey, one live burrowing owl was documented at burrow immediately adjacent to the active dairy farm and within a dirt berm along an access road. The burrow was briefly inspected and whitewash, feathers, and a pellet were present. Due to the time of year of the biological reconnaissance survey, this owl may be a year-round resident, winter resident, migrant, or transient or new colonizer (CDFG 2012). No evidence of breeding was observed at the time of the sighting; however, this was not expected due to the time of year (i.e., fall and the non-breeding season [generally September 1 through January 31]).

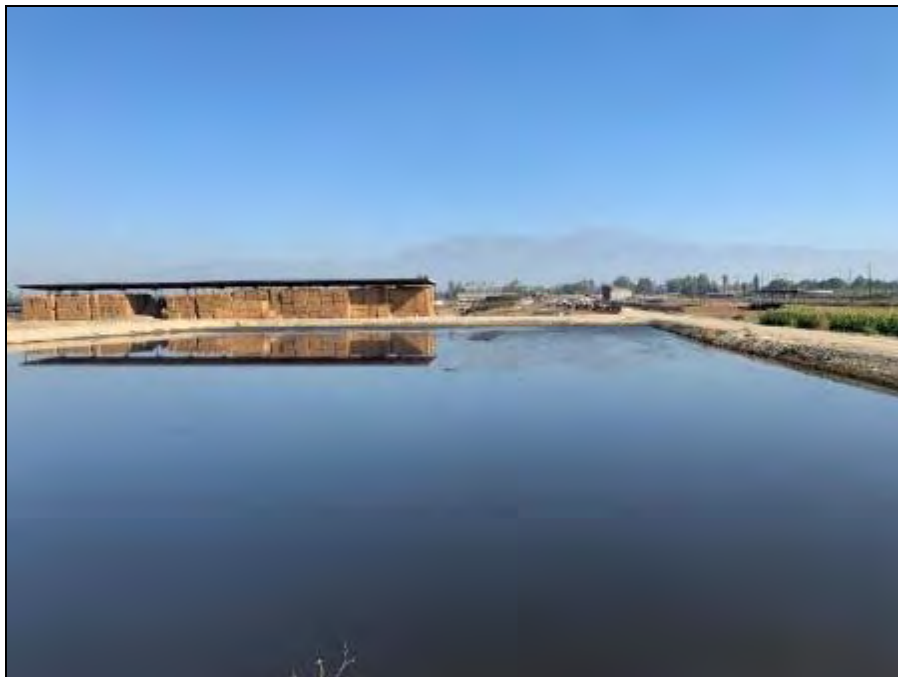
Photo 8. Open Water (i.e., Detention Basin) in the Northeastern Portion of the Project Area (on Active Dairy Farm). Facing north.

Open Water within the Project Area consisted of manufactured waste management basins. Some of these basins were filled with water from adjacent agricultural or farming practices. Others showed signs of water being present in the past (i.e., cracked soils). This type of land cover was documented adjacent to the active dairy operation in five waste management basins located in the northern portion of the Project site.

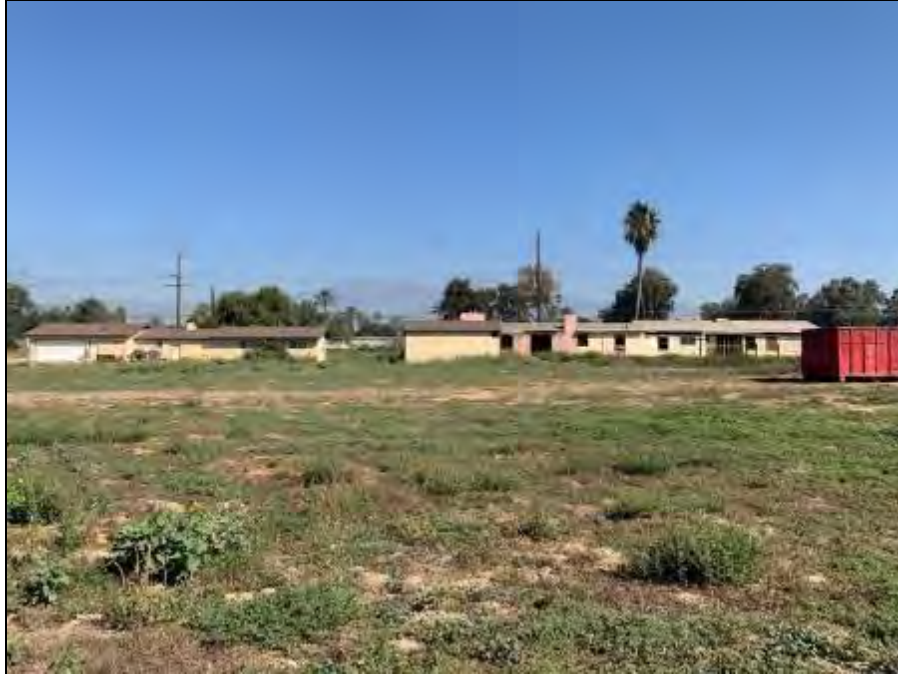
Photo 10. Mixture of Occupied and Abandoned Buildings Located in Northeastern Portion of the Project Area. Facing north.

Areas of potential bat-roosting habitat were identified in the Project Area in occupied and abandoned building structures on the dairy farm property as well as in mature trees, including palm trees with intact frond skirts. Scattered bat guano was observed within one of the abandoned structures; however, the entirety of the interior of each of the structures could not be inspected due to safety concerns. Additional structures east of the dairy farm property, within the Project site, were within occupied private property and therefore were not inspected for bat habitat suitability. Additionally, bridges over the Cucamonga Creek Flood Control Channel, east of the Project Area, may provide suitable bat roosting habitat. Access to these structures was not granted at the time of the biological reconnaissance survey.

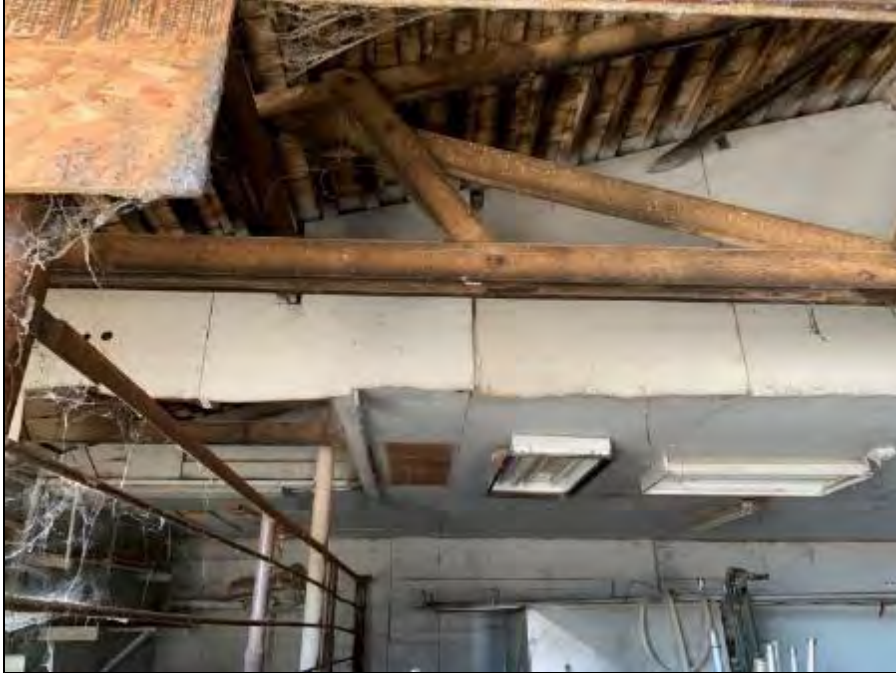
Photo 12. Storage Building with Night Roosting Potential for Bat Species. Located in Northeastern Portion of the Project Area.

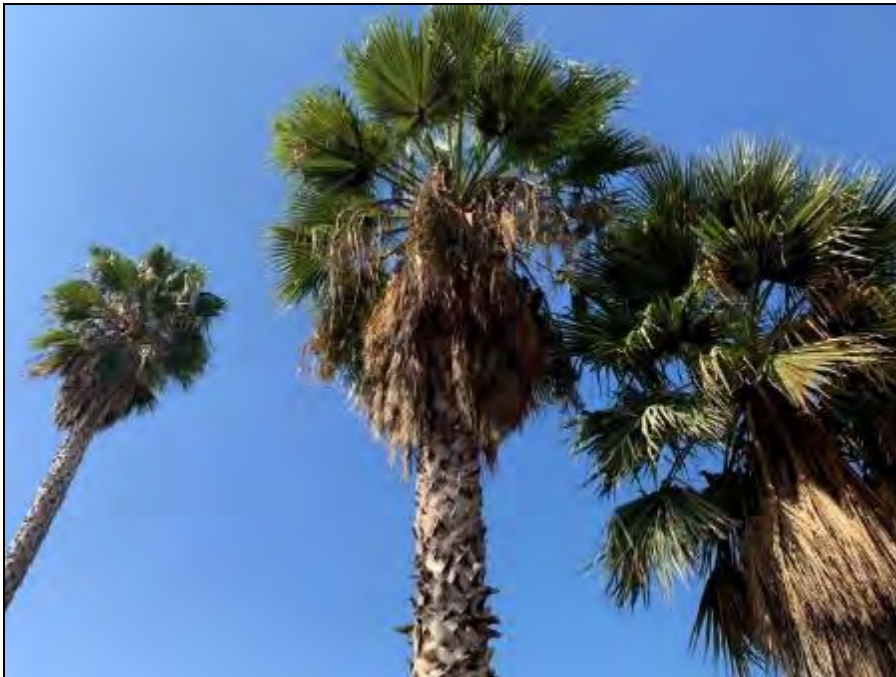
Photo 13. Example of Untrimmed Palm Trees throughout the Project Area. Suitable for Bat Roosting.

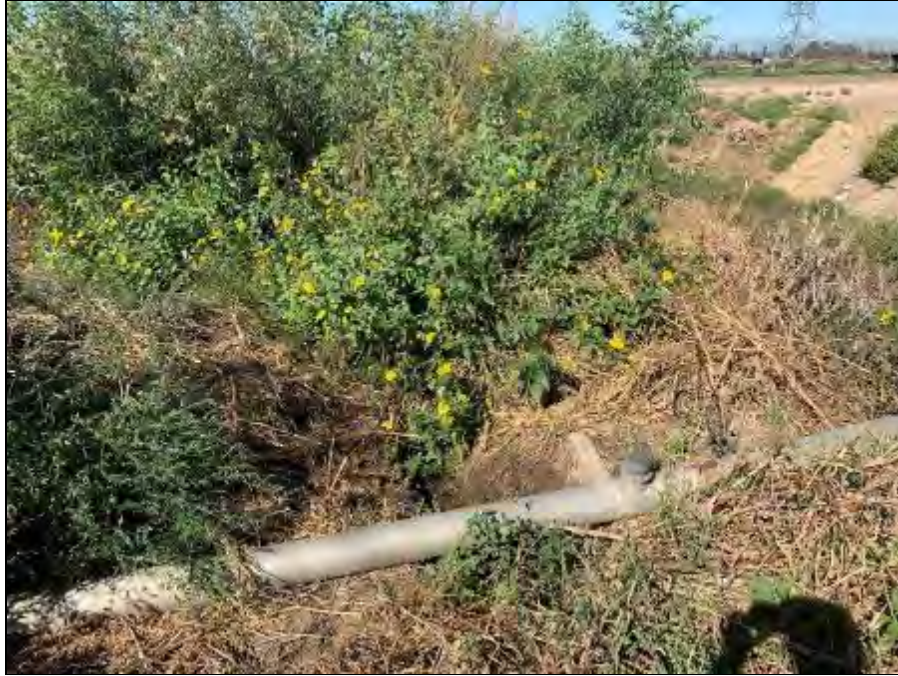
Photo 21. Irrigation Pipes Feeding into the Excavated Basin located north of Edison Avenue and within the Project Area.

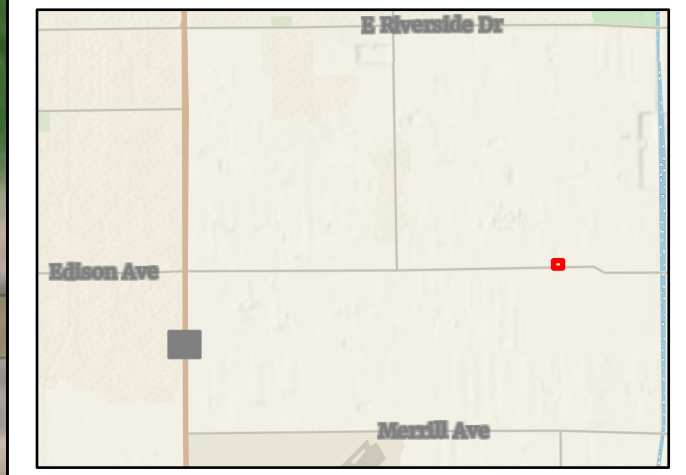
Figure 5. Aquatic Resources Delineation

¹ Subject to U.S. Army Corps of Engineers verification. This exhibit depicts information and data produced in accord with the wetland delineation methods described in the 1987 Corps of Engineers Wetland Delineation Manual and the Regional Supplement to the Corps of Engineers Wetland Delineation Manual: Arid West Region, Version 2.0 as well as the Updated Map and Drawing Standards for the South Pacific Division Regulatory Program as amended on February 10, 2016, and conforms to Sacramento District specifications. However, feature boundaries have not been legally surveyed and may be subject to minor adjustments if more accurate locations are required.
 * The acreage value for each feature has been rounded to the nearest 1/100 decimal. Summation of these values may not equal the total potential Waters of the U.S. acreage reported.

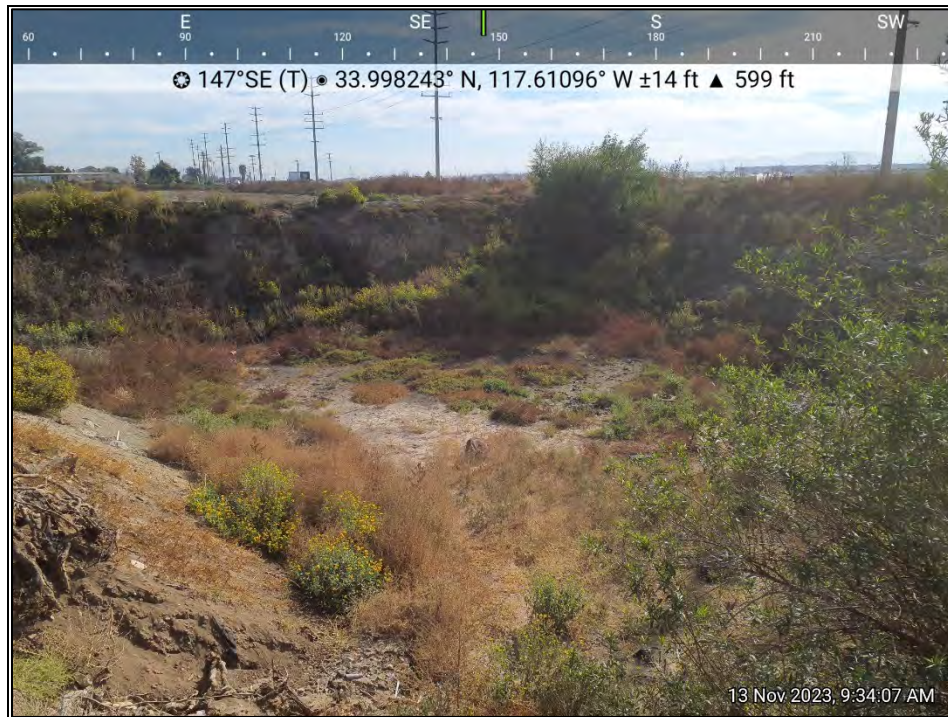
Photo 1. Waste Management Basin Located within Study Area with a Few Mulefat Shrubs and Black Willows Present in the Southeast Corner (Far Distance).

No aquatic resources were identified within the Study Area. Three sample points were collected in the waste management basin within the Study Area (Figure 5). None of the sample points passed the three-criteria necessary to be a wetland. Soils were significantly disturbed throughout the bottom of the waste management basin and included fill material as well as runoff of soils from adjacent cropland.

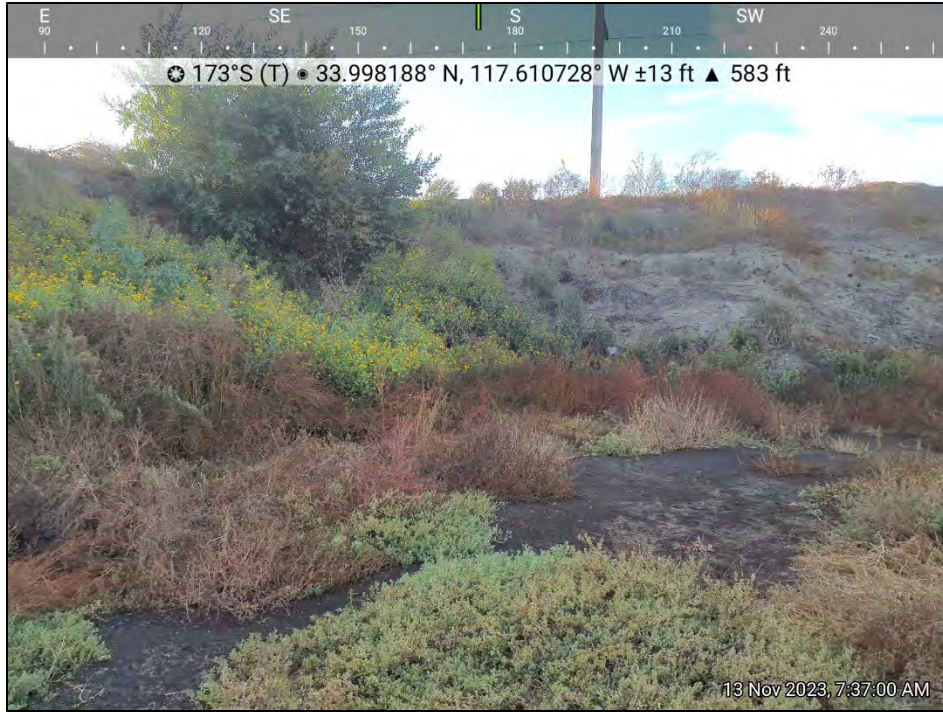
Photo 3. Saturated Soils Present in Waste Management Basin at the Time of Field Survey.

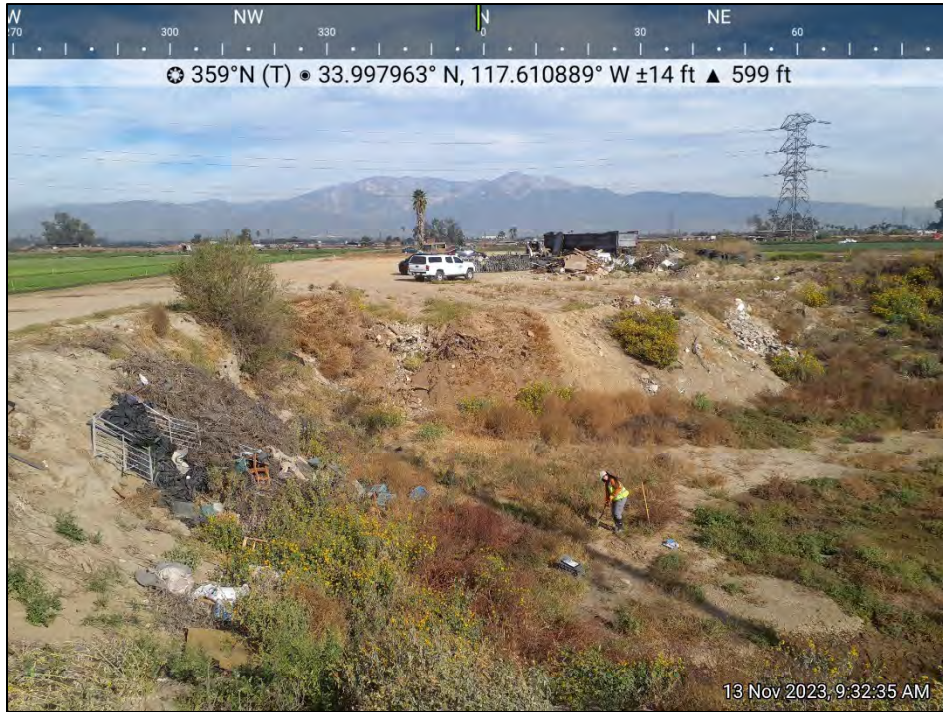
Photo 4. Disturbances Present, including Pieces of Old Furniture, Uprooted Vegetation, Dirt Fill, and Trash Present Along the Northern and Eastern Walls of the Basin.

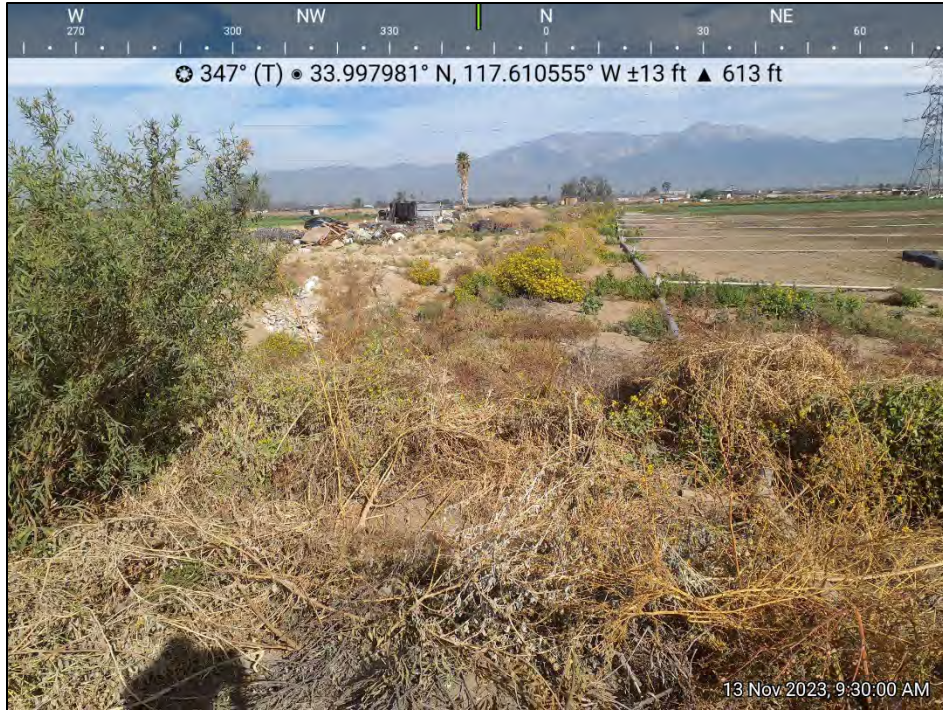
Photo 5. Irrigation Piping Present Along the Eastern Boundary of the Study Area, Which Appear to Provide a Source of Hydrology to the Waste Management Basin.

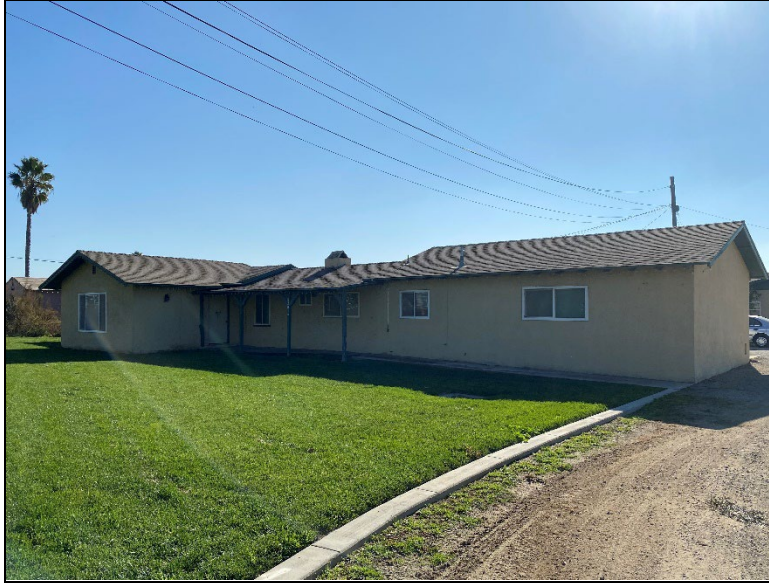
Figure 3. Northern façade (view southeast; December 13, 2023).

Just to the west sits a circa 1966 one-story, single-family, Ranch-style dwelling (P-36-13241) topped by a cross gabled roof with rounded bargeboards on the projecting front gabled eastern section of the house (Figure 3). L-shaped in plan, the house features non-original rough textured stucco which is punctuated by non-original vinyl frame windows on all elevations. A flat panel wood door highlights the west end of the front façade and serves as the primary entrance.

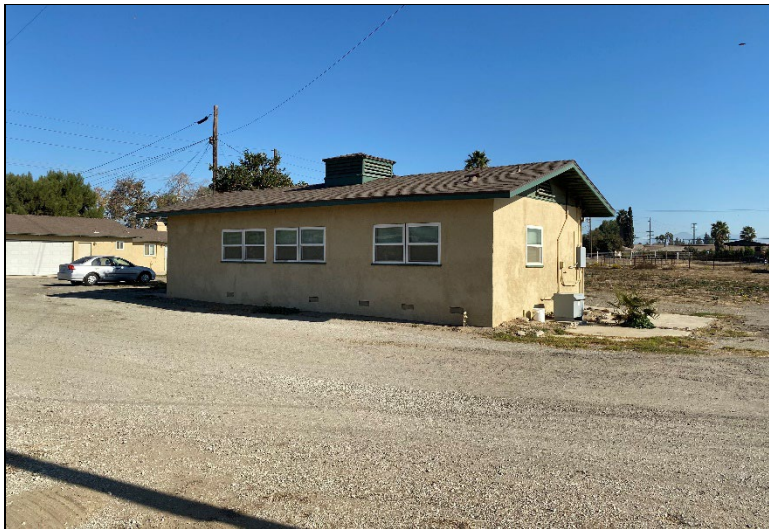
Figure 4. Eastern façade (view west; December 13, 2023).

Further to the south is a small circa 1955 one-story, single-family, Ranch-style house surmounted by a side gabled roof with a projecting wing on the east elevation topped by a front gabled roof. The house sits on a T-shaped plan with rough textured stucco cladding exterior elevation and vinyl frame windows interspersed on all sides of the dwelling (Figure 4).

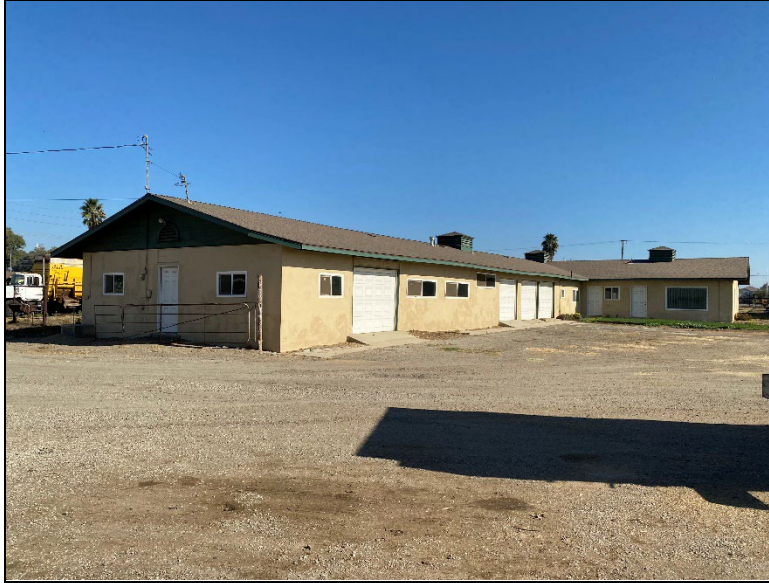
Figure 5. Western and Southern façades (view southwest; December 13, 2023).

This dwelling is flanked to the south by a circa 1948 one-story, single-family, Ranch-style house (P-36-13243) on an L-shaped plan (Figure 5). A side gabled roof tops the house and features three decorative dove-cote vents along the peak. Non-original rough textured stucco clads exterior surfaces and fenestration consists of non-original vinyl frame windows on all sides. Two wood frame doors on the east end of the south elevation provide the primary entrance along with three garage door openings on the same façade. Decorative vents punctuate gable faces.

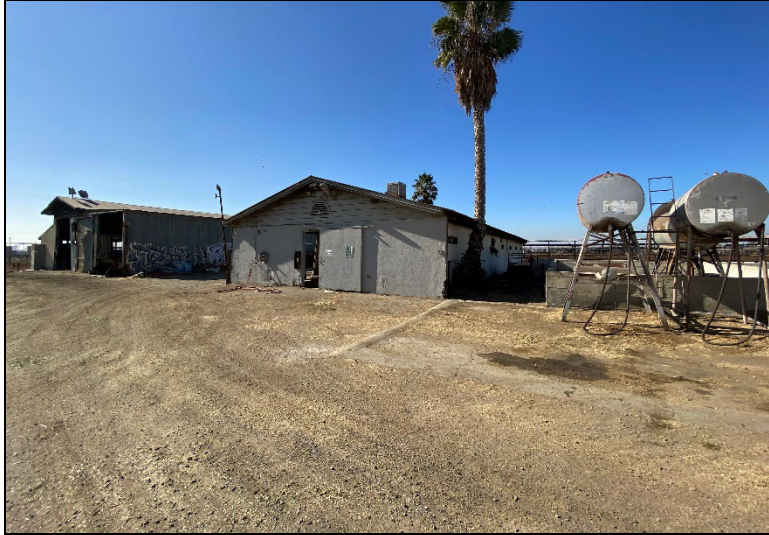
Figure 6. Eastern façade (view southwest; December 13, 2023).

At the very south end of the building cluster sit two circa 1948 farm storage buildings and 12 canopy structures built in the 1980s (Figure 6). The northernmost farm storage building features a front gabled corrugated metal roof, rough textured stucco cladding, and a rectangular plan. A sliding wood door serves as the primary entrance to the western façade. The building has limited fenestration and an exposed southern elevation.

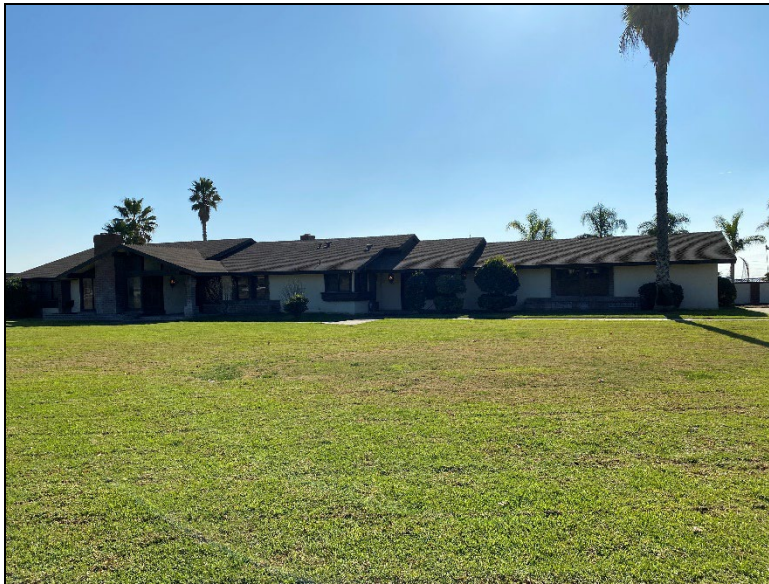
Figure 7. Northern façade (view south; December 13, 2023).

The property's northwestern corner contains a circa 1978 Ranch-style dwelling and dairy barn structure (Figures 7 and 8). The one-story Ranch-style dwelling features a side gabled roof, a rectangular plan, and rough textured stucco cladding with brick trim. Fenestration consists of aluminum slider windows on all sides. A centered and projecting front gabled section of the roof shelters a wood frame door which provides the primary entrance to the house that is by a brick chimney. Just to the west is a two-story, front gabled dairy barn on a rectangular plan. Window treatments consist of three aluminum slider windows on the primary north elevation. Two flat panel wood doors act as entrance ways on the primary façade and the west elevation contains three freight entrances with metal roll-up doors. Four brick pilasters on the primary façade distinguish the building.

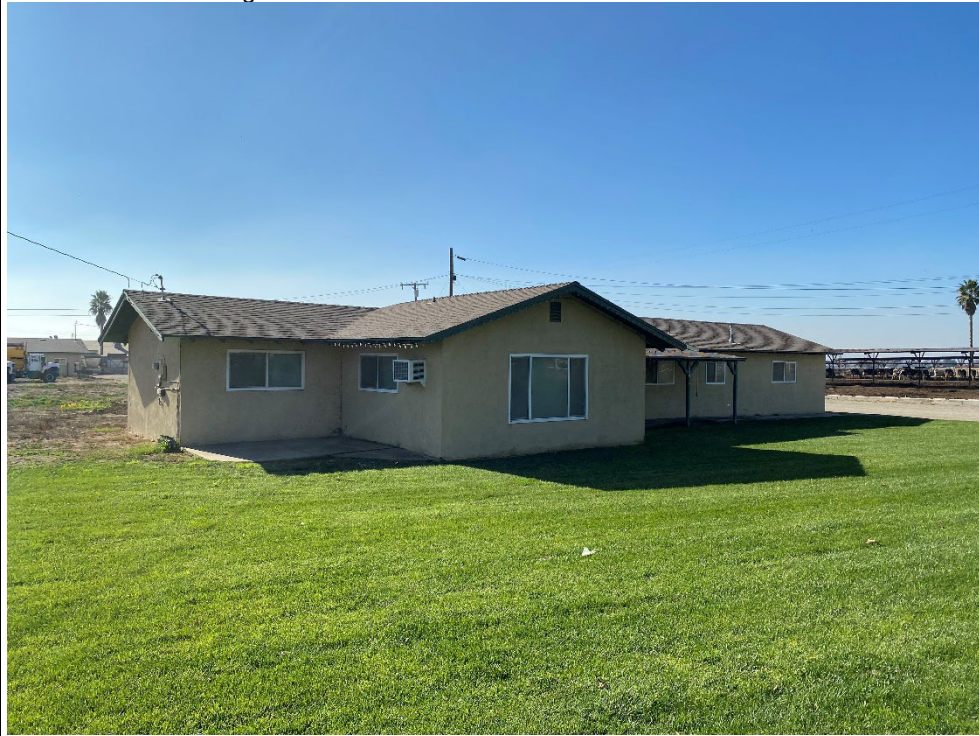
P5a. Photo or Drawing

Overview of property
 View south, December 13, 2023

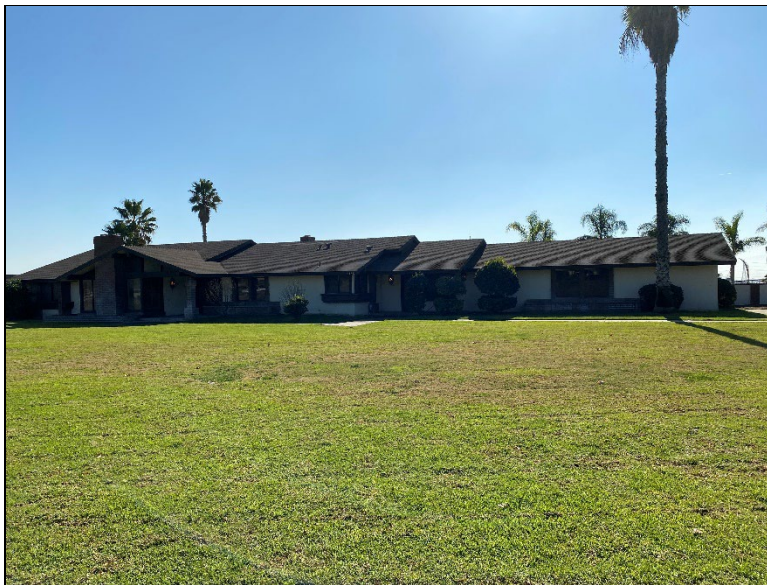
Figure 7. Northern façade (view south; December 13, 2023).

The property's northwestern corner contains a circa 1978 Ranch-style dwelling and dairy barn structure (Figures 7 and 8). The one-story Ranch-style dwelling features a side gabled roof, a rectangular plan, and rough textured stucco cladding with brick trim. Fenestration consists of aluminum slider windows on all sides. A centered and projecting front gabled section of the roof shelters a wood frame door which provides the primary entrance to the house that is by a brick chimney. Just to the west is a two-story, front gabled dairy barn on a rectangular plan. Window treatments consist of three aluminum slider windows on the primary north elevation. Two flat panel wood doors act as entrance ways on the primary façade and the west elevation contains three freight entrances with metal roll-up doors. Four brick pilasters on the primary façade distinguish the building.

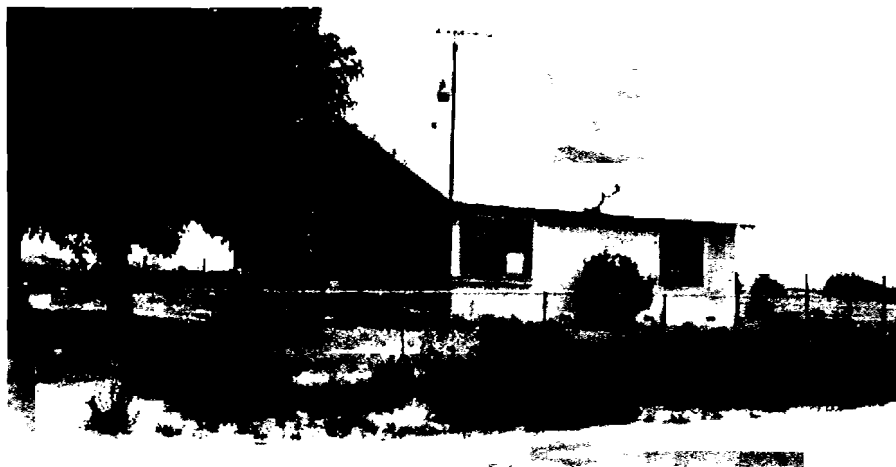
Figure 3. Building located at 9572 Merrill Avenue.

One extant building on the project site, a house located at 9572 Merrill Avenue, was constructed more than 45 years ago (Figure 3). According to a grant deed on file at the San Bernardino County Assessor's office, the residence dates to 1956. It is typical of many extant houses in the Ontario area which were built during the post-World-War-II construction boom. The results of records research do not indicate that it is associated with significant historical events or persons, and it is not architecturally distinctive, and it does not have potential to yield important historical information. The building does not meet CRHR eligibility criteria and it is not a historical resource as defined by CEQA.

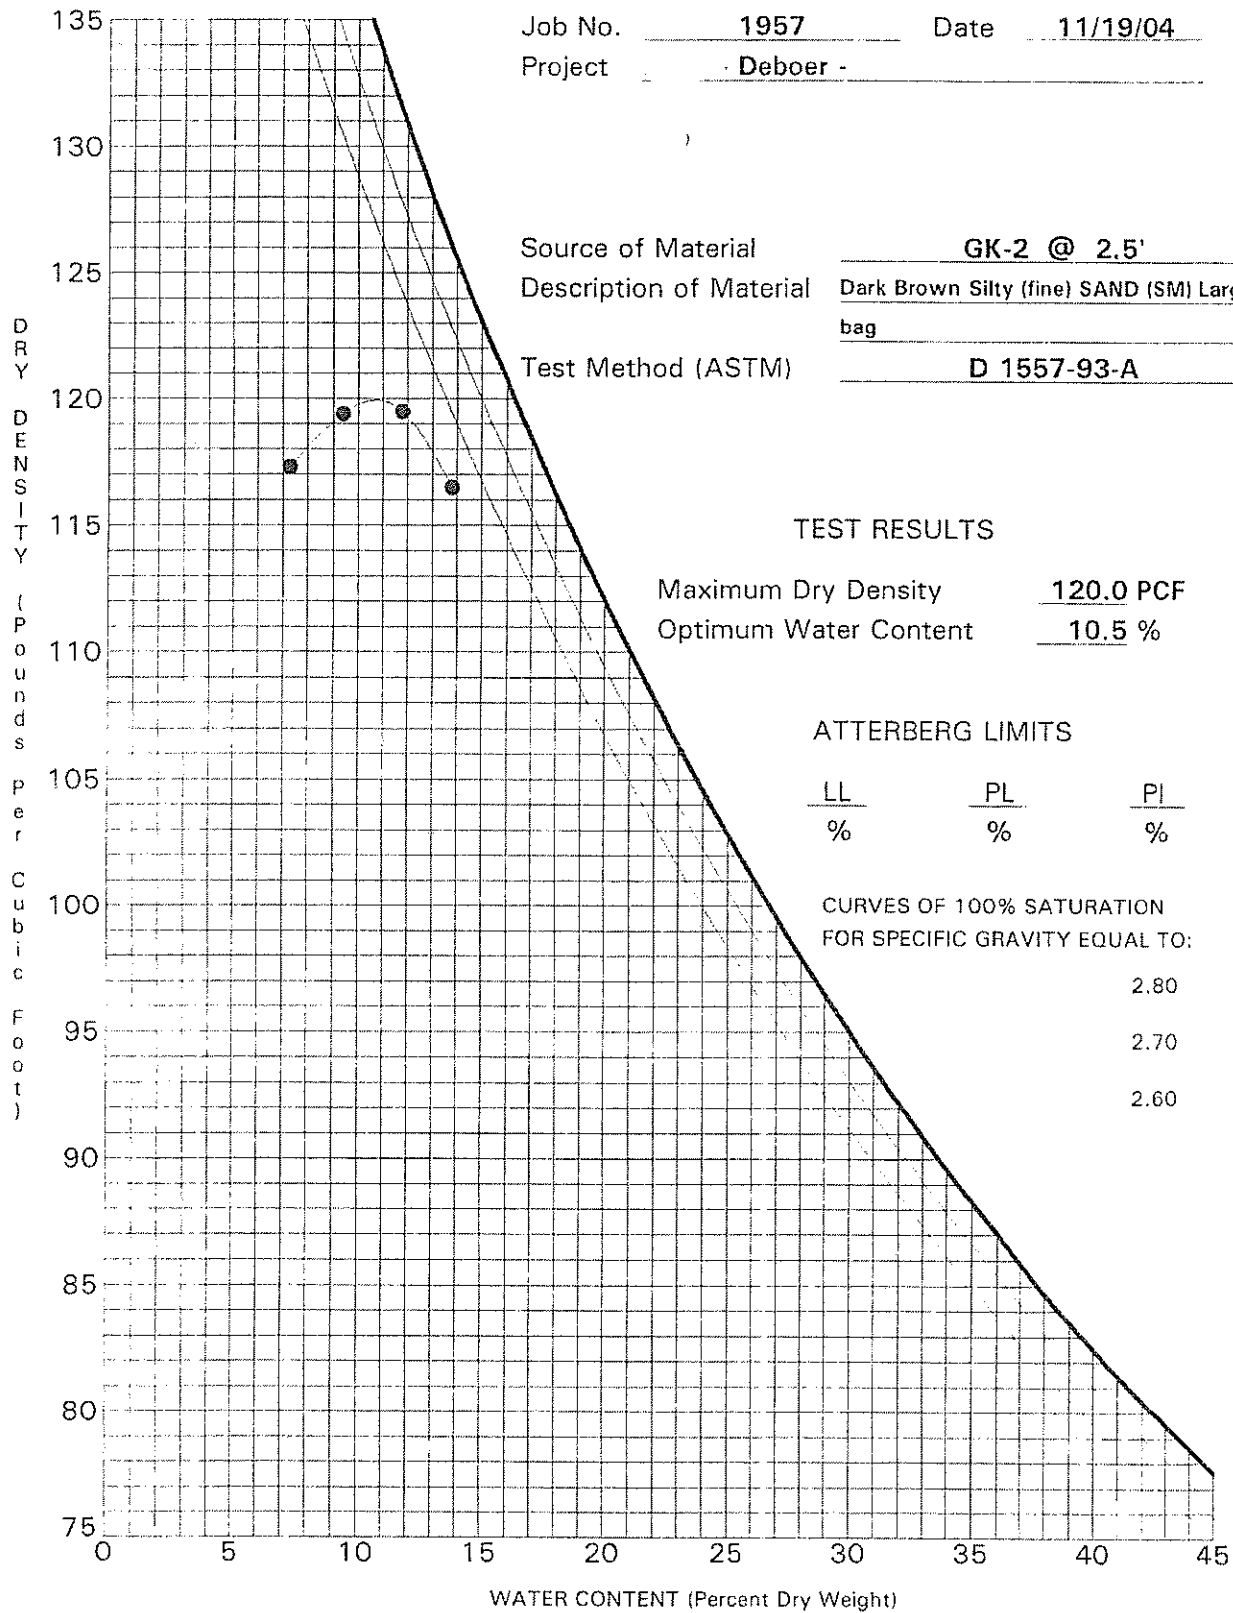
Source of Material GK-2 @ 2.5'
 Description of Material Dark Brown Silty (fine) SAND (SM) Large bag
 Test Method (ASTM) D 1557-93-A

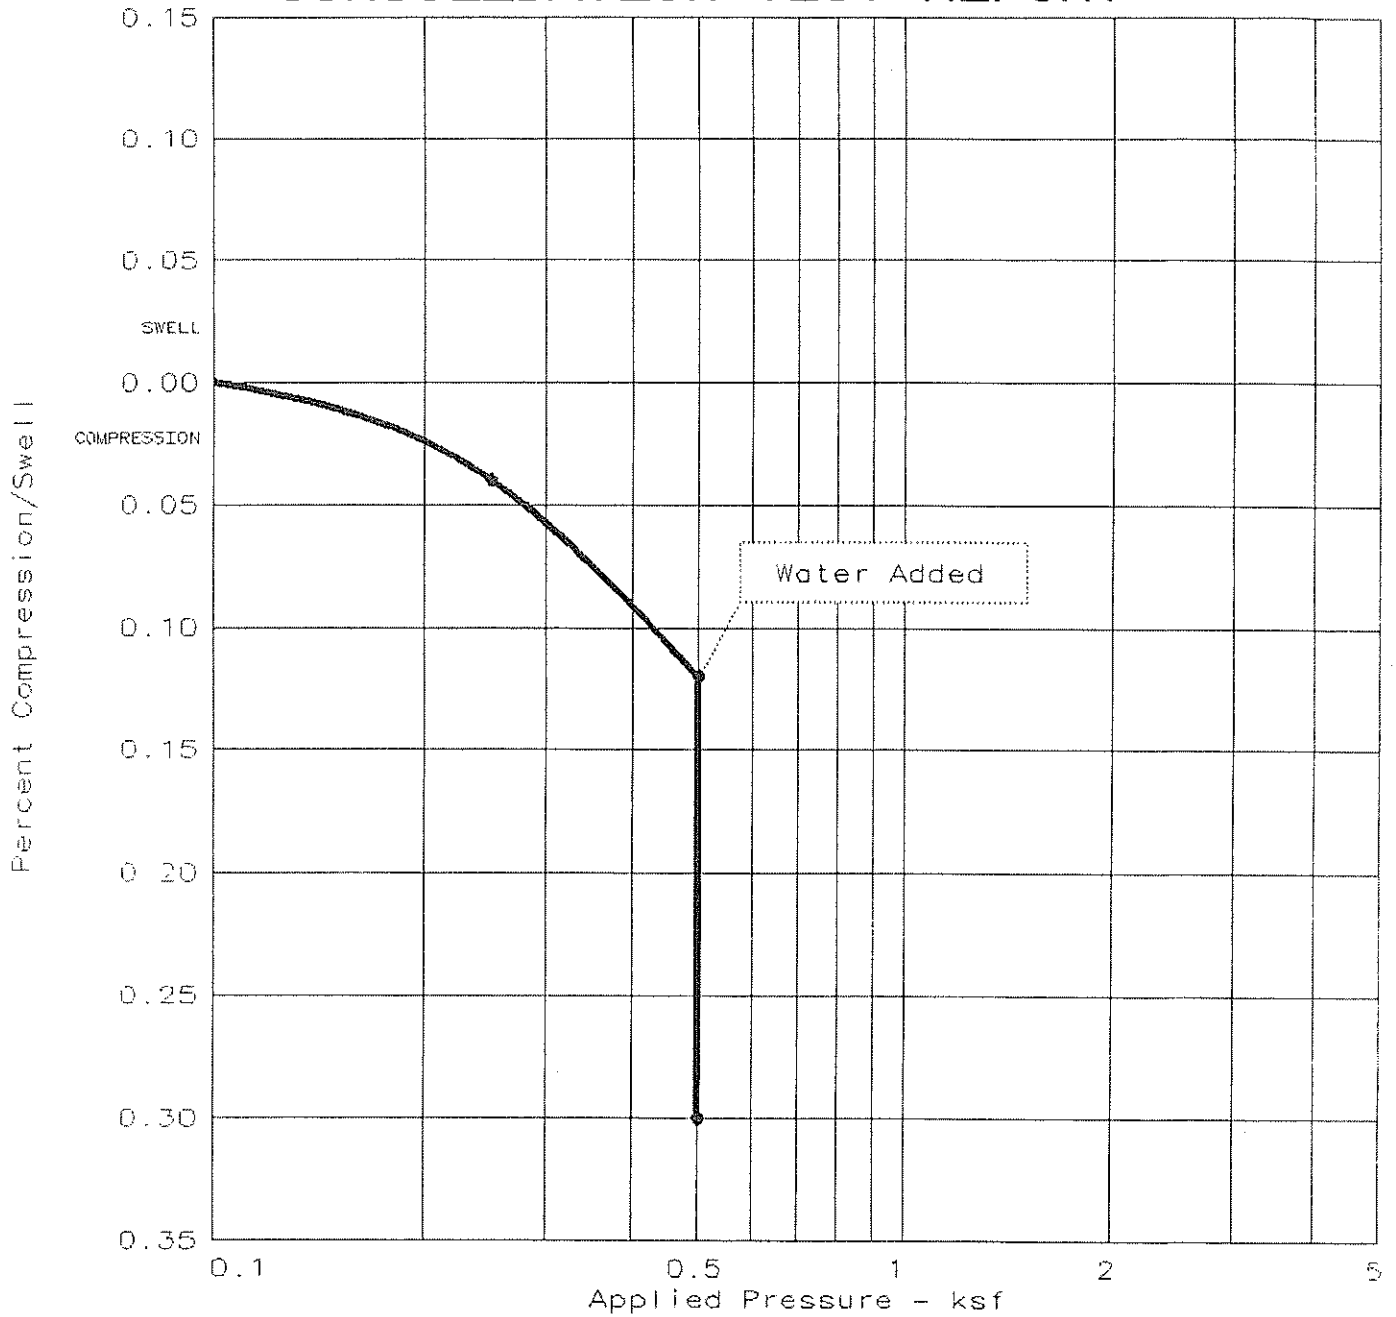
CONSOLIDATION TEST REPORT

Clpse. %	Nat. Sat.	Nat. Moist.	Dry Density	LL	PI	Sp.Gr.	Initial void ratio
0.2	27.0 %	5.7	106.8	N/P	N/P	2.680	0.5665
