Appendix E1 Biological Resources Report

Biological Technical Report for the Ontario Regional Sports Complex Project

San Bernardino County, California

March 2024

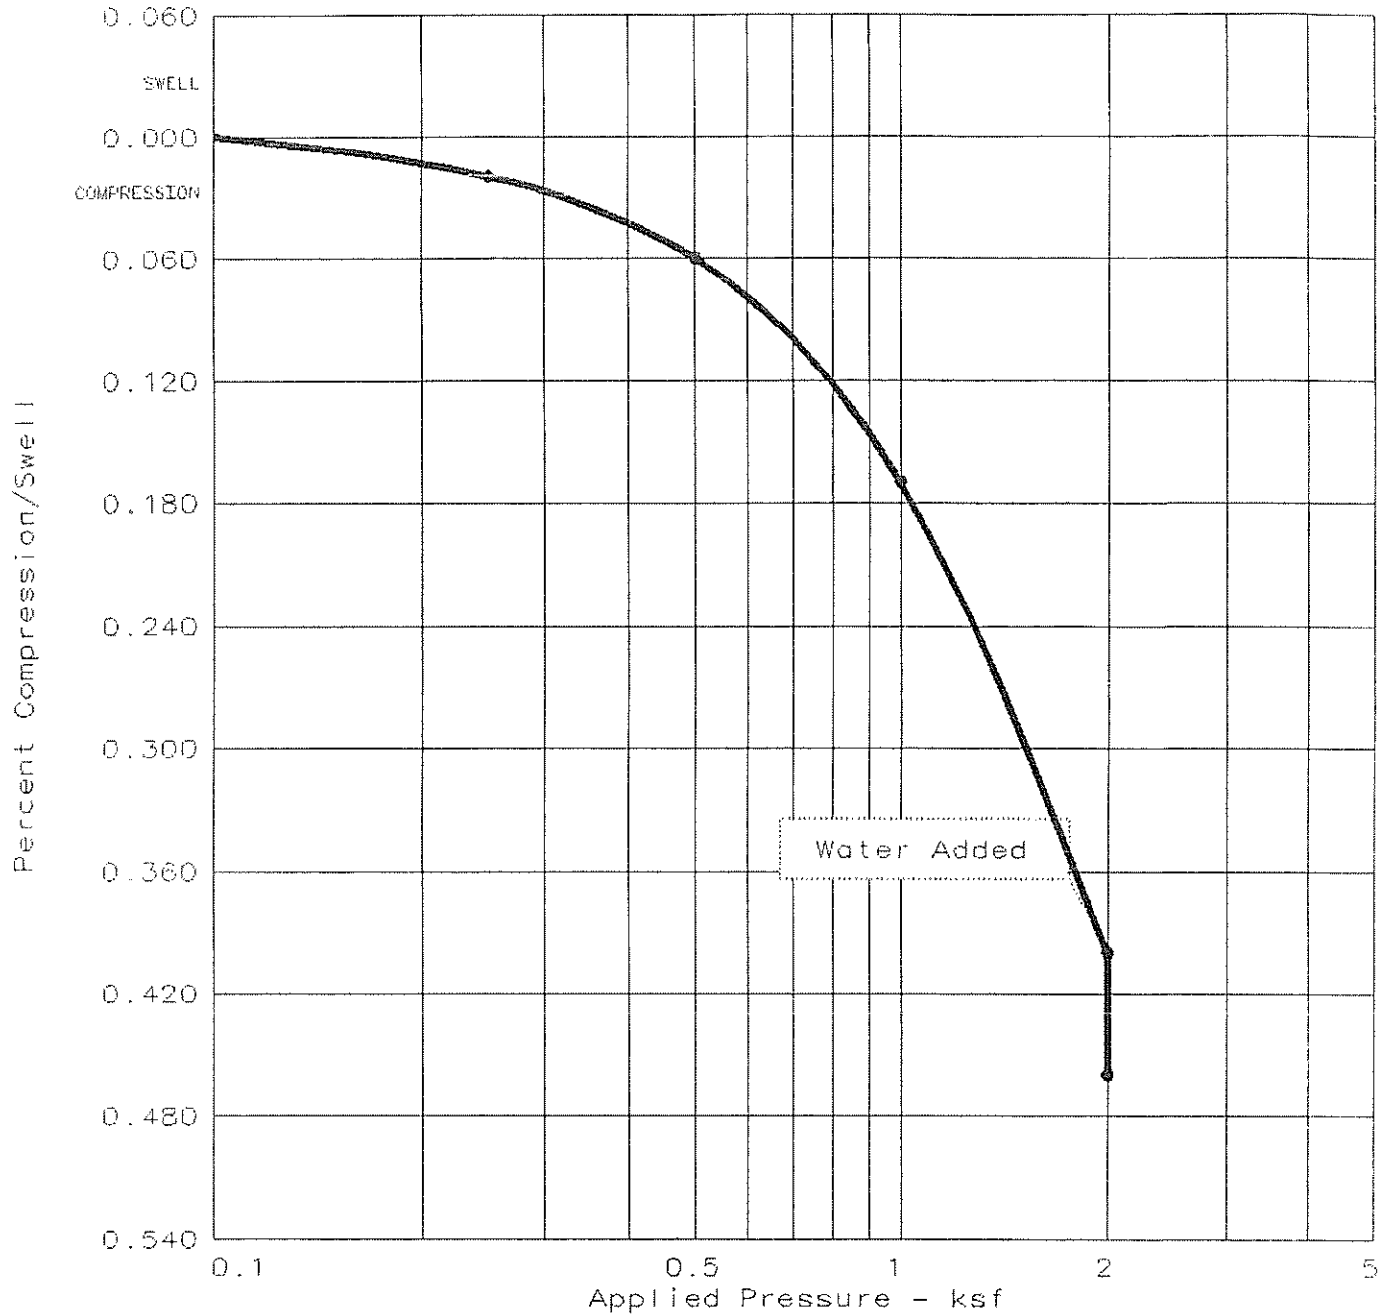
CONSOLIDATION TEST REPORT

Clpse. %	Nat. Sat.	Nat. Moist.	Dry Density	LL	PI	Sp.Gr.	Initial void ratio
0.1	93.1 %	21.4	104.1	N/A	N/A	2.700	0.6195

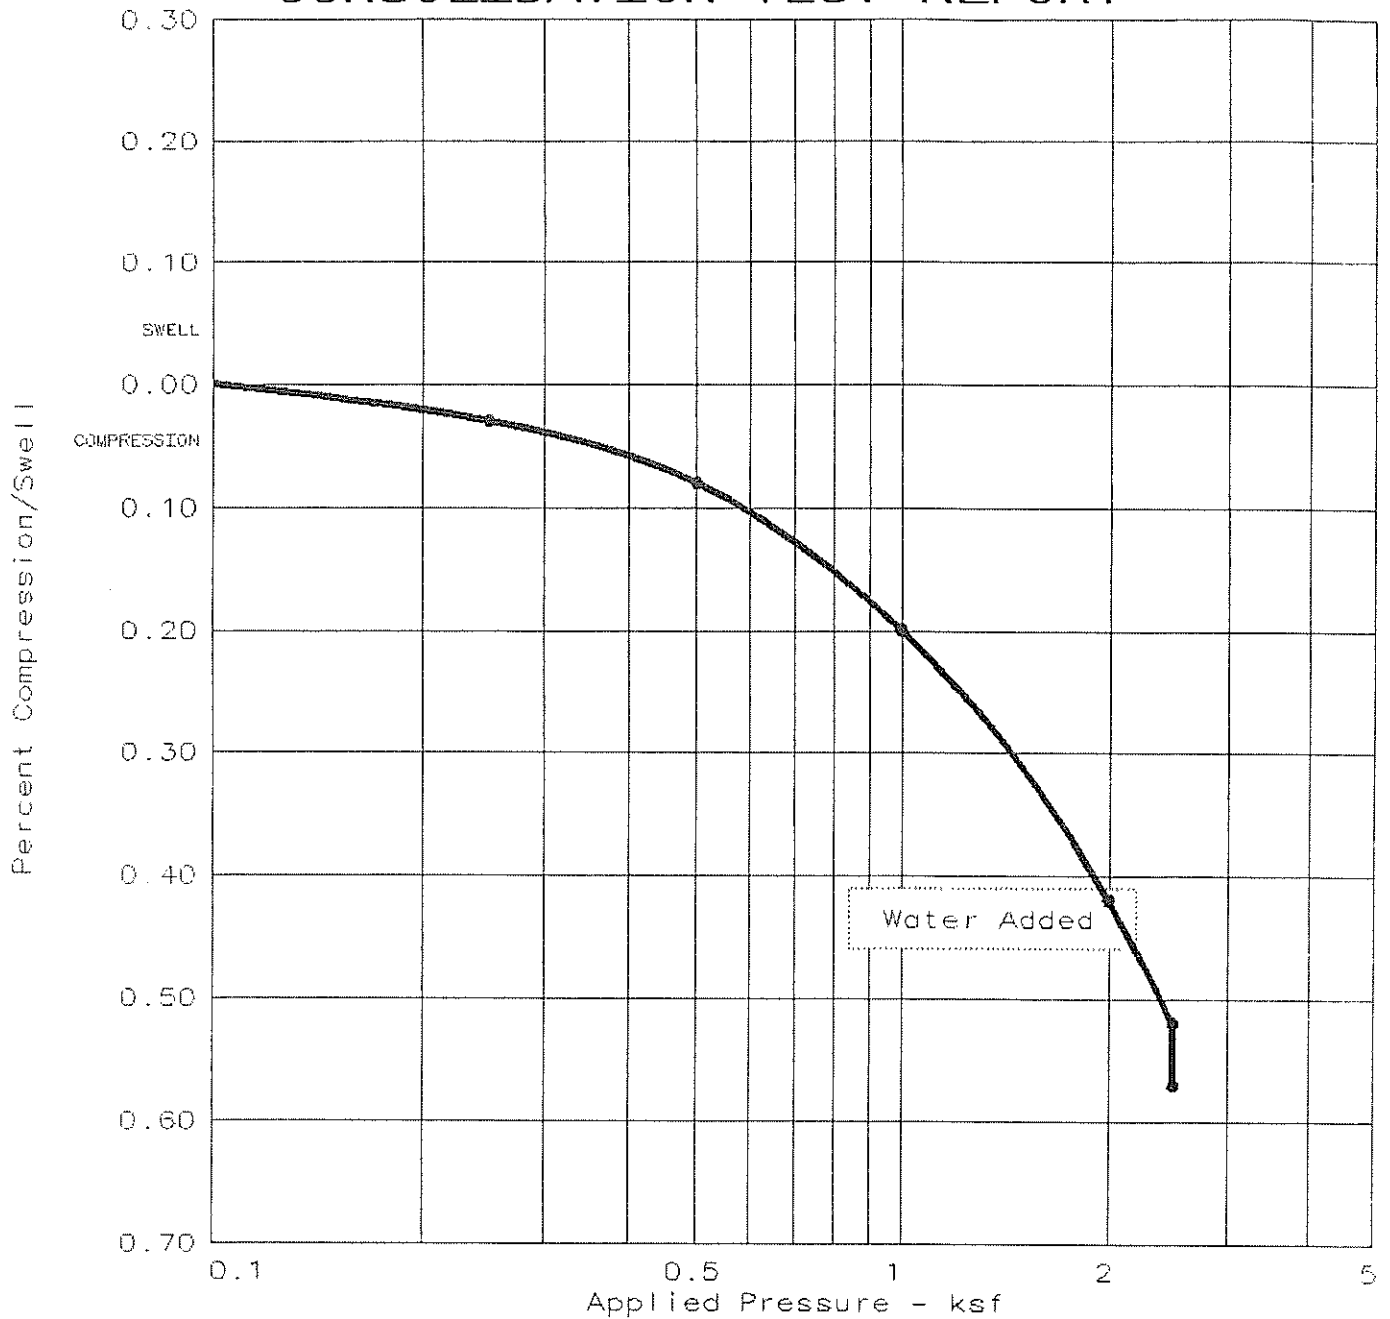
CONSOLIDATION TEST REPORT

Clpse. %	Nat. Sat.	Nat. Moist.	Dry Density	LL	PI	Sp.Gr.	Initial void ratio
0.1	99.9 %	24.4	101.6	N/A	N/A	2.700	0.6585

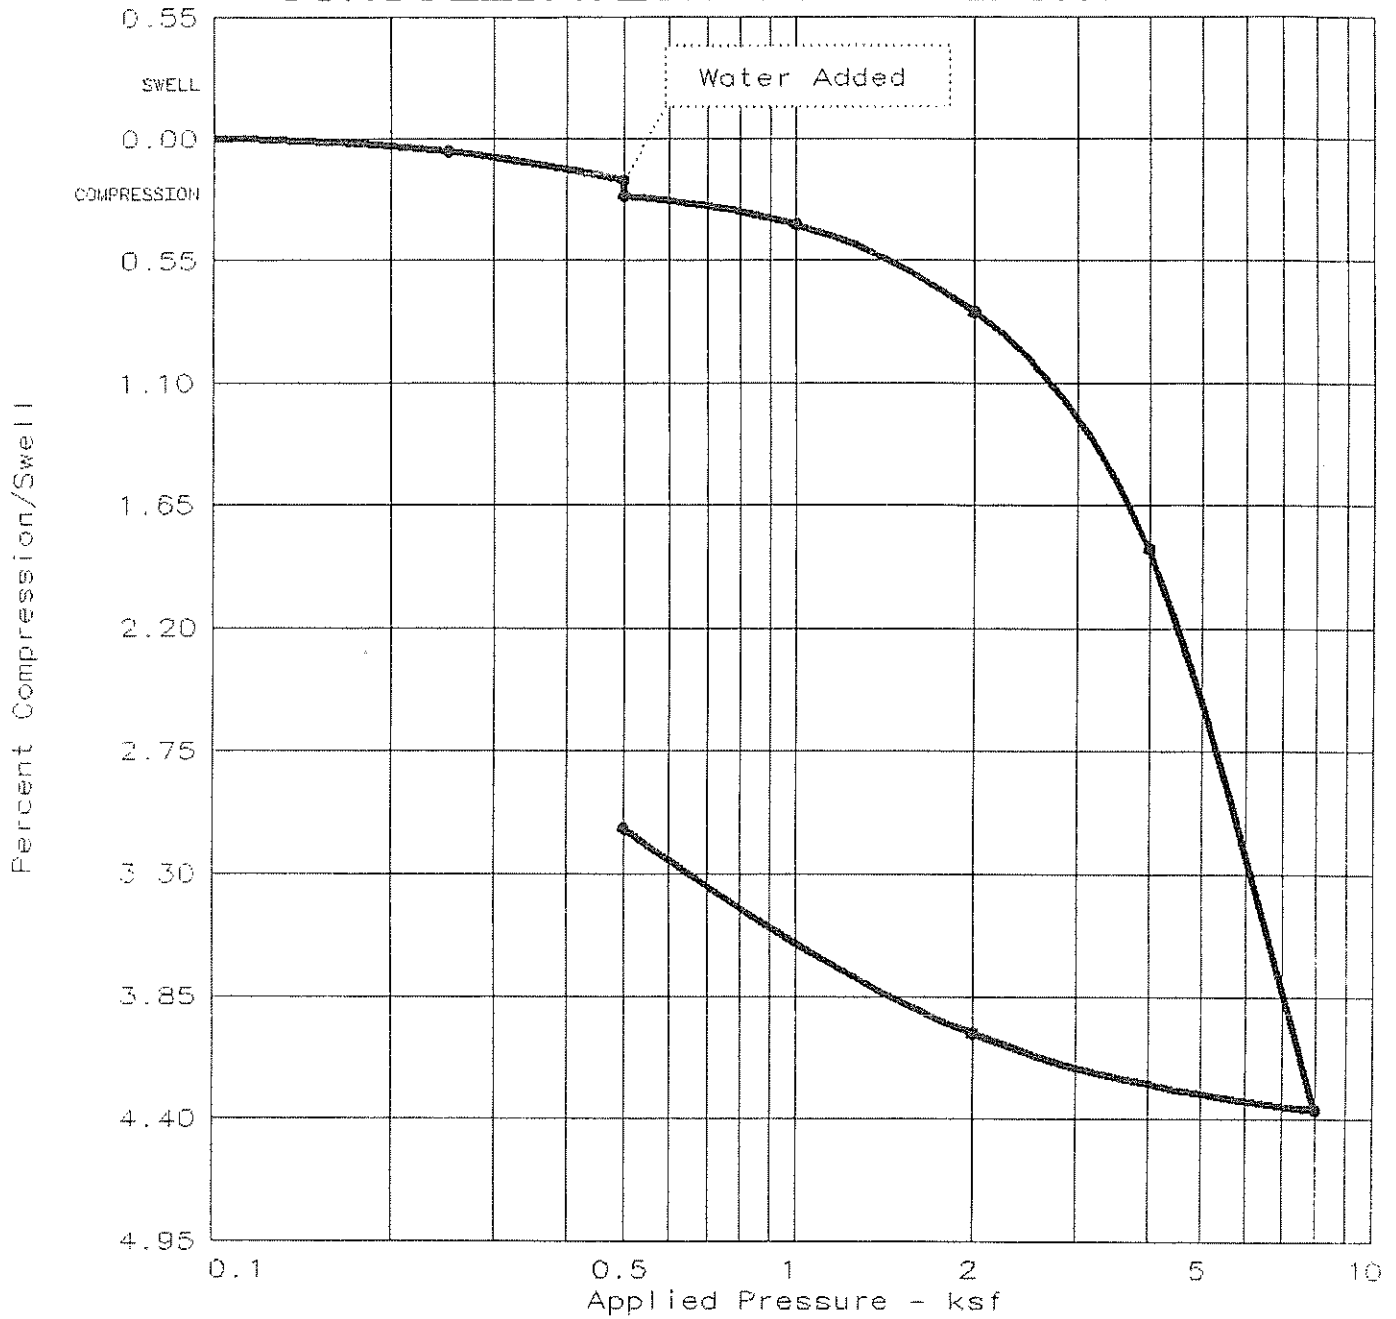
CONSOLIDATION TEST REPORT

Clpse. %	Nat. Sat.	Nat. Moist.	Dry Density	LL	PI	Sp.Gr.	Initial void ratio
0.1	84.9 %	15.4	113.2	N/A	N/A	2.700	0.4887

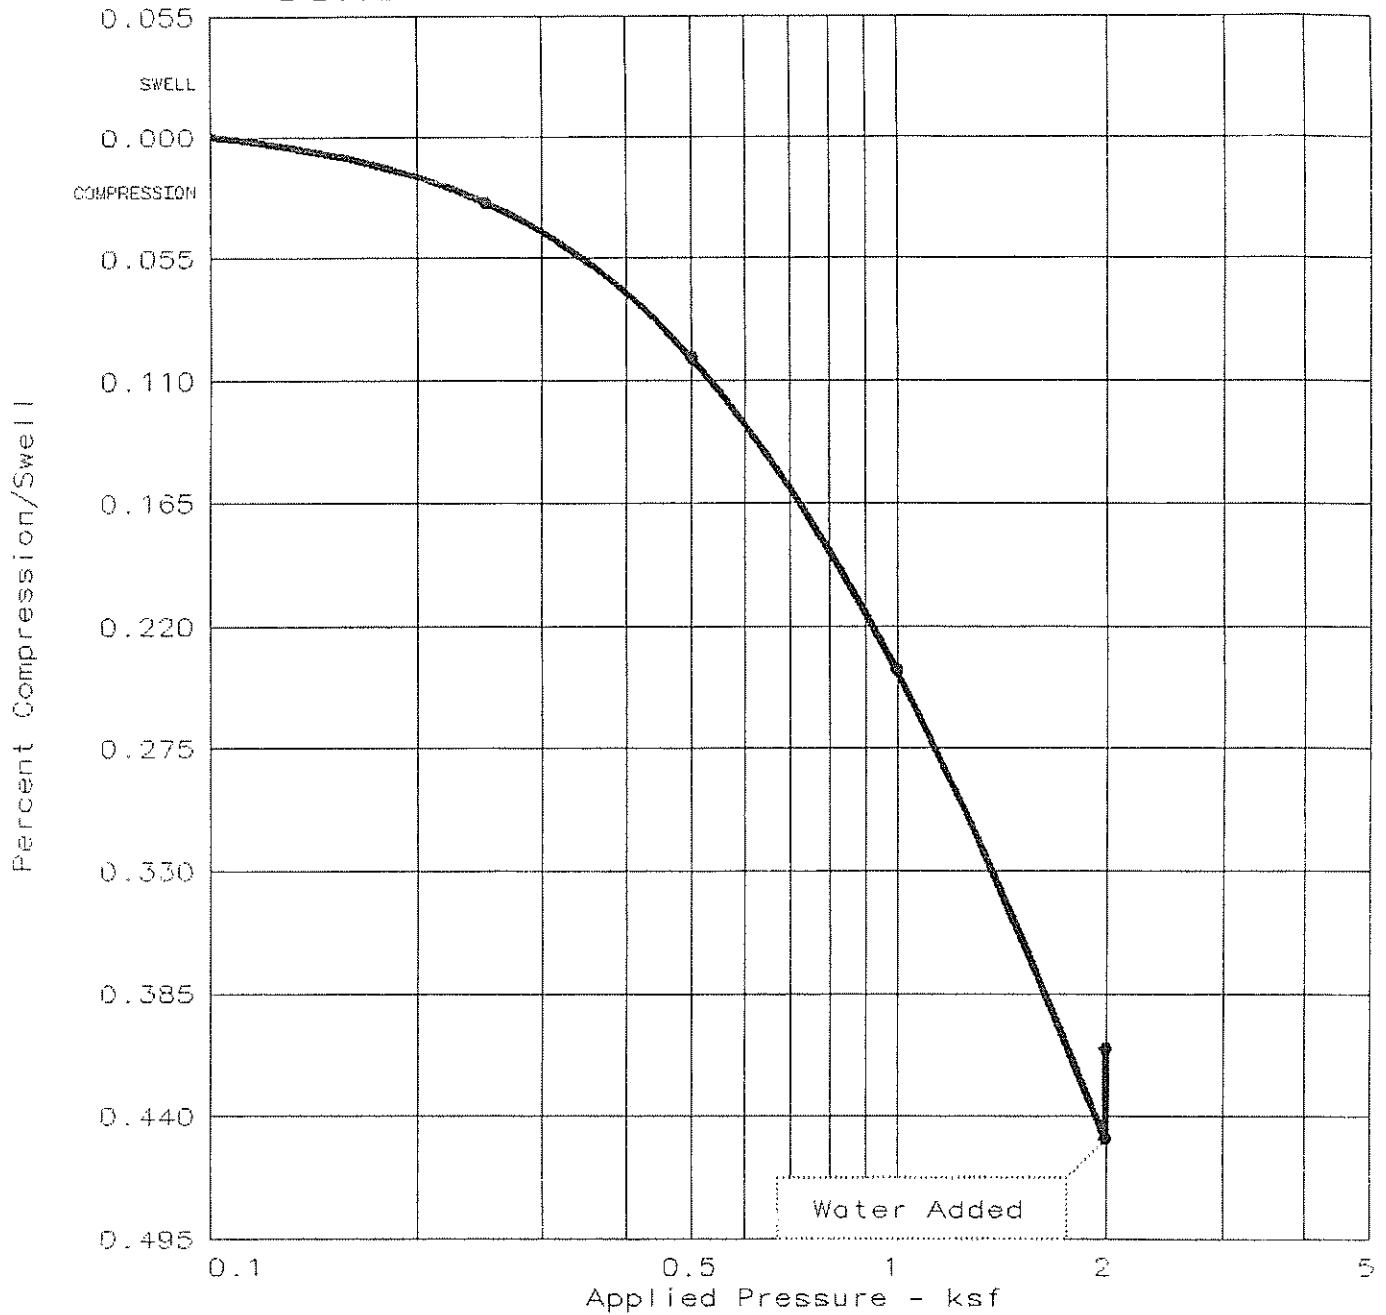
CONSOLIDATION TEST REPORT

Natural Saturation	Natural Moisture	Dry Density	LL	PI	Sp.Gr.	Initial void ratio
56.3 %	11.8	107.5	N/A	N/A	2.700	0.5676

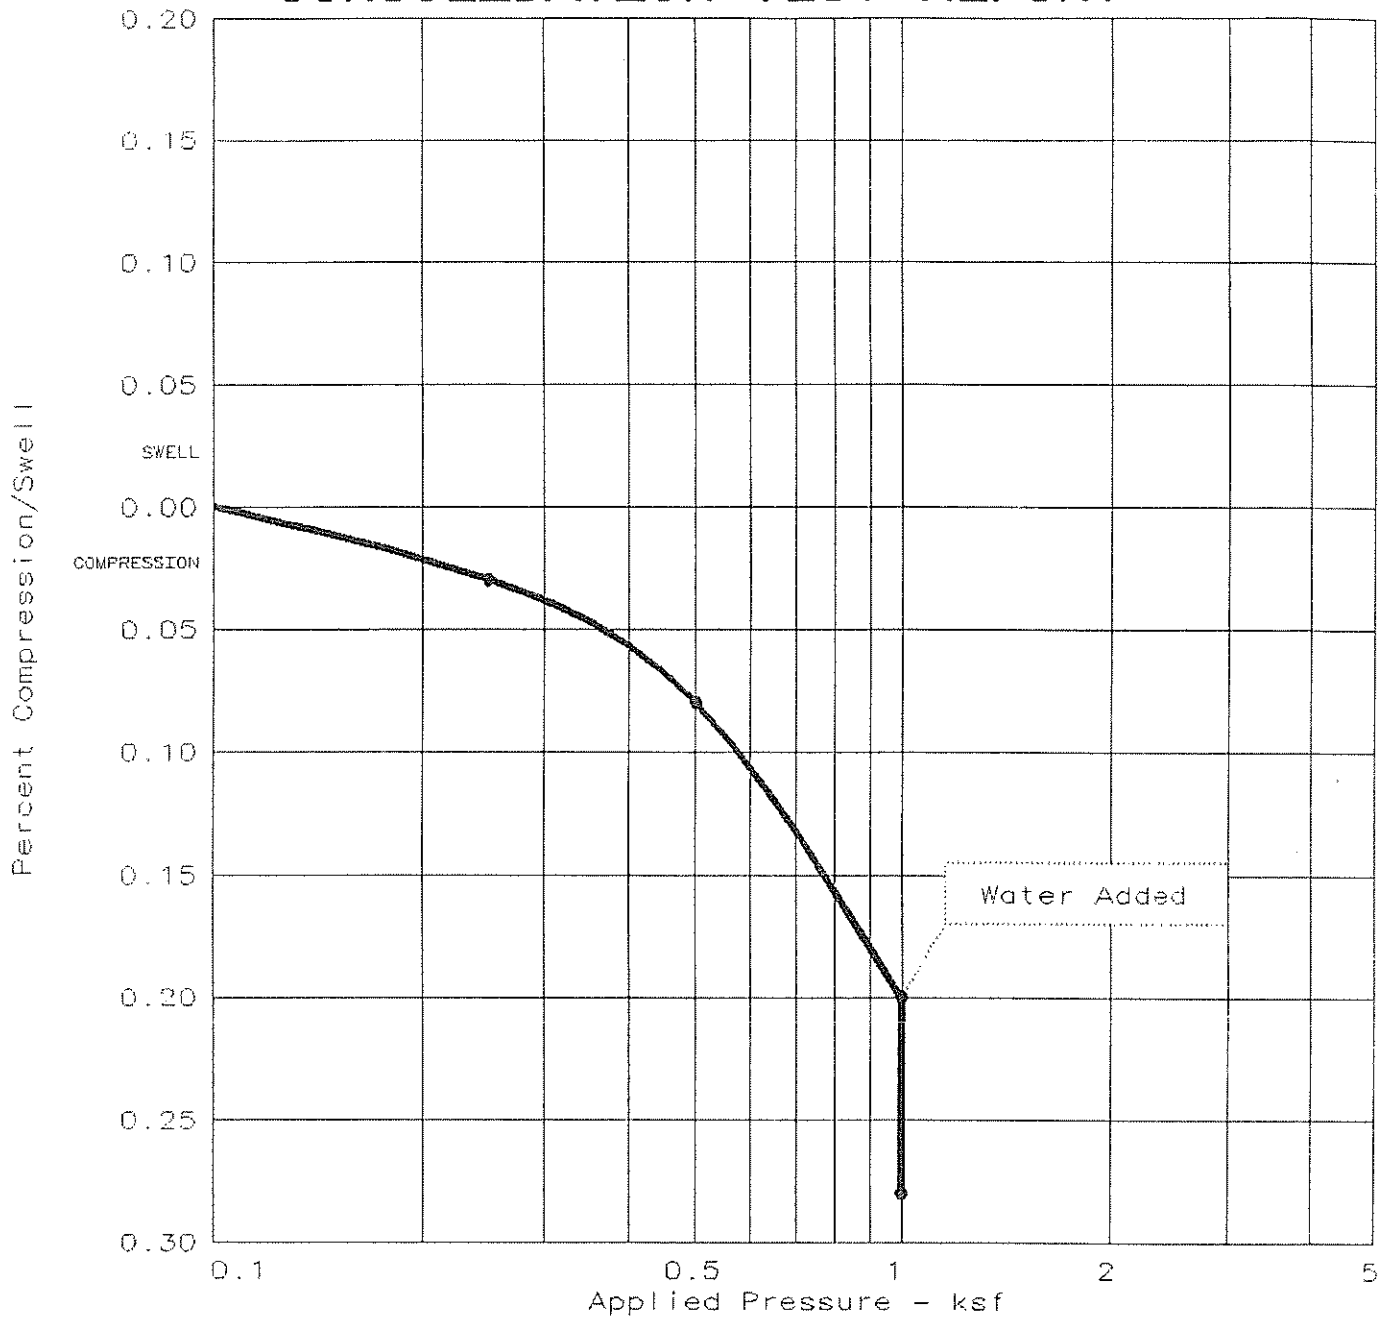
CONSOLIDATION TEST REPORT

Clpse. %	Nat. Sat.	Nat. Moist.	Dry Density	LL	PI	Sp.Gr.	Initial void ratio
0.1	10.5 %	2.4	104.5	N/A	N/A	2.680	0.6015

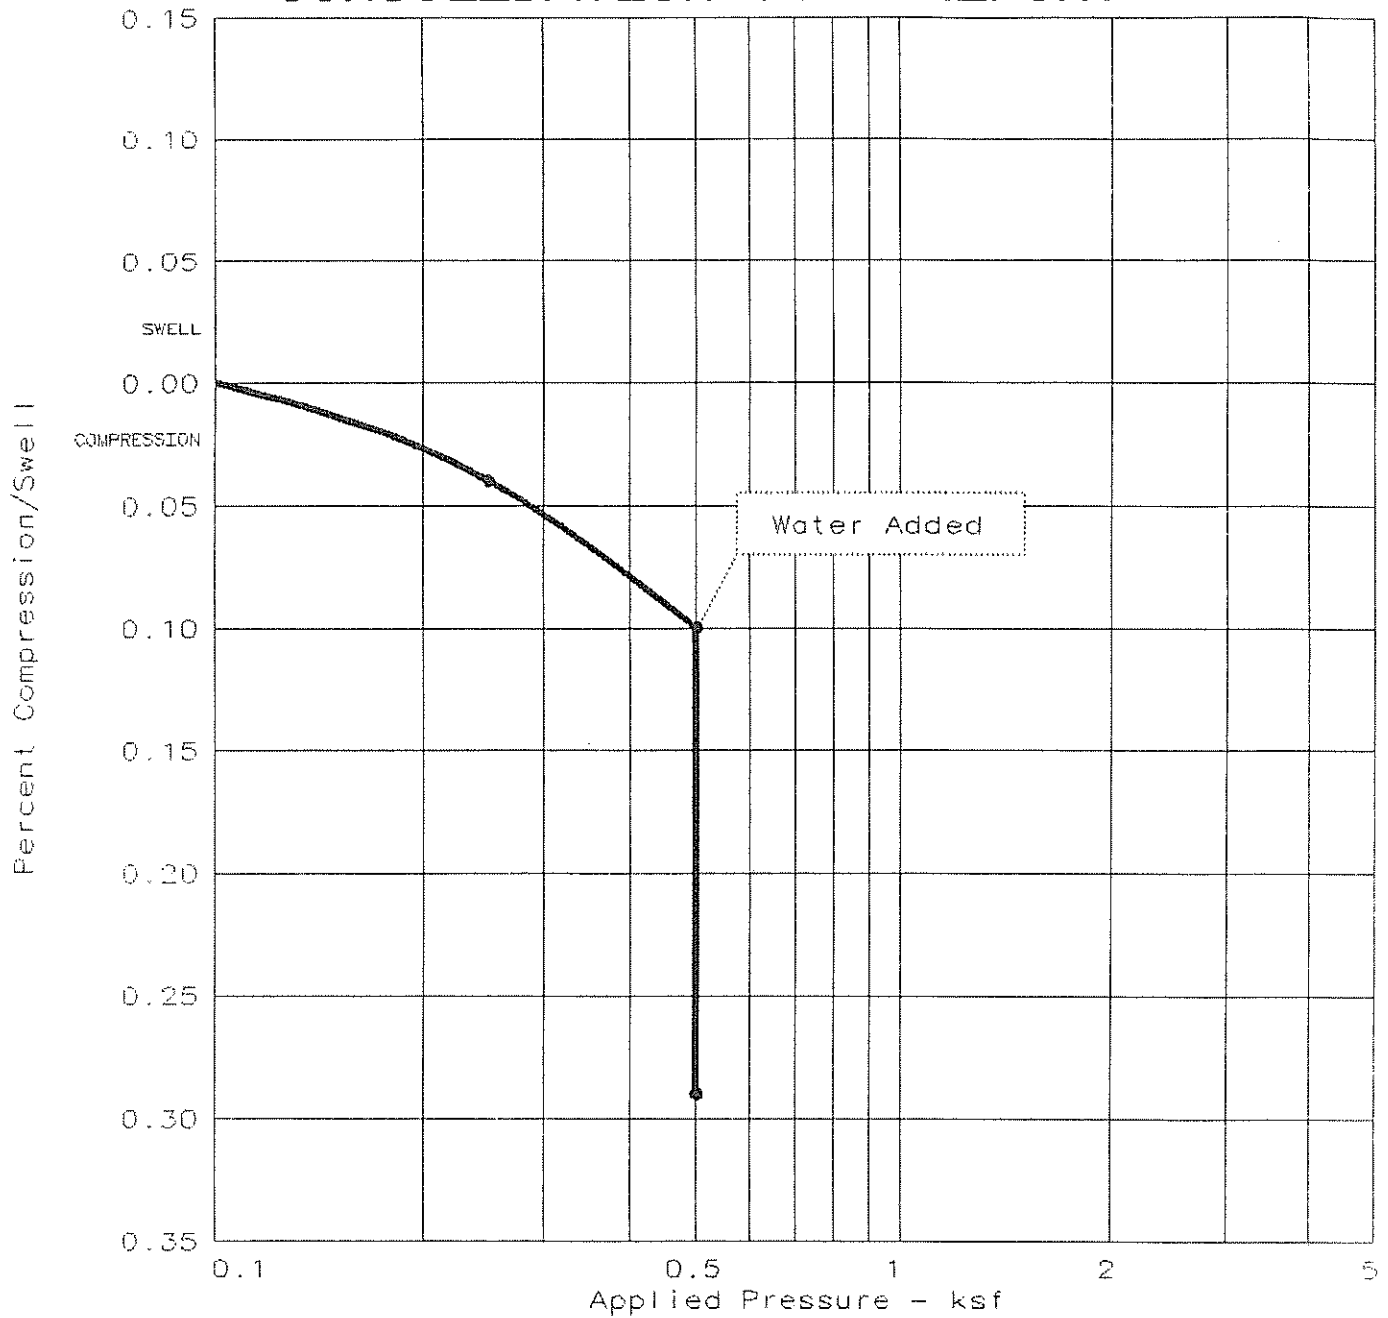
CONSOLIDATION TEST REPORT

Clpse. %	Nat. Sat.	Nat. Moist.	Dry Density	LL	PI	Sp.Gr.	Initial void ratio
0.2	30.5 %	6.3	107.6	N/P	N/P	2.680	0.5550

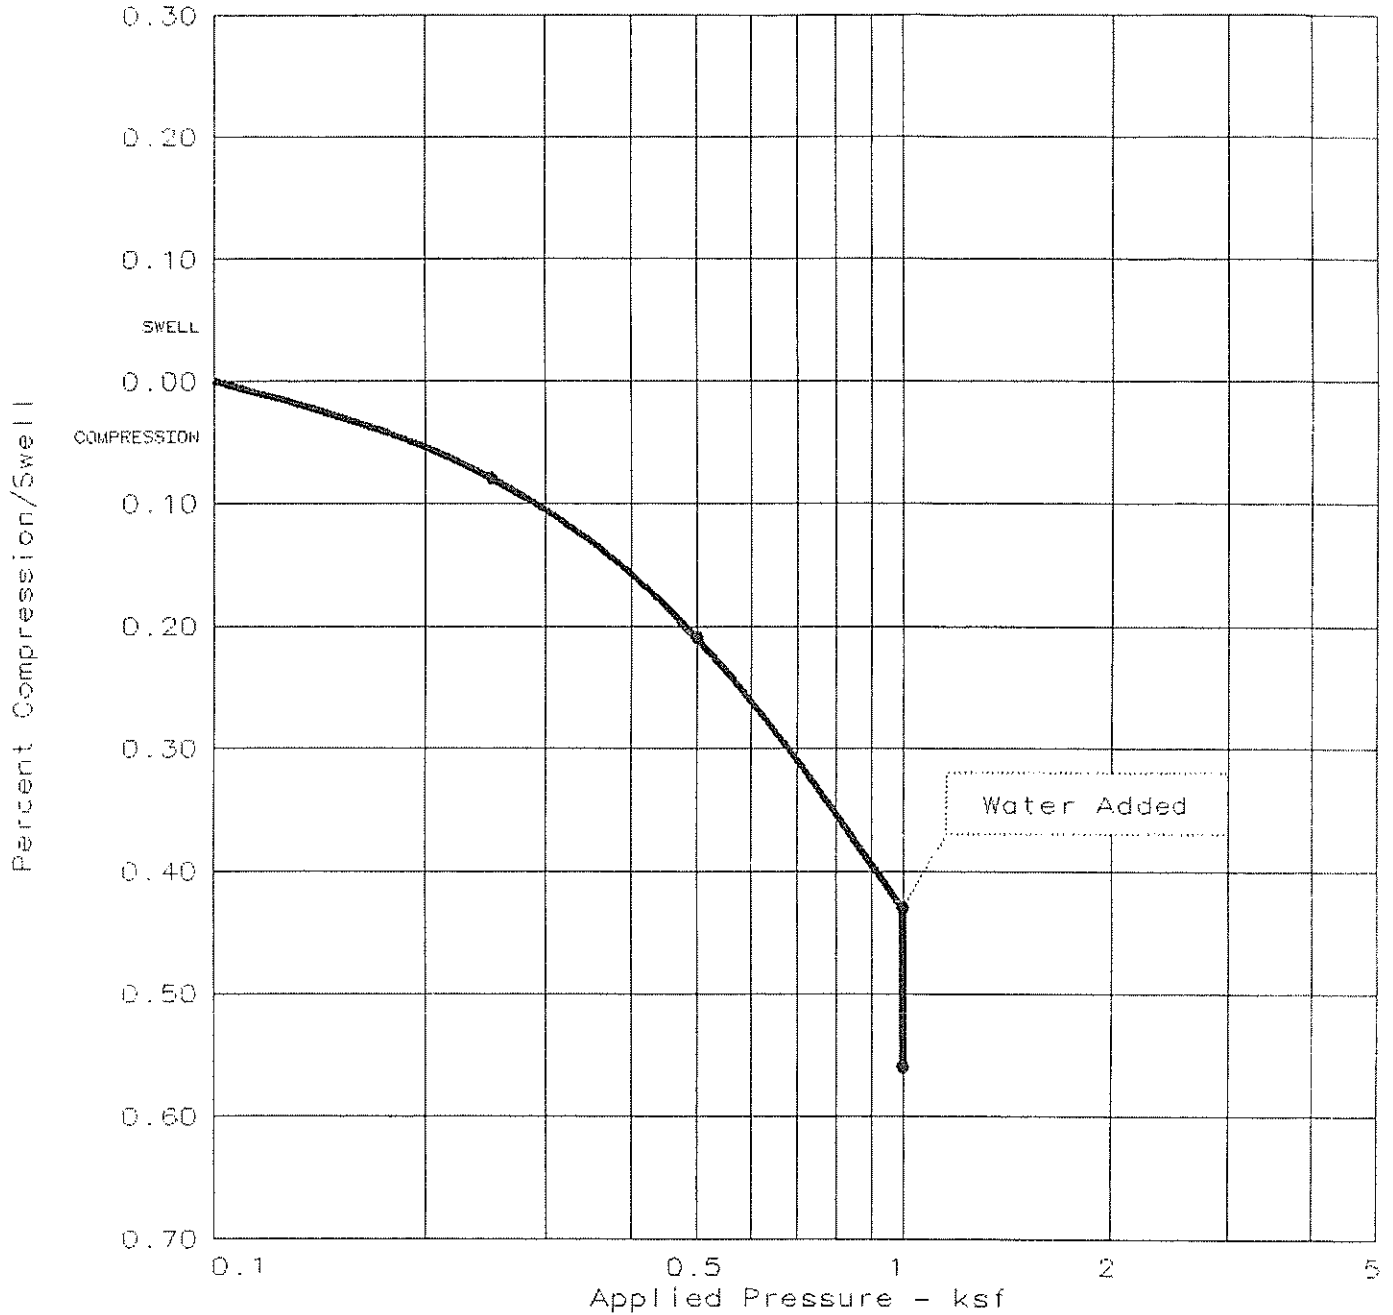
CONSOLIDATION TEST REPORT

Clpse. %	Nat. Sat.	Nat. Moist.	Dry Density	LL	PI	Sp.Gr.	Initial void ratio
0.2	97.5 %	20.7	107.1	N/A	N/A	2.700	0.5739

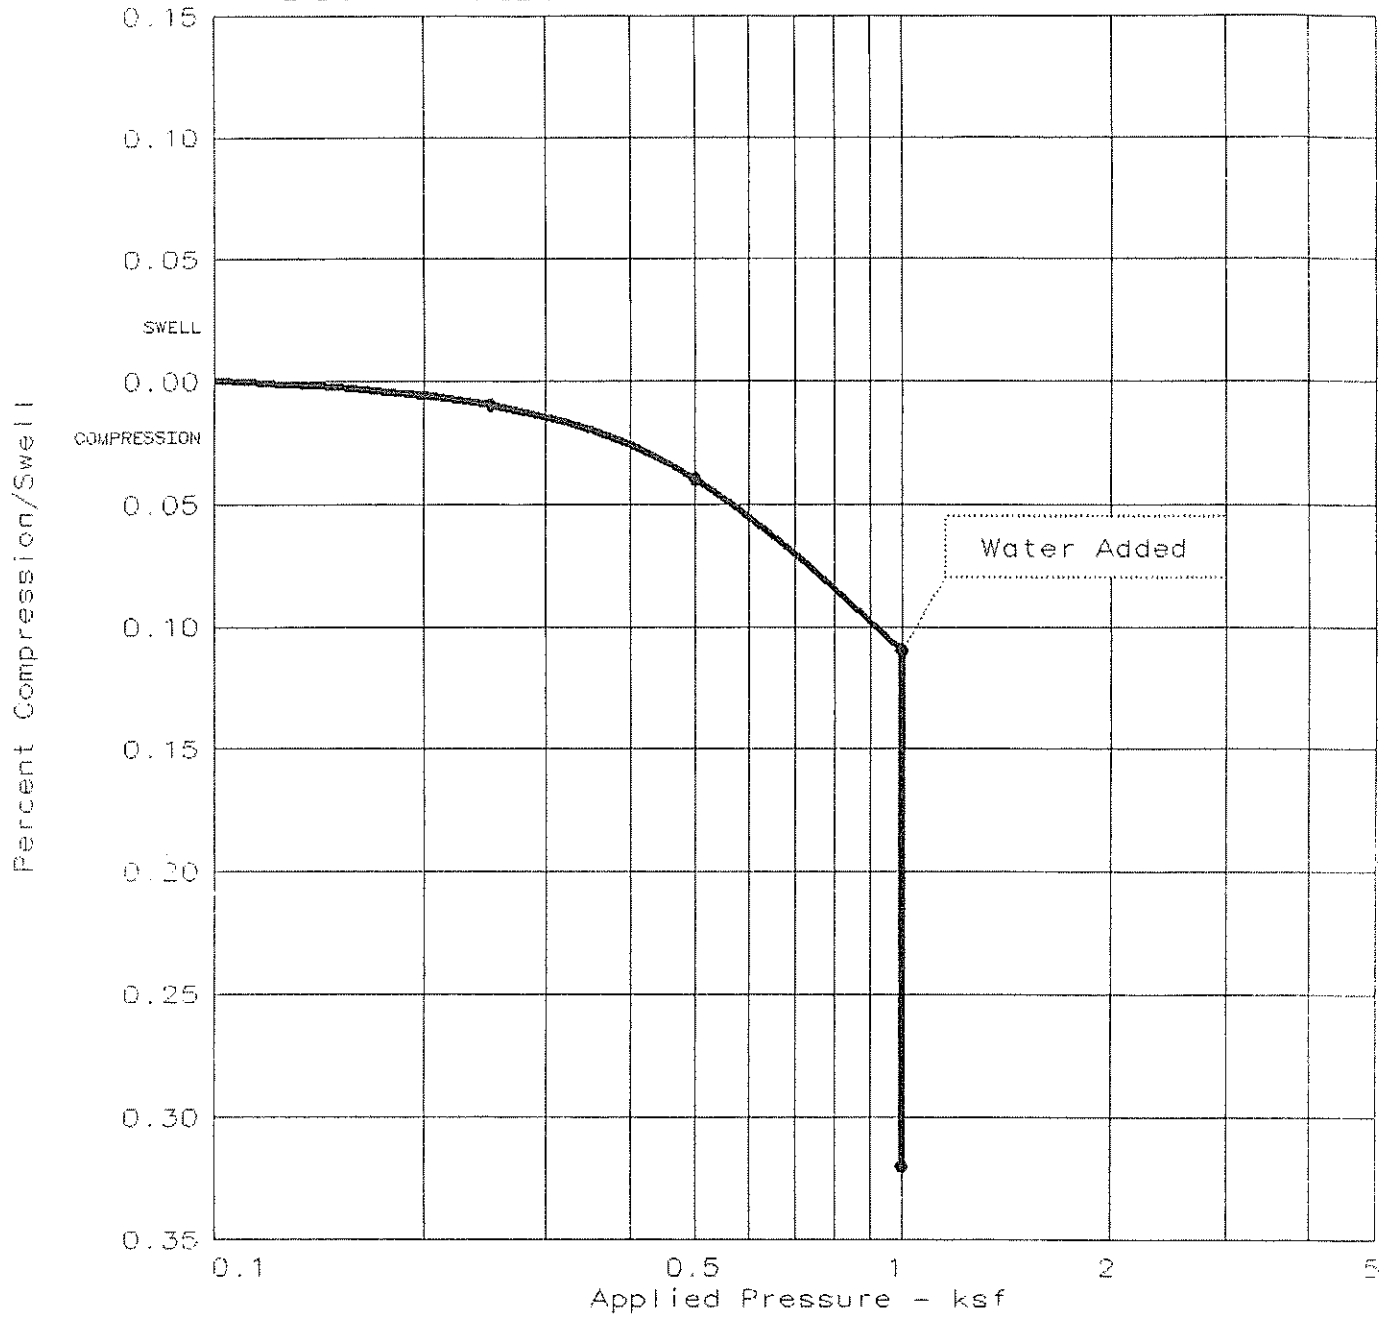
CONSOLIDATION TEST REPORT

Clpse. %	Nat. Sat.	Nat. Moist.	Dry Density	LL	PI	Sp.Gr.	Initial void ratio
0.2	20.1 %	2.9	121.0	N/P	N/P	2.680	0.3825

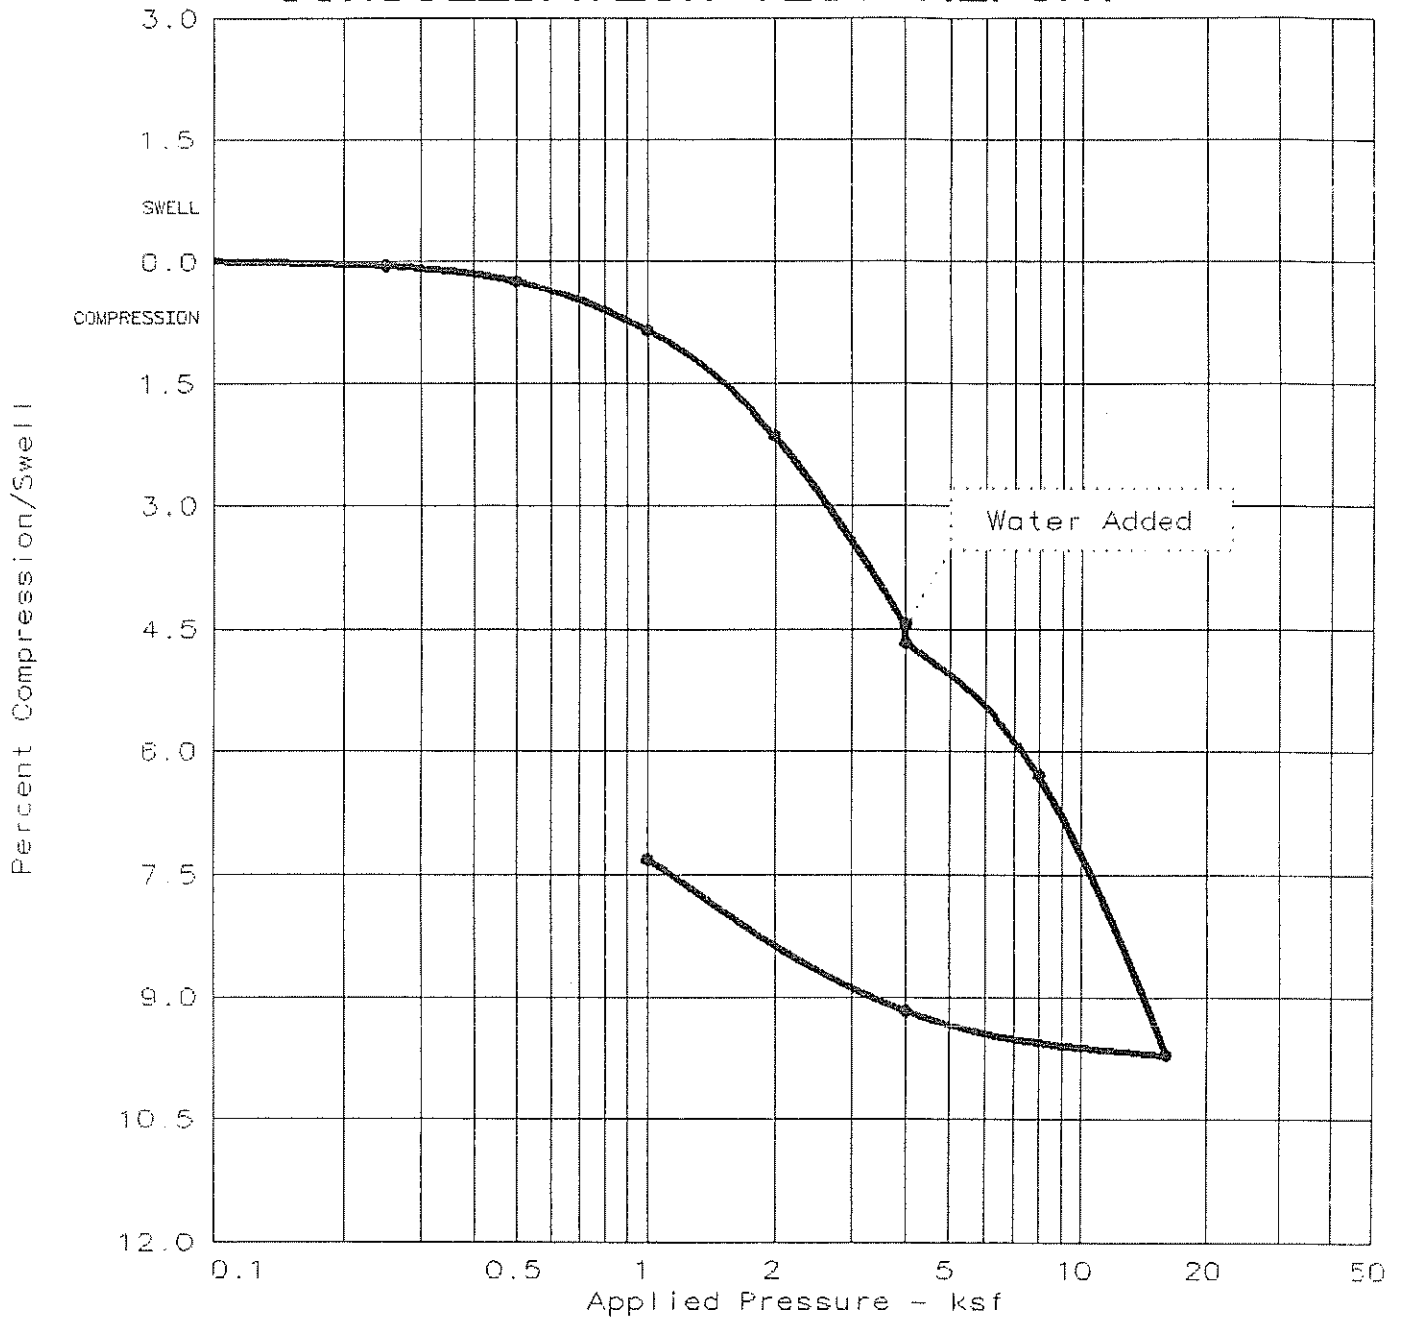
CONSOLIDATION TEST REPORT

Clpse. %	Nat. Sat.	Nat. Moist.	Dry Density	LL	PI	Sp.Gr.	Initial void ratio
0.2	98.9 %	19.8	109.4	N/A	N/A	2.700	0.5406

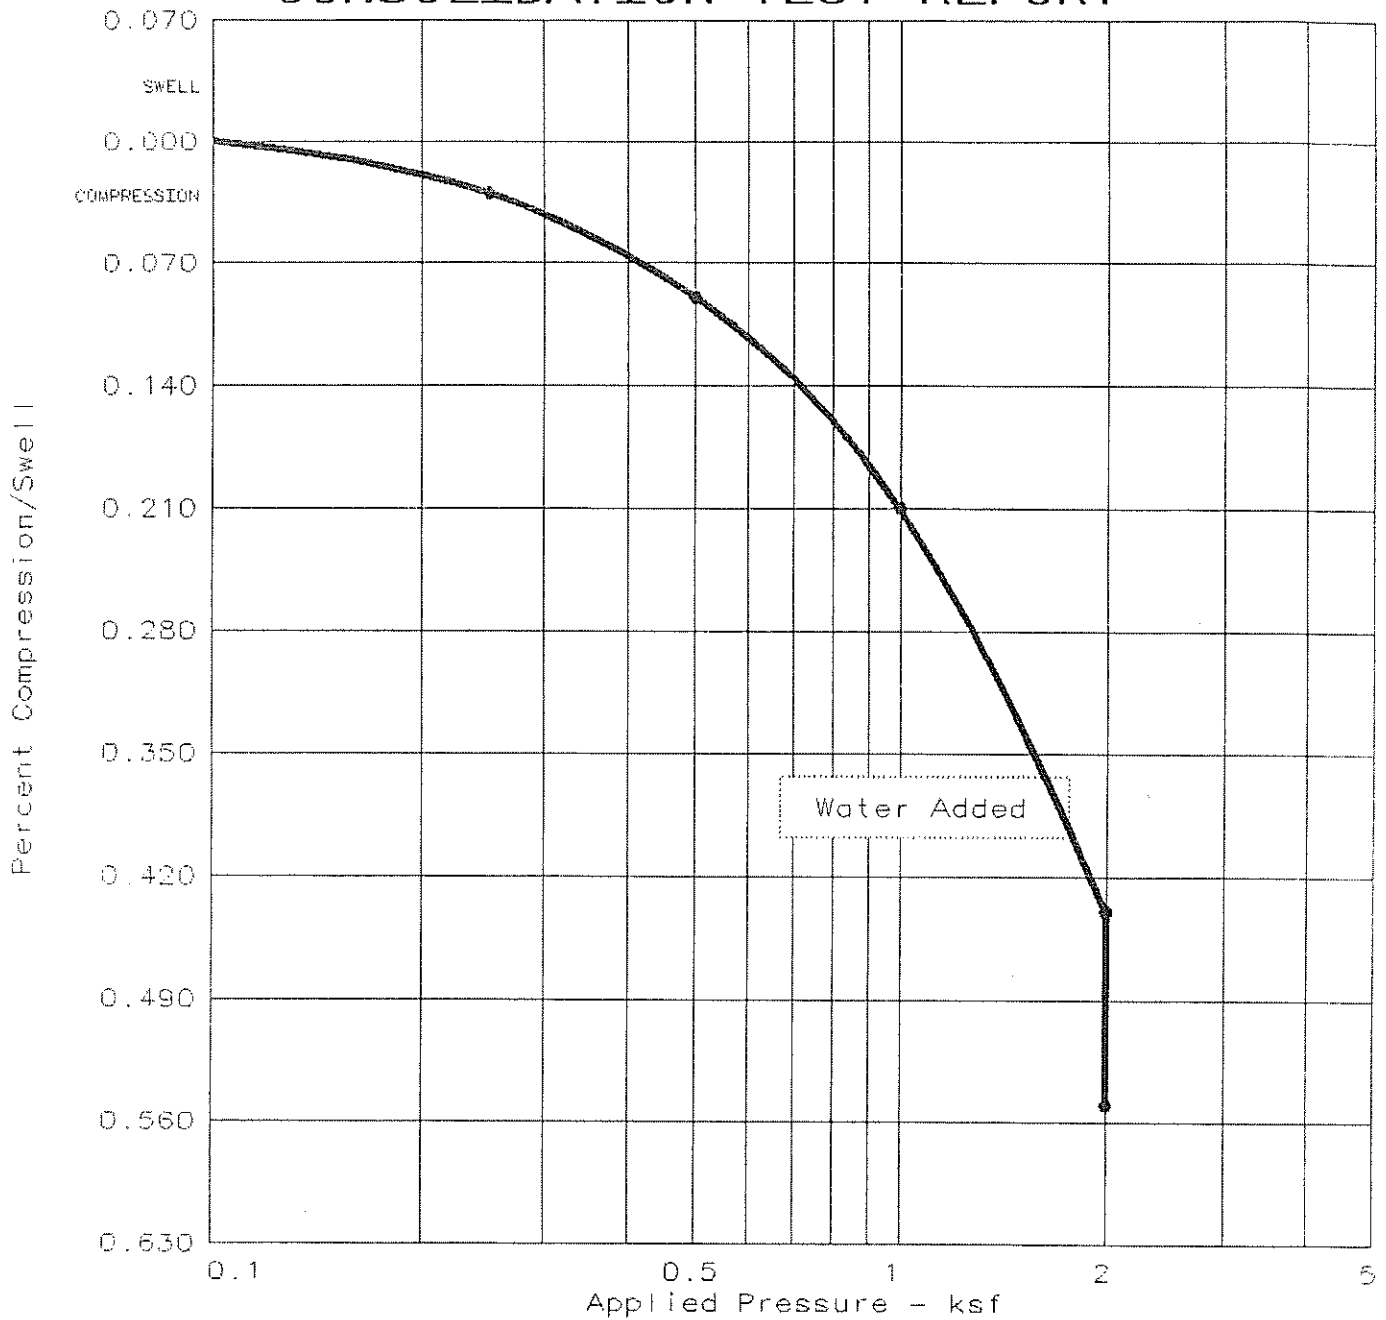
Clpse. %	Nat. Sat.	Nat. Moist.	Dry Density	LL	PI	Sp.Gr.	Initial void ratio
0.2	42.0 %	5.0	126.6	N/P	N/P	2.680	0.3211

TEST RESULTS	MATERIAL DESCRIPTION
Project No.: 1957 Project: Deboer Location: GK-11 @ 15.0 Ft. Date: 10-05-04	Brown Silty SAND (SM) Class: SM Remarks: Tested by: HVK Checked by: GDT
CONSOLIDATION TEST REPORT	Fig. No. _____

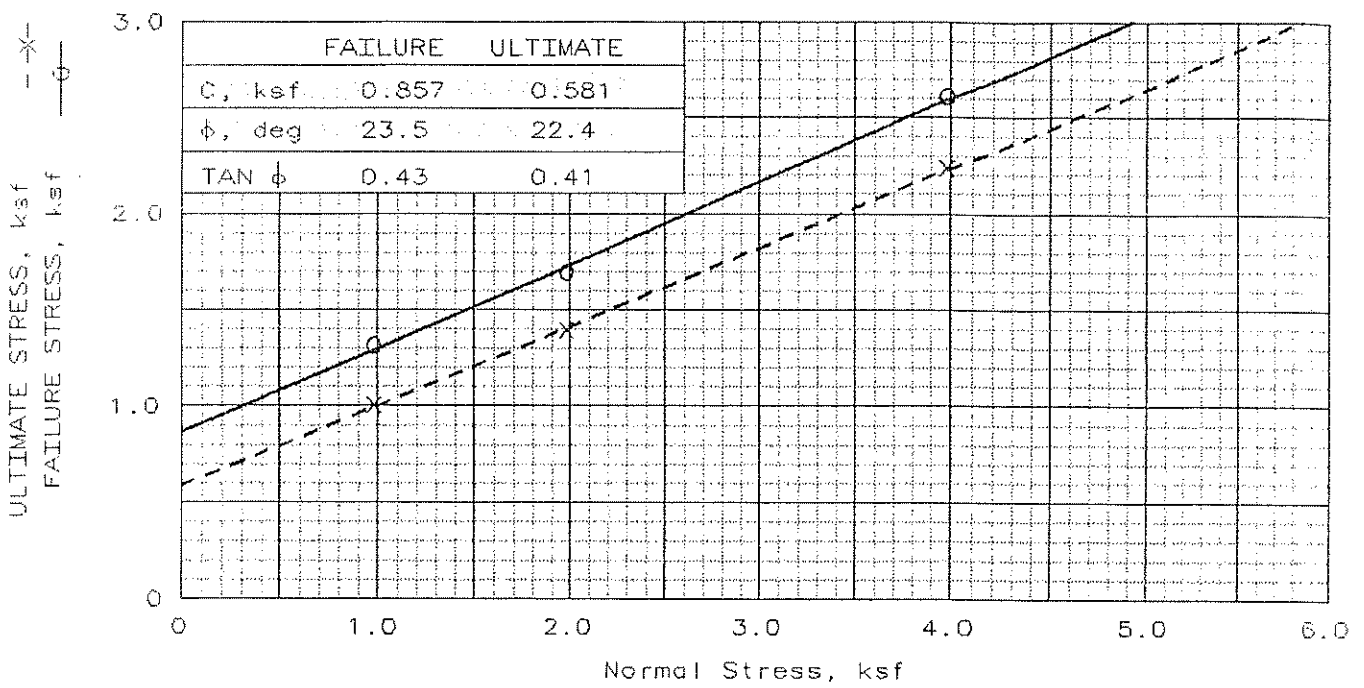
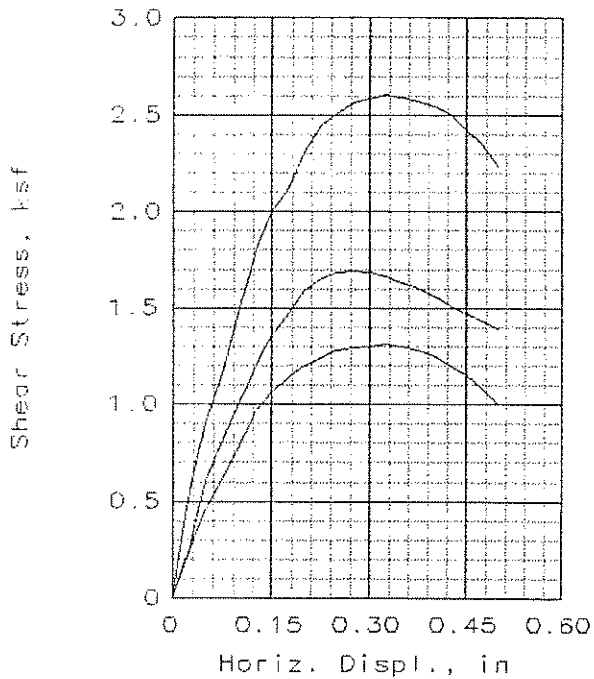
1	2	3	
INITIAL	WATER CONTENT, %	12.4	12.4	12.4
	DRY DENSITY, pcf	115.8	115.8	115.8
	SATURATION, %	73.8	73.8	73.8
	VOID RATIO	0.455	0.455	0.455
	DIAMETER, in	2.420	2.420	2.420
	HEIGHT, in	2.000	2.000	2.000
AT TEST	WATER CONTENT, %	16.1	16.1	15.5
	DRY DENSITY, pcf	116.9	117.2	118.6
	SATURATION, %	98.4	99.2	99.3
	VOID RATIO	0.442	0.438	0.421
	DIAMETER, in	2.420	2.420	2.420
	HEIGHT, in	1.982	1.977	1.954
NORMAL STRESS, ksf	1.000	2.000	4.000	
FAILURE STRESS, ksf	1.312	1.693	2.605	
DISPLACEMENT, in	0.325	0.275	0.325	
ULTIMATE STRESS, ksf	1.002	1.393	2.234	
DISPLACEMENT, in	0.500	0.500	0.500	
Strain rate, in/min	0.00750	0.00750	0.0075

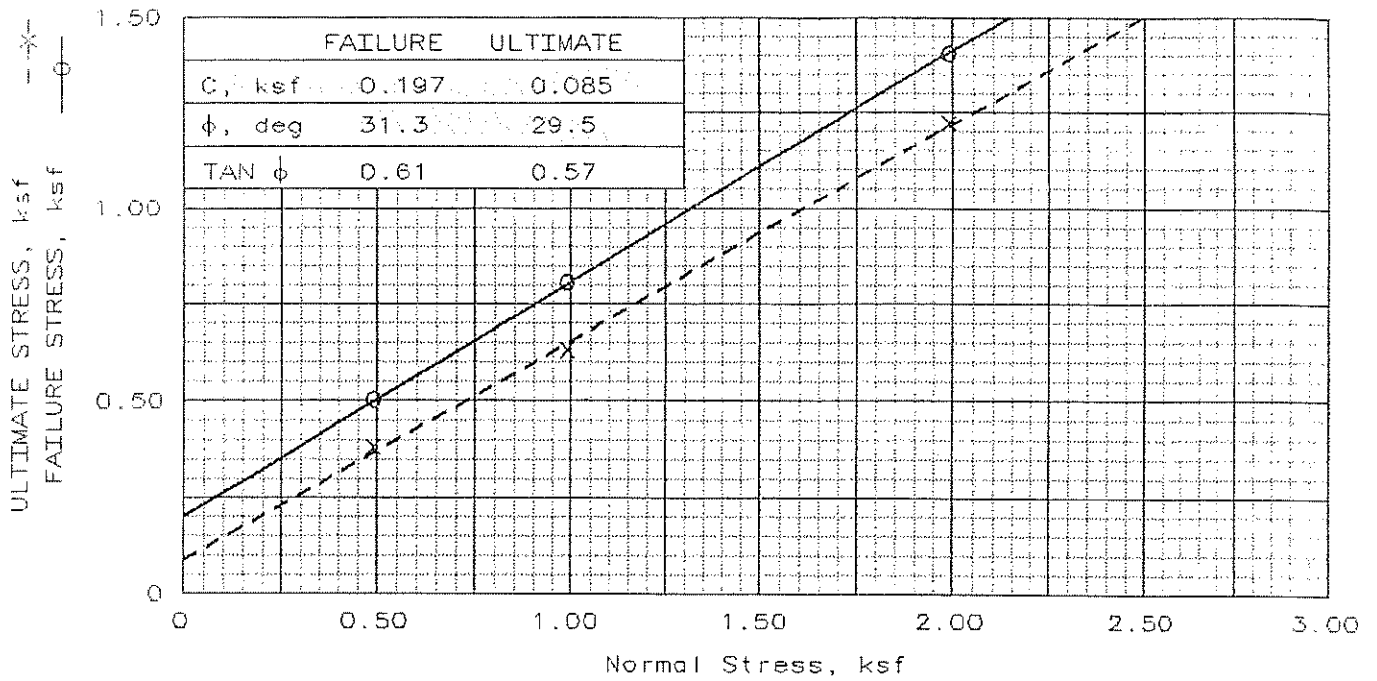
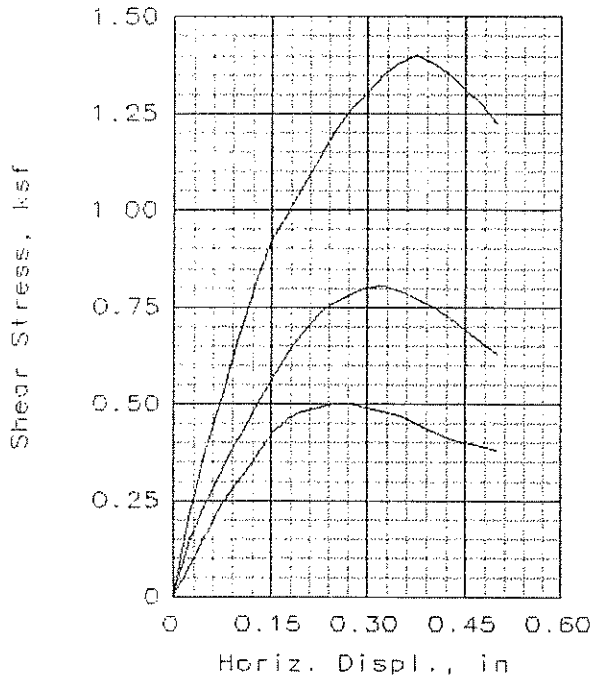
DIRECT SHEAR TEST REPORT

1	2	3	
INITIAL	WATER CONTENT, %	9.3	9.3	9.3
	DRY DENSITY, pcf	106.9	107.0	107.0
	SATURATION, %	43.9	43.7	43.7
	VOID RATIO	0.565	0.569	0.570
	DIAMETER, in	2.420	2.420	2.420
	HEIGHT, in	2.000	2.000	2.000
AT TEST	WATER CONTENT, %	19.5	19.4	18.1
	DRY DENSITY, pcf	107.8	109.3	112.3
	SATURATION, %	94.6	97.4	98.5
	VOID RATIO	0.552	0.536	0.495
	DIAMETER, in	2.420	2.420	2.420
	HEIGHT, in	1.984	1.958	1.905
NORMAL STRESS, ksf	0.500	1.000	2.000	
FAILURE STRESS, ksf	0.501	0.804	1.403	
DISPLACEMENT, in	0.250	0.325	0.375	
ULTIMATE STRESS, ksf	0.381	0.631	1.222	
DISPLACEMENT, in	0.500	0.500	0.500	
Strain rate, in/min	0.00750	0.00750	0.0075

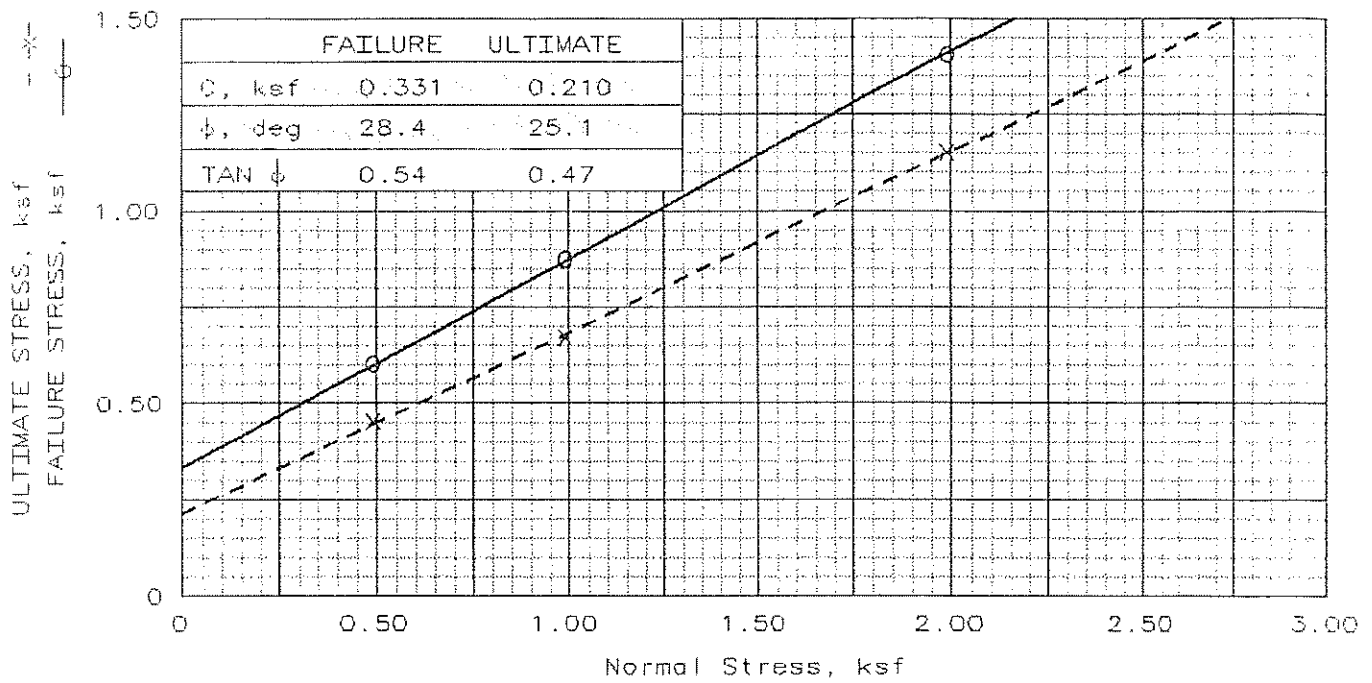
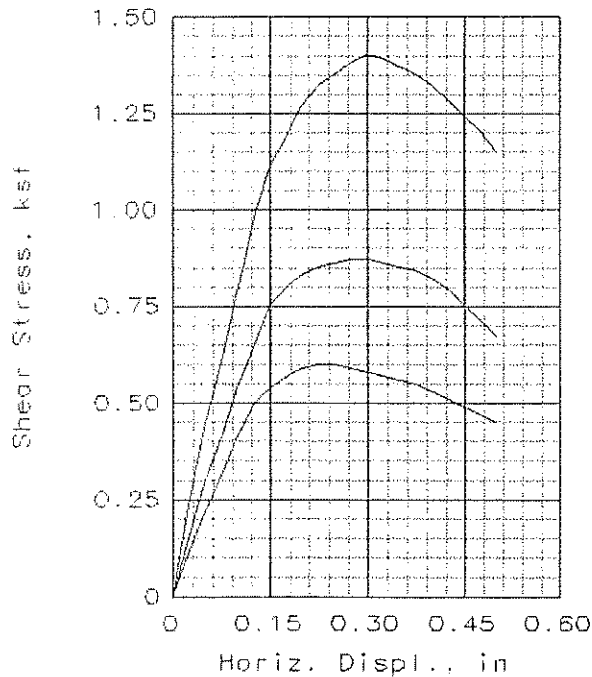
DIRECT SHEAR TEST REPORT

1	2	3	
INITIAL	WATER CONTENT, %	11.1	11.1	11.1
	DRY DENSITY, pcf	119.9	119.7	119.9
	SATURATION, %	74.4	74.1	74.3
	VOID RATIO	0.401	0.402	0.401
	DIAMETER, in	2.420	2.420	2.420
	HEIGHT, in	2.000	2.000	2.000
AT TEST	WATER CONTENT, %	14.0	14.2	13.7
	DRY DENSITY, pcf	120.8	121.0	122.4
	SATURATION, %	96.3	98.3	99.1
	VOID RATIO	0.390	0.388	0.372
	DIAMETER, in	2.420	2.420	2.420
	HEIGHT, in	1.985	1.979	1.958
NORMAL STRESS, ksf	0.500	1.000	2.000	
FAILURE STRESS, ksf	0.601	0.872	1.403	
DISPLACEMENT, in	0.225	0.275	0.300	
ULTIMATE STRESS, ksf	0.451	0.671	1.152	
DISPLACEMENT, in	0.500	0.500	0.500	
Strain rate, in/min	0.00750	0.00750	0.0075
