Appendix E1 Biological Resources Report

Biological Technical Report for the Ontario Regional Sports Complex Project

San Bernardino County, California

March 2024

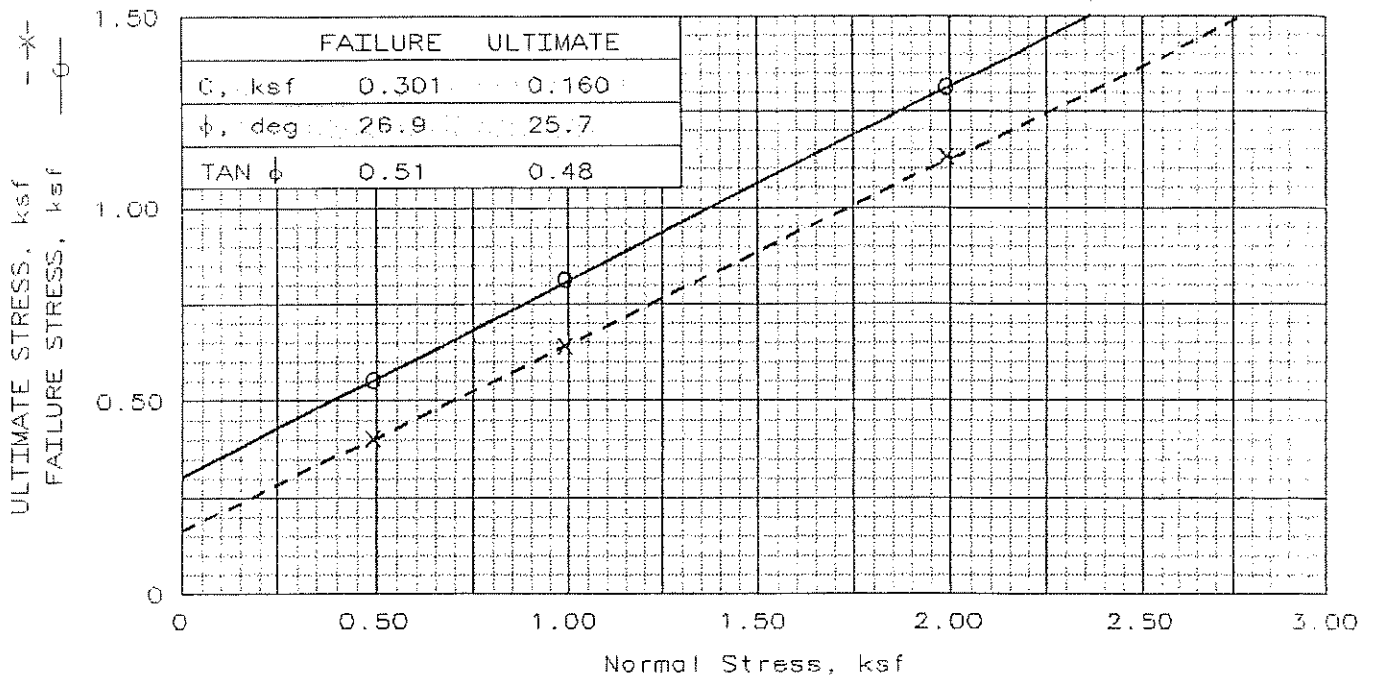
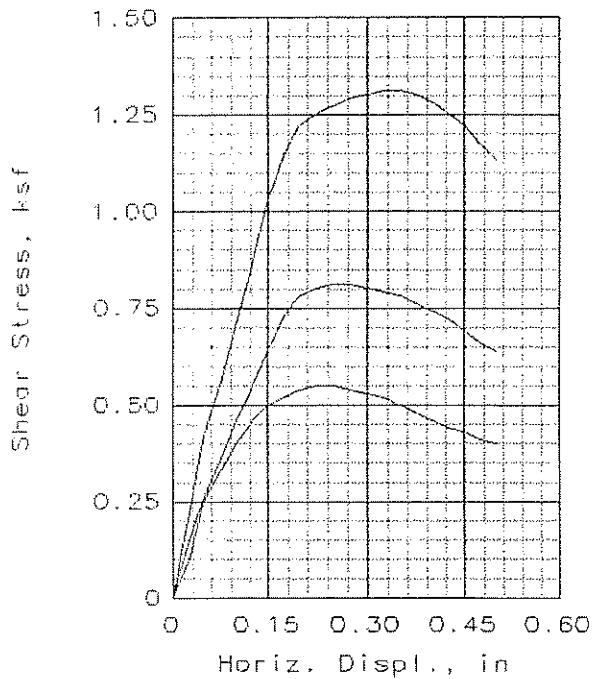
1	2	3	
INITIAL	WATER CONTENT, %	14.4	14.4	14.4
	DRY DENSITY, pcf	111.7	111.7	111.7
	SATURATION, %	76.7	76.6	76.7
	VOID RATIO	0.508	0.509	0.505
	DIAMETER, in	2.420	2.420	2.420
	HEIGHT, in	2.000	2.000	2.000
AT TEST	WATER CONTENT, %	17.3	18.0	17.1
	DRY DENSITY, pcf	112.6	112.7	113.0
	SATURATION, %	93.9	98.0	94.0
	VOID RATIO	0.497	0.495	0.491
	DIAMETER, in	2.420	2.420	2.420
	HEIGHT, in	1.985	1.982	1.978
NORMAL STRESS, ksf	0.500	1.000	2.000	
FAILURE STRESS, ksf	0.551	0.811	1.312	
DISPLACEMENT, in	0.225	0.250	0.325	
ULTIMATE STRESS, ksf	0.401	0.641	1.132	
DISPLACEMENT, in	0.500	0.500	0.500	
Strain rate, in/min	0.00750	0.00750	0.0075

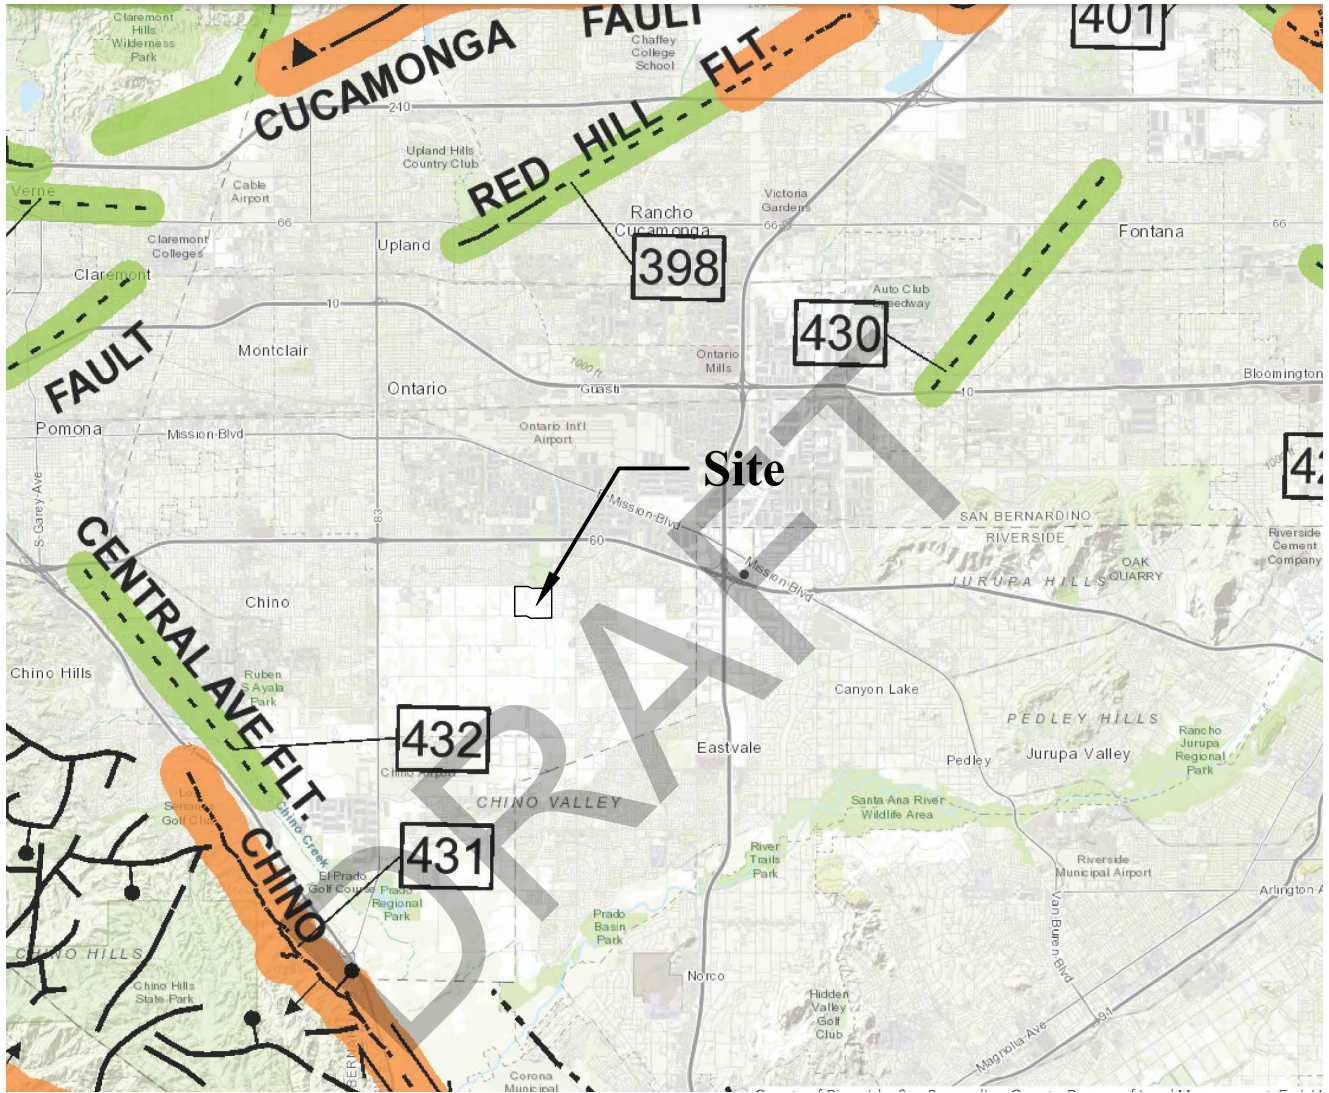
RMA JOB NO.:
00-232255-01
 SHEET NO.:
1 OF 1
 FIGURE NO.:
3

REGIONAL FAULT MAP

Scale: 1" ≈ 3 miles
