ONTARIO INTERNATIONAL AIRPORT HISTORIC CONTEXT STATEMENT

Prepared for:
City of Ontario

September 2017

ASM Project Number 27400

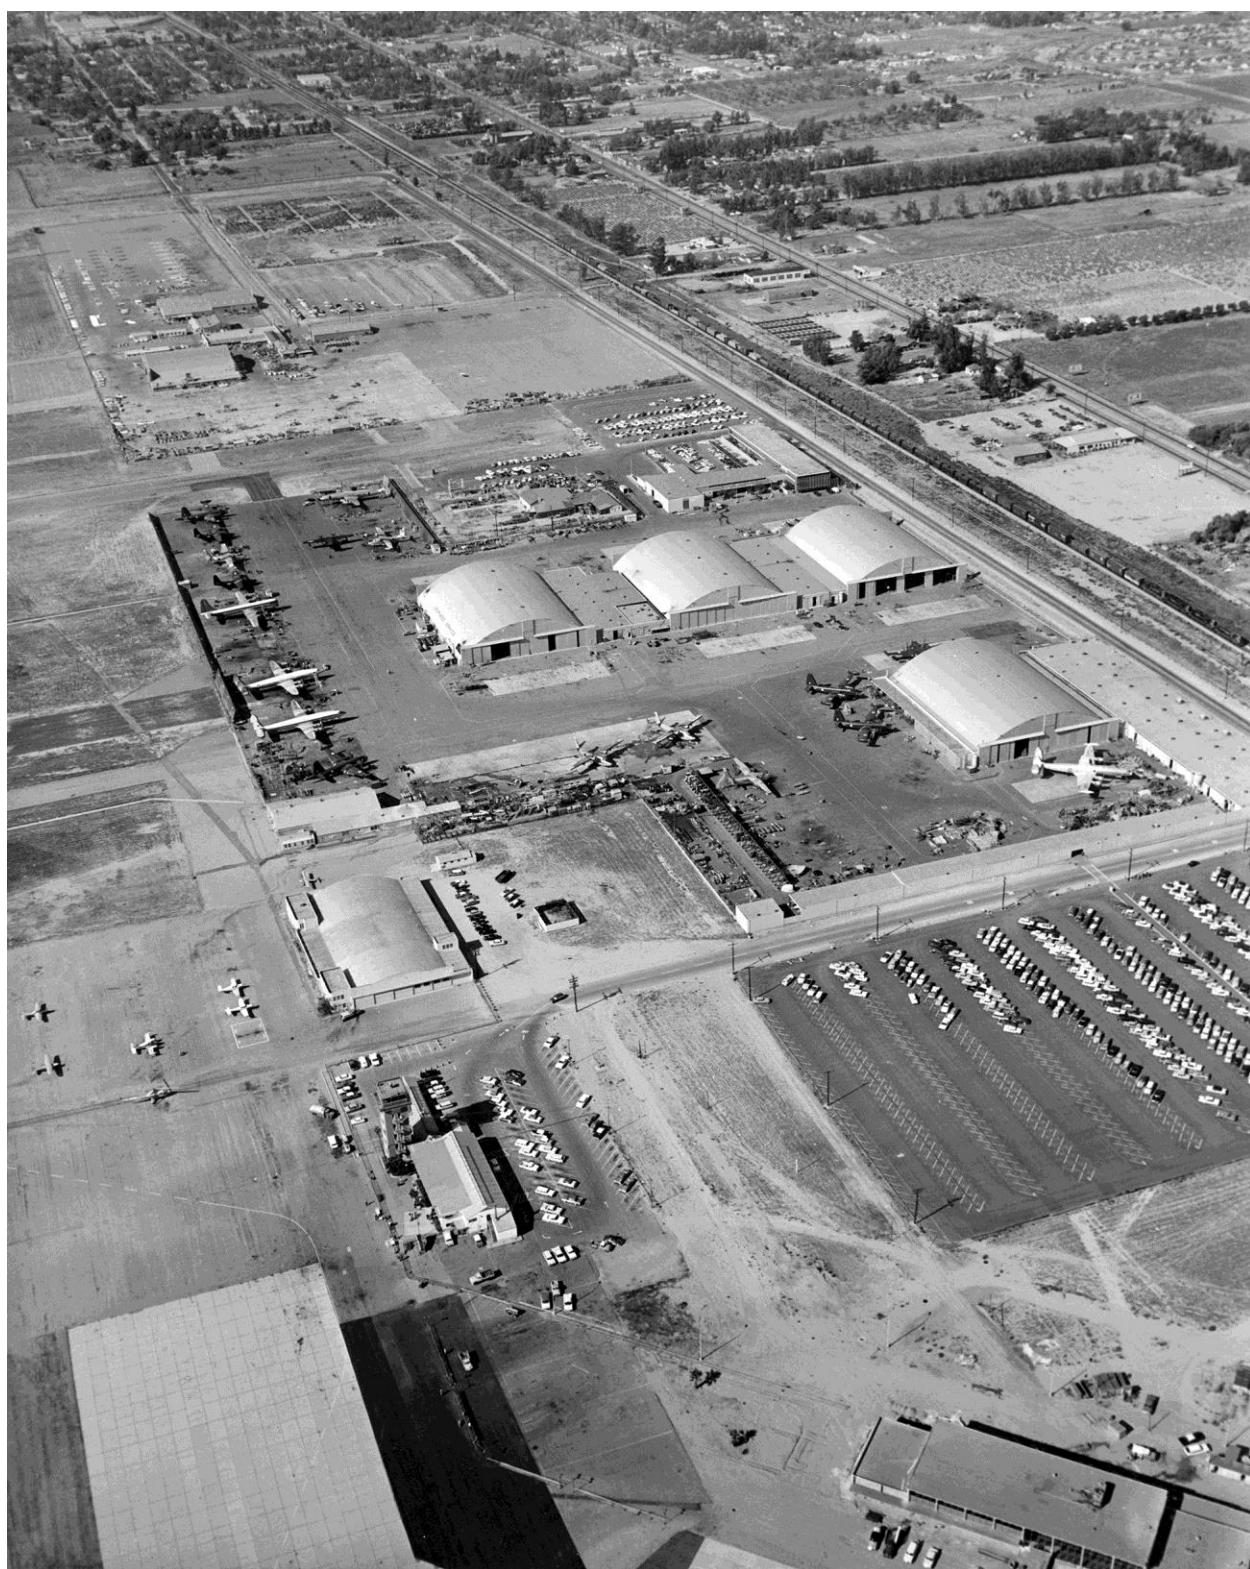
Figure 8. Aerial view of LAS area (the hangar in the fore right has been demolished), post-1953. Photographer: Gordon Ayers. Source: Ontario City Library Robert E. Ellingwood Model Colony Room. Accession No. 3677.

From 1952 to 1998, LAS, a division of Lockheed Aircraft Corporation, operated at ONT, primarily within a 70-acre parcel in the northwest area of the airport. During its 46 years of operation at Ontario, Lockheed built more than 25 structures, including hangars, office buildings, machine shops, and auxiliary buildings (Douglas and Livingstone 2006) (Figures 8-11).

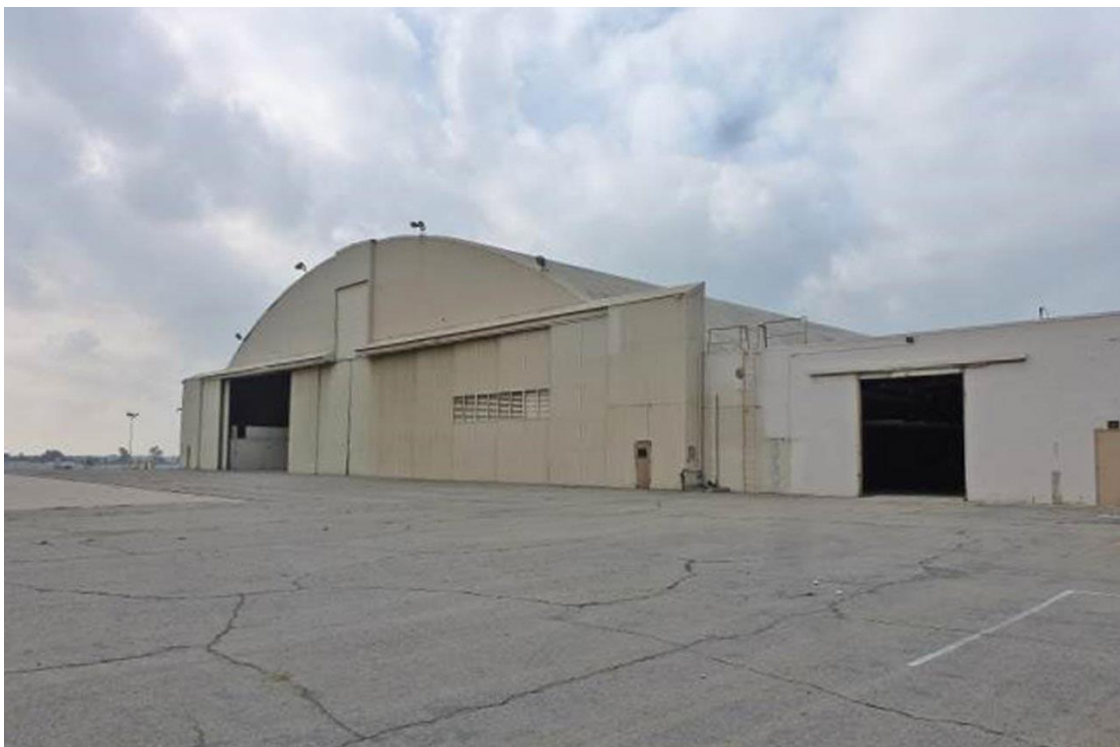
Figure 11. Lockheed Hangar 2, looking southwest. December 6, 2016.
Source: ASM.

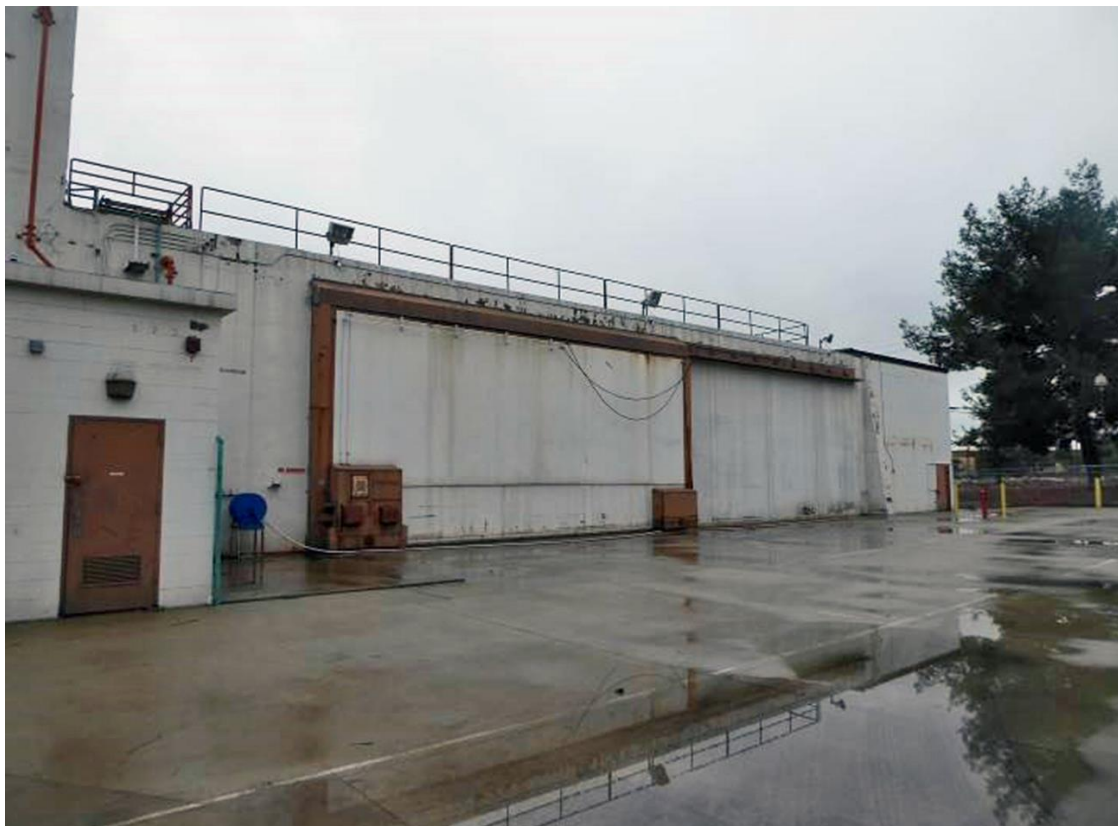
Figure 17. GE Jet Engine Test Cell 1, looking southwest. December 6, 2016.
Source: ASM.

The GE Jet Engine Test Cell Area is located to the southeast of the main GE operations on East Mission Boulevard (Figure 17). The initial components of the testing area were constructed in 1956, and the facility was used to test military and commercial aircraft jet engines after they were overhauled. The site consists of two thick-walled concrete test cells, storage structures, a preparation-for-testing building, offices, and a guard house.¹⁷

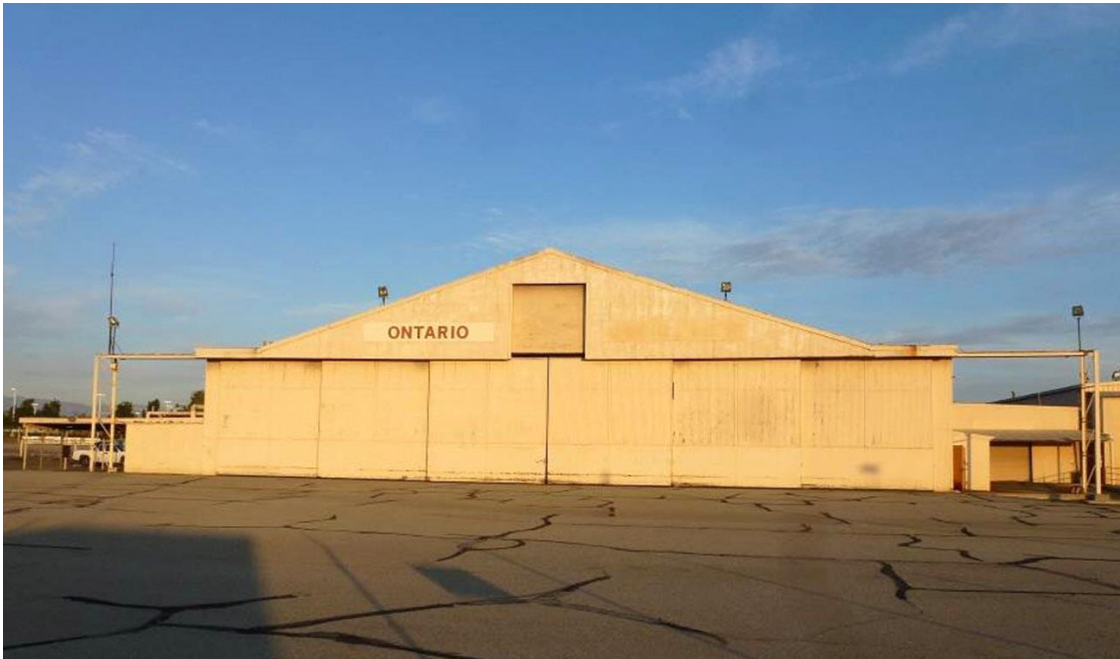
Figure 18. Aerojet-General Hangar, looking east at the west façade. December 6, 2016. Source: ASM.

Aerojet-General Corporation completed construction on a 19,000-square foot facility at ONT in 1958 to the west of Cucamonga Creek Channel at ONT. The facility included hangar space, as well as offices, a lobby, engine store, and a repair shop in an attached concrete block structure (Figure 18).¹⁹ Aerojet-General Corporation maintained an overhaul base at the airport to service its fleet of seven transport aircraft used on company business.²⁰

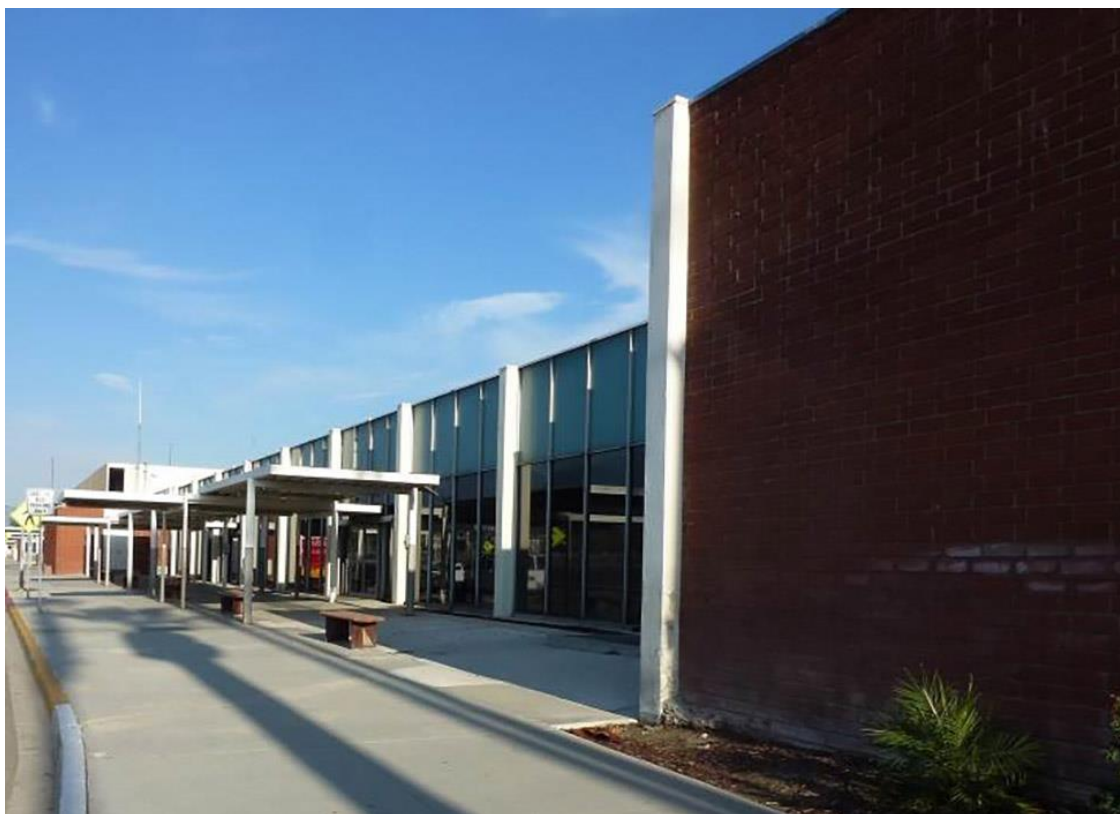
Figure 26. Primary façade of Terminal One, showing additions.
December 6, 2016. *Source: ASM.*

By 1959-1960, the terminal was replaced by the current Terminal One complex (Figures 22-25). Designed for expansion, the Terminal One building was enlarged extensively in two phases in the 1960s, and again in the 1970s. In 1983 and 1993, the terminal received two more additions (Figure 26). In 1965, a freestanding single-story Federal Aviation Authority (FAA) office building was added to the complex. Terminal One was vacated in 1998, when the current terminals two and four were opened.

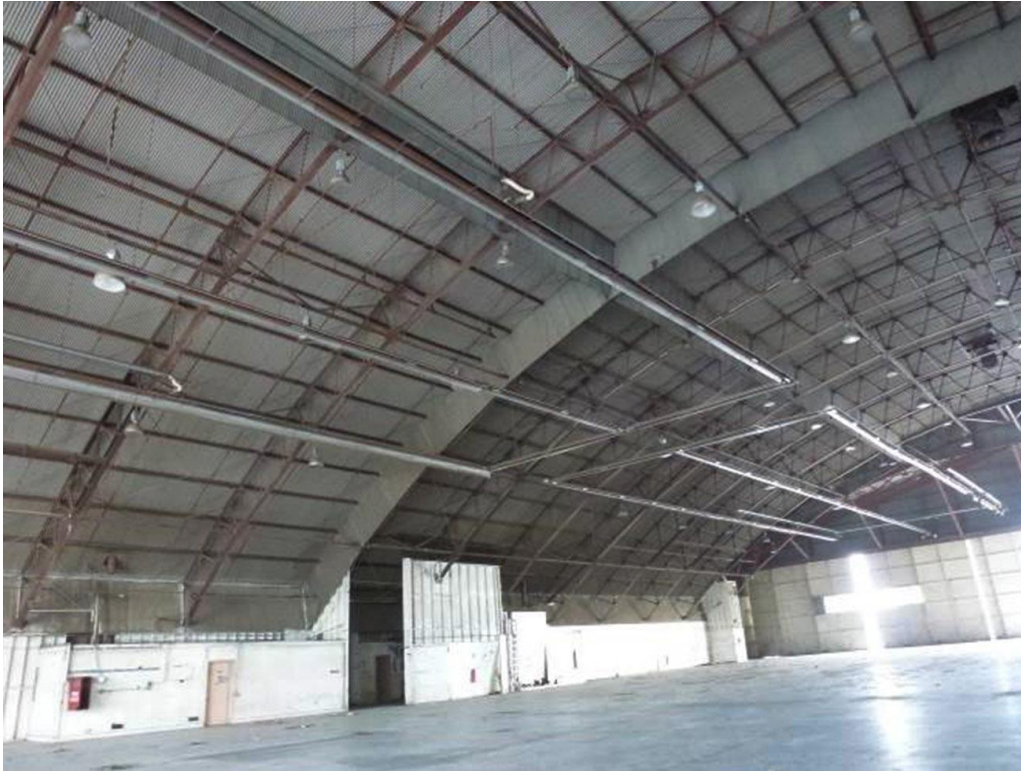
Figure 30. Interior of Lockheed Hangar 2. December 6, 2016.
Source: ASM.

The advent of aviation and related activities in the twentieth century necessitated a new type of building to house the flying machine, both for storage and as enclosed workspaces for aircraft modification and repair. The founders of Latimer Field, Ontario's first airfield, designed and constructed a hangar that improved on the hangars of the day, which had large, single-piece doors that ran on tracks out from the sides. The new hangar had doors that were segmented and hinged, so that the tracks could run along the sides of the building and thus be protected from the wind (Neward 1970:7-8). As the size and mechanical complexity of airplanes increased, the size and construction technology of hangars increased as well (Aaron 2011:5-2).

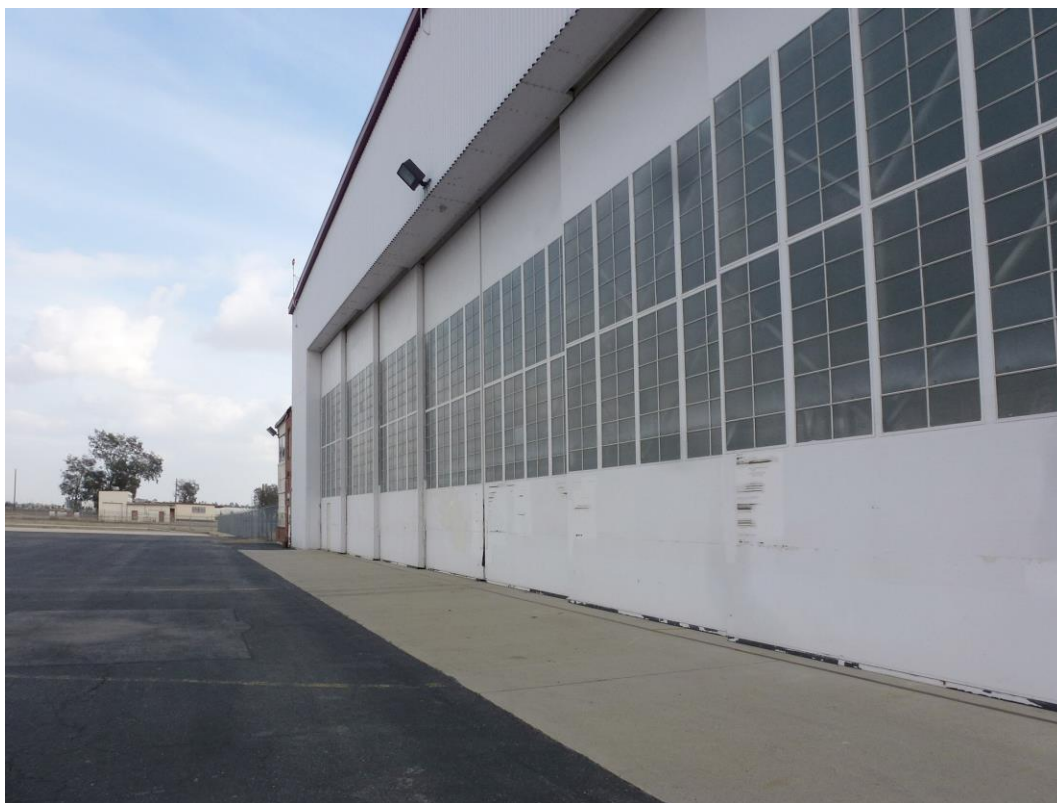
Figure 32. Multi-leaved doors on ANG Hangar. December 6, 2016.

- Hangars should retain original doors and tail cuts
- Exterior cladding may be replaced
- Hangars should retain original massing
- Newer auxiliary buildings might be attached

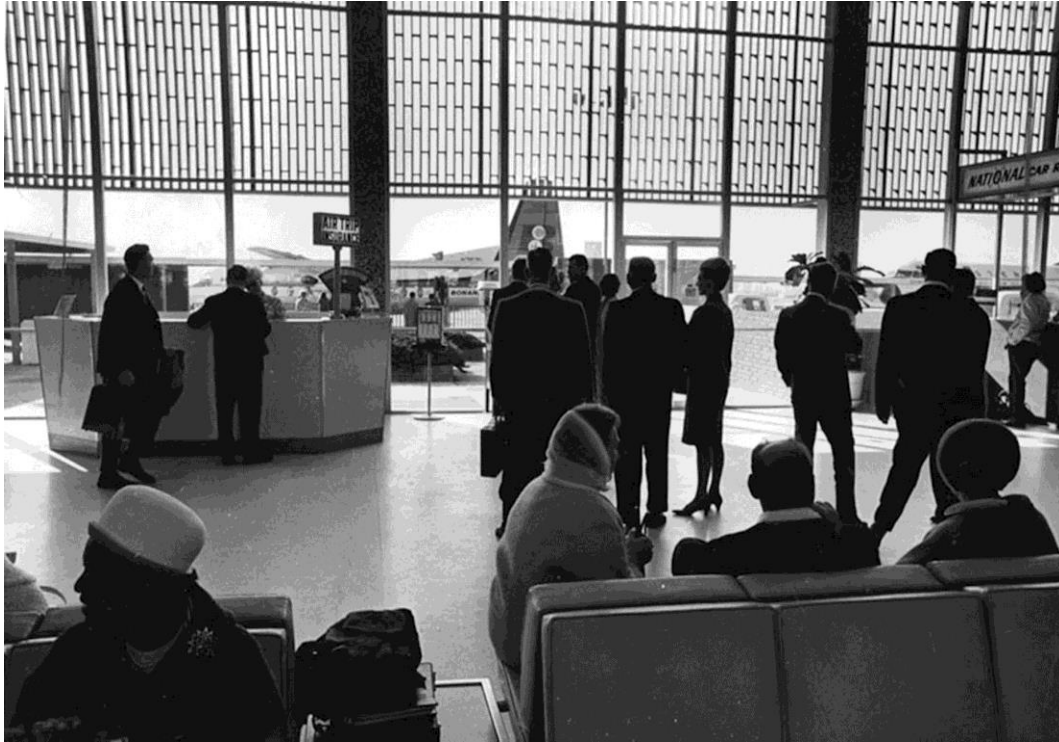
Figure 33. The lobby waiting room at Terminal One. April 1, 1967.
Herald-Examiner Collection, Los Angeles Public Library. Accession No. LAPL00054961.

Ontario, Calif., Airport, by architects Harnish, Morgan & Causey, is a small, efficient flying facility which also pays some attention to architecture. The tall, two-story waiting room with ticket offices has the usual glass fronts facing the field and the approach road, but in this case they were handsome, glare-shielding grilles. California's climate permits open-air walkways to the loading stations. Pleasant planting has been started around them. General contractor for the terminal is Service Construction Co.³⁰

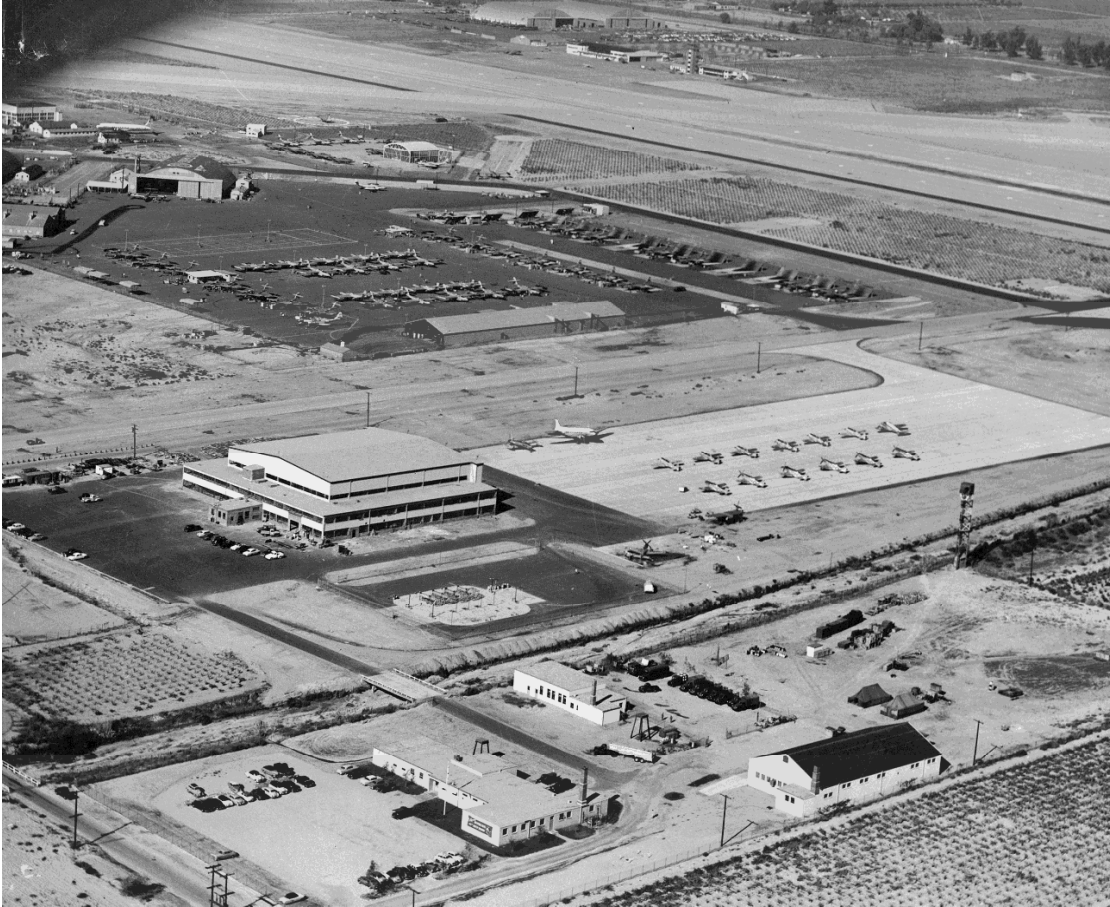
Image 1. Aerial view of Air National Guard area, looking northwest. Mid-1950s.
Photographer: LADOA. Source: Ontario City Library Robert E. Ellingwood Model Colony Room. Accession No. 149.

The Air National Guard Hangar, located at 2475 E. Avion St. at Ontario International Airport, is a complex comprising an aircraft hangar with a two-story office/workshop complex known as a "lean-to" adjoining the hangar on three sides. In addition, there are two wings on the south façade, housing a boiler room and a diesel tank facility. The hangar is a multi-story building of steel frame construction enclosing a single open space to accommodate aircraft. It is rectangular in form and sits on a poured-concrete foundation that opens on the north to the aircraft apron. The hangar is composed of corrugated metal and is capped by a low-pitched front-gabled roof. A continuous row of steel-frame six-over-three fixed windows spans three sides of the hangar. At the north façade is a double set of telescoping hangar-type doors that retract into enclosed housing at the sides. A continuous row of multi-light windows spans the width of the doors. At the interior of the hangar the steel truss construction is visible on the ceiling and walls. The floor is smooth poured concrete, and lighting is provided by regularly spaced industrial pendant fixtures, as well as the rows of windows on all sides.
