FINAL ENVIRONMENTAL IMPACT REPORT

West Haven Specific Plan

**PHASE I ENVIRONMENTAL
SITE ASSESSMENT
35± ACRE MINABERRY TRUST PROPERTY
APN 218-151-19 AND -23
ONTARIO AREA
SAN BERNARDINO COUNTY, CALIFORNIA**

**PROJECT NO. 31396.2
SEPTEMBER 8, 2000**

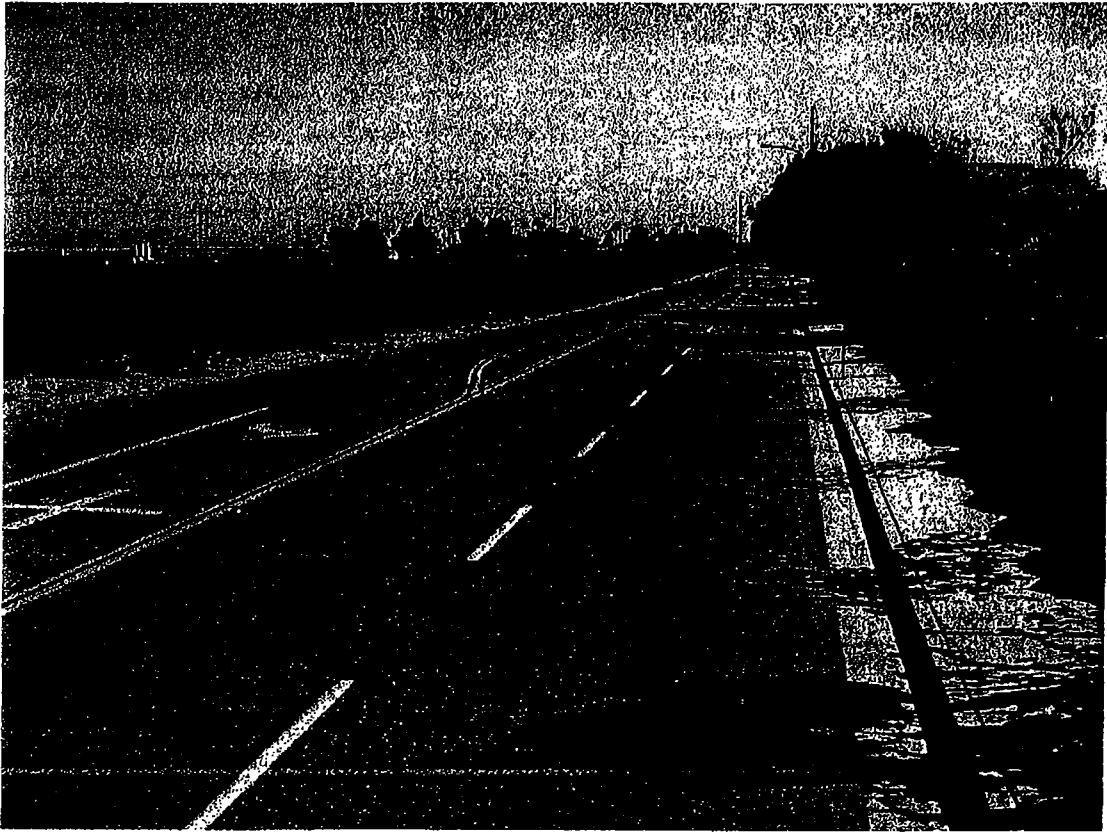
VIEW LOOKING SOUTH DOWN TURNER AVENUE FROM NORTHWEST CORNER OF THE SITE. SITE IS TO THE LEFT WITH SINGLE FAMILY RESIDENCES TO THE RIGHT.

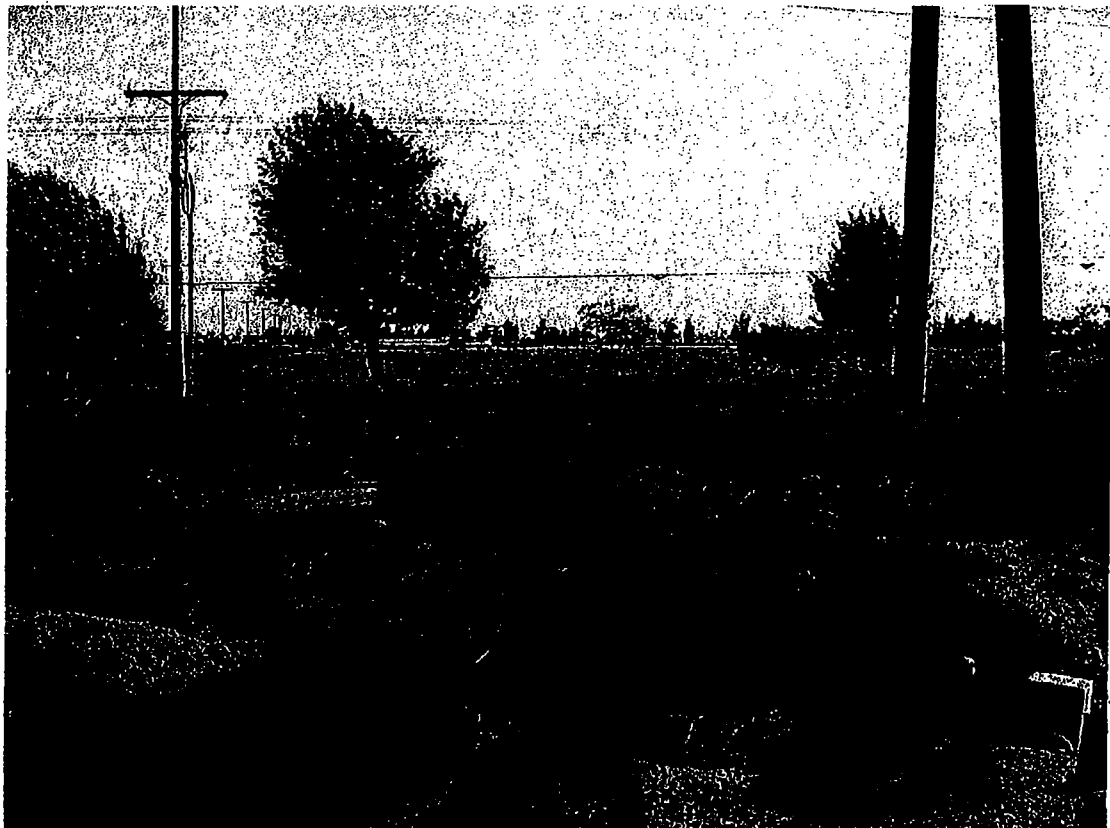
**VIEW LOOKING SOUTH AT POWER LINE EASEMENT SOUTH OF SITE AT TURNER AVENUE
SHOWING AGRICULTURAL FIELD SOUTHWEST OF SITE.**

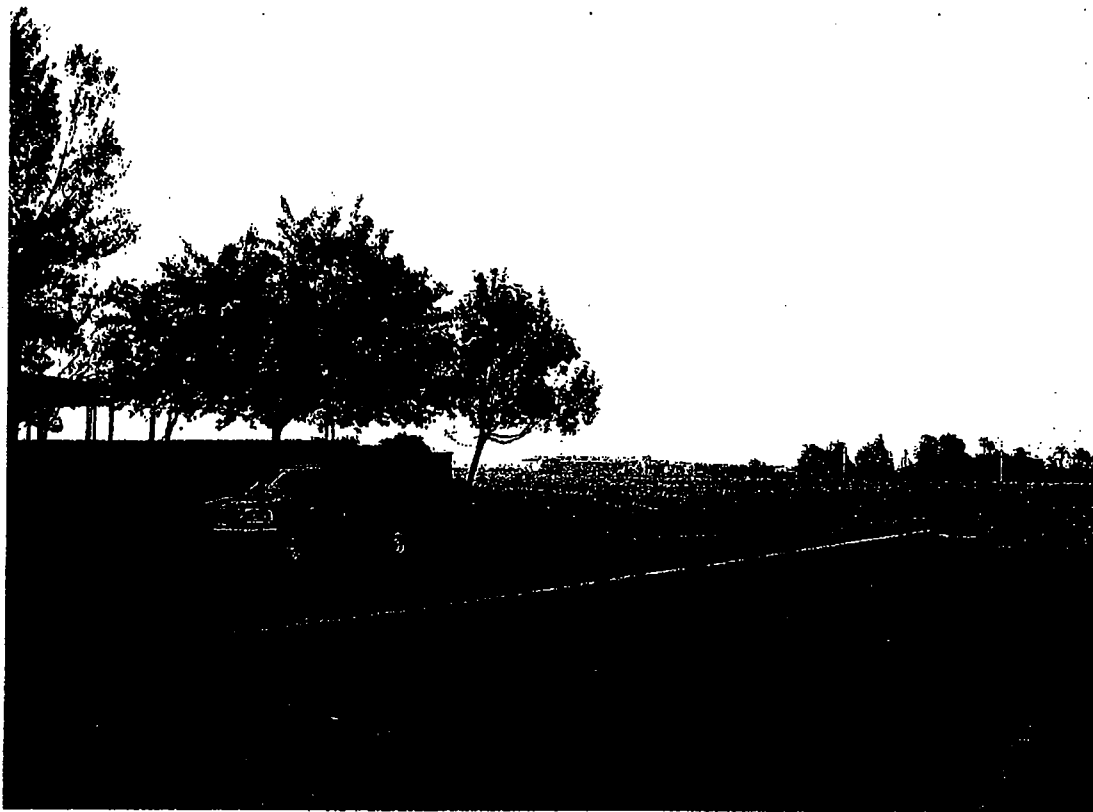
PHOTO 1 - VIEW FACING SOUTHEASTERLY FROM TURNER AVENUE SHOWING THE SITE (VACANT) AND THE RESIDENTIAL PROPERTY NORTH OF THE SITE.

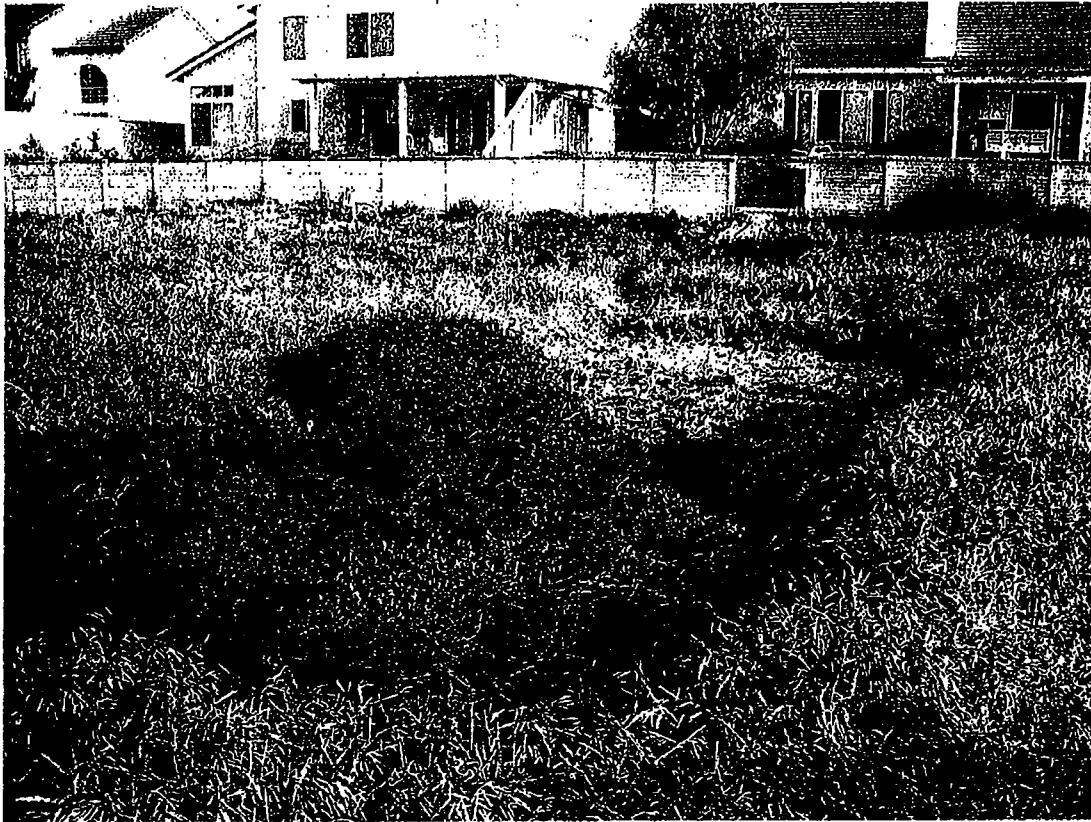
PHOTO 3 - VIEW FACING NORTH SHOWING THE RESIDENCES TO THE NORTH OF THE SITE. IN THE FOREGROUND IS THE BORROW AREA THAT A RESIDENT HAS MADE TO OBTAIN SOME FILL DIRT FOR HIS BACK YARD.

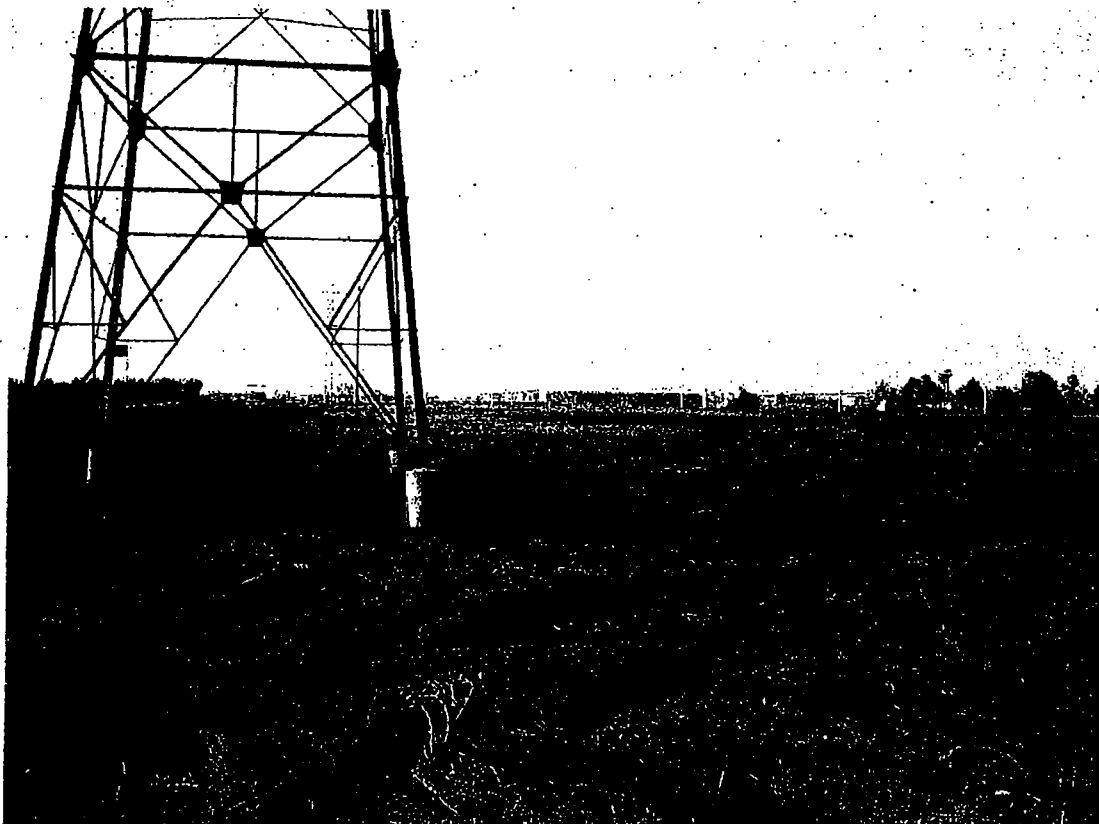
PHOTO 12 - VIEW FACING SOUTH FROM THE NEC OF THE SITE SHOWING THE SITE TO THE RIGHT AND A DAIRY TO THE LEFT (EAST).
