Guasti Conservation Plan Final

September 23, 2008

Thirtieth Street Architects, Inc.
2821 Newport Boulevard
Newport Beach, CA 92663
949/673-2643

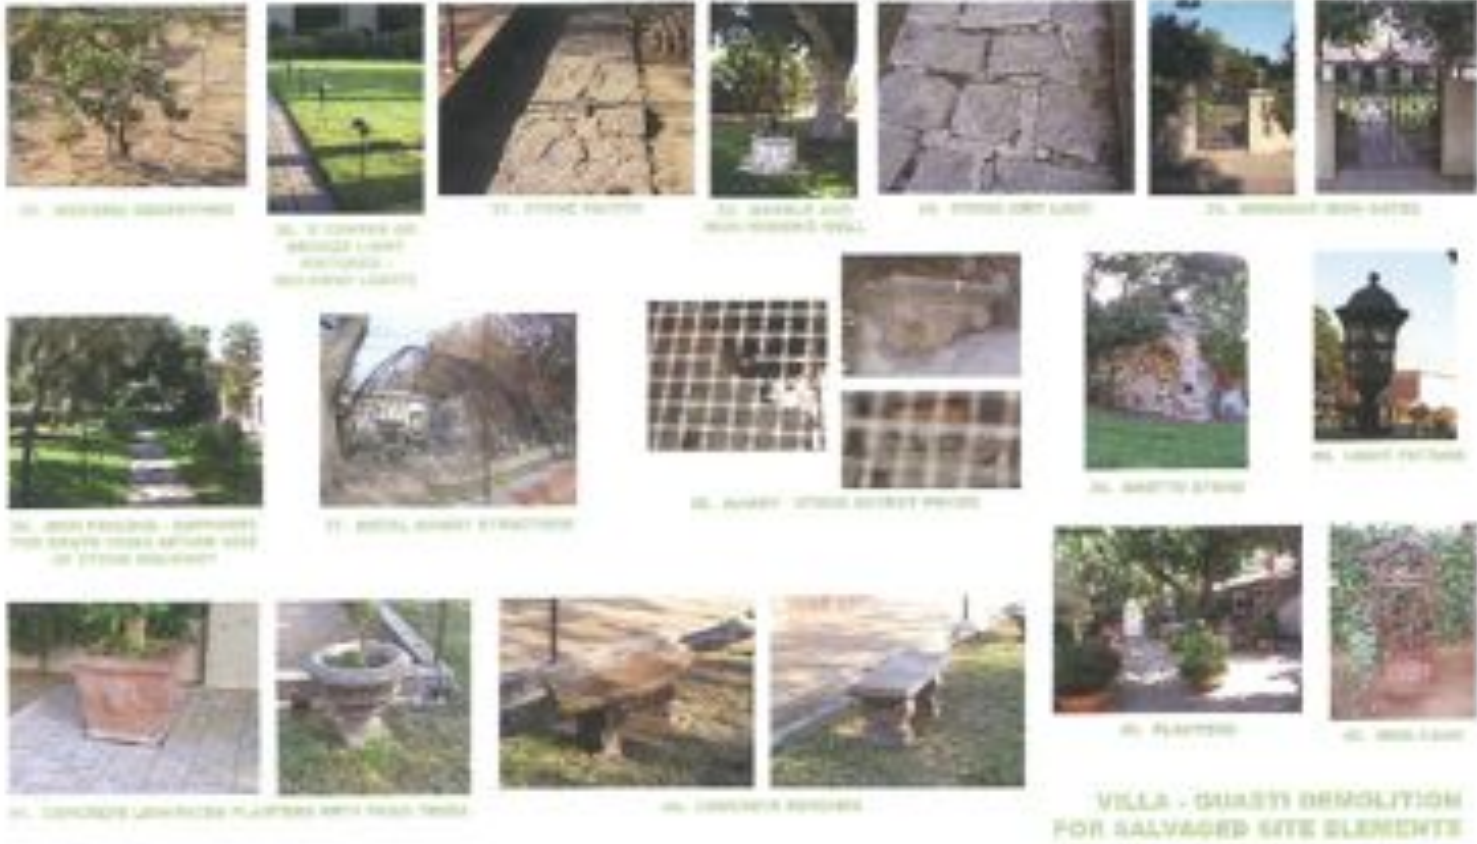
VILLA - GUASTI DEMOLITION FOR SALVAGED SITE ELEMENTS

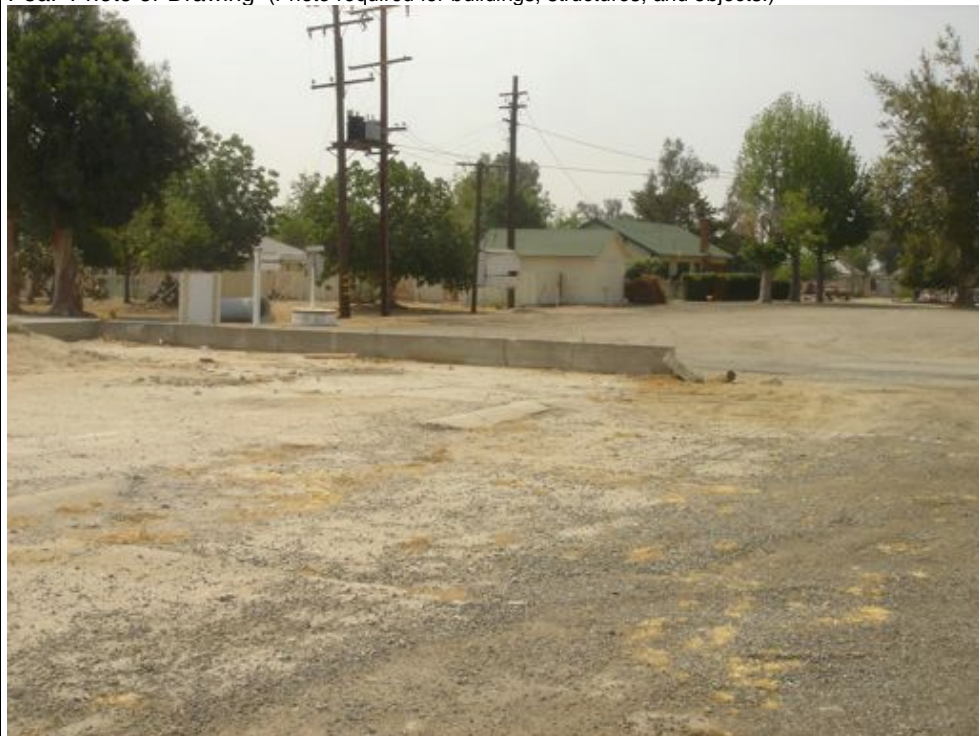
P5b. Description of Photo: (View, date, accession #) View looking south, July 2008.

***P3a. Description:** (Describe resource and its major elements. Include design, materials, condition, alterations, size, setting, and boundaries)
 The building was demolished between 1994 and 2007. All that remains of the 9,000 square foot industrial building is the concrete foundation wall.

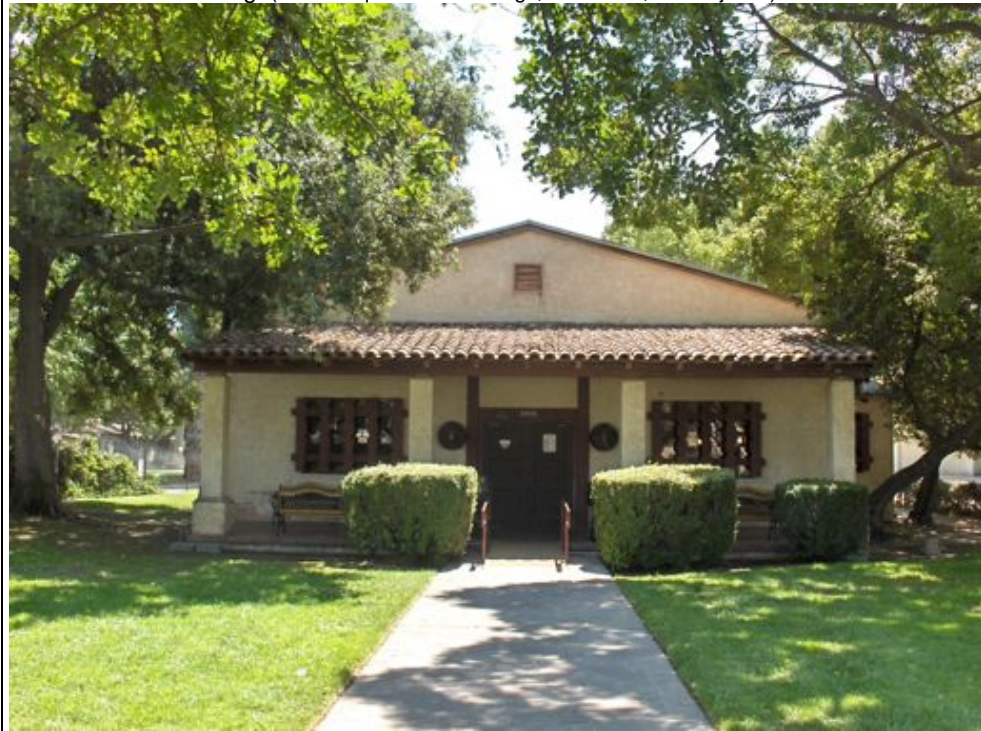
P5b. Description of Photo: (View, date, accession #) View looking south, July 2007.

*P3a. Description: (Describe resource and its major elements. Include design, materials, condition, alterations, size, setting, and boundaries)
 A one-story, rectangular massed building with low-pitched gable roof. The building was constructed of concrete block in a rectangular mass 40 feet wide x 84 feet long. A shed roof porch extends along the north (front) elevation and is 11 feet deep, clad in red clay Mission tile, and is supported by four large square masonry posts. The entire structure is clad in a concrete stucco finish and the roof of the main block appears to be covered by flat roofing material. The front entrance is a pair of wood doors. The porch floor is square red clay tile. On the west elevation, a small gable-roof ell was built with a fireplace and chimney. The majority of the windows are metal framed casement type.
 The building was recorded in 1984 as being used for a restaurant. It continued to be used for this purpose until its demolition.

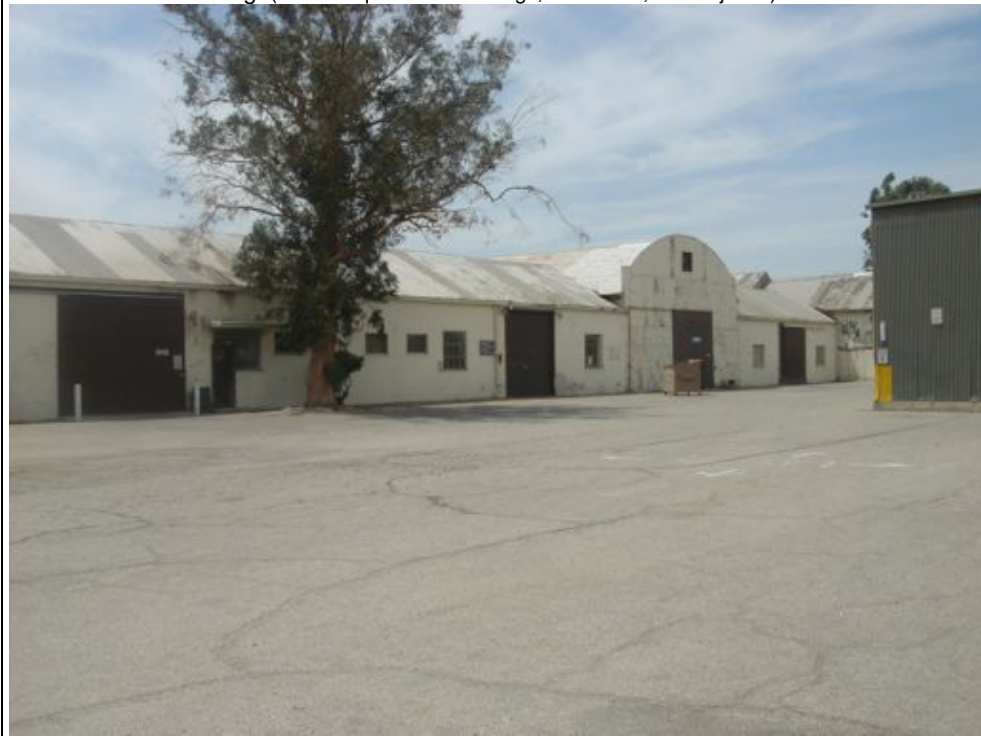
P5b. Description of Photo: (View, date, accession #) Partial view looking southwest, July 2007.

The original part of this building was built around 1932 with dimensions of 115 feet x about 265 feet, including a 15 foot x 62 foot extension t the north on the west end of the building. It has a concrete foundation, box frame with corrugated iron exterior, and a gable and sawtooth roof. It was used for shipping, storage, (of empty bottles only) and bottling. A winery warehouse with 62 foot x 115 foot dimensions was added on the east end of the original building around 1946. It has a concrete foundation, brick and reinforced concrete construction, beams, pilasters, and an arched roof. A covered concrete dock area along the east and part of the south sides is raised to allow access to a railroad spur next to int. The building also has a basement and was used for shipping, and empty bottle storage. Around 1948, an L-shaped office was added to the north of the 1946 addition. It has a concrete foundation, brick walls, and a hip composition roof.

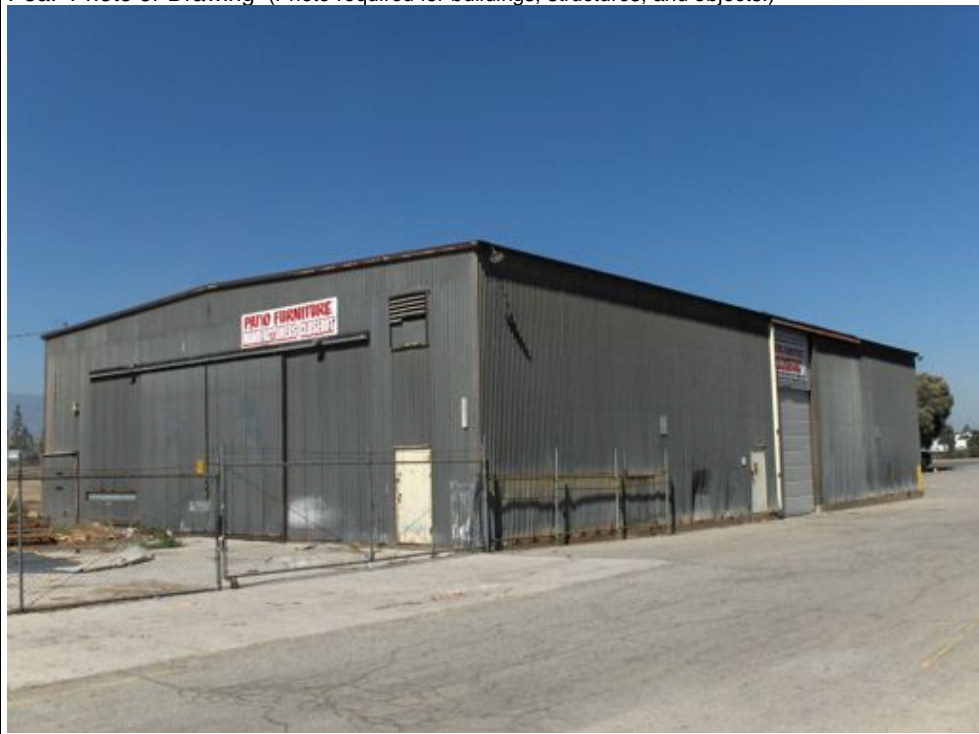
P5b. Description of Photo: (View, date, accession #) View looking southwest, July 2007.

*P3a. Description: (Describe resource and its major elements. Include design, materials, condition, alterations, size, setting, and boundaries)
 This is a tall one-story industrial building of metal frame construction with a low-pitched gable roof. The building has metal siding and sits on concrete foundation. The rectangular massed building is approximately 5,000 square feet.

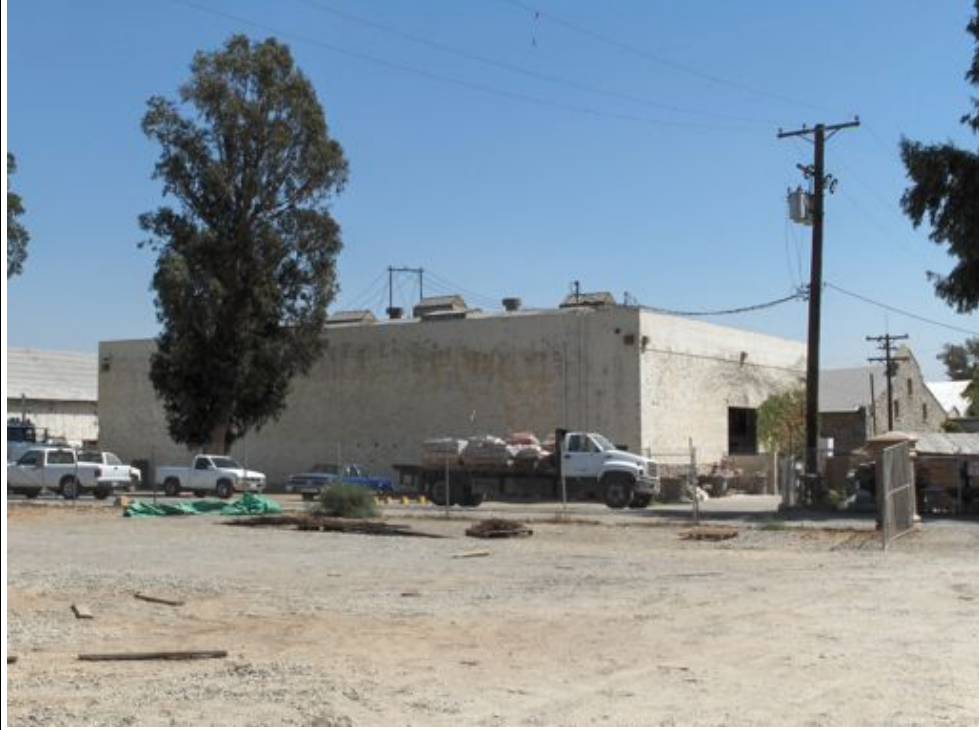
P5b. Description of Photo: (View, date, accession #) View looking southeast, July 2007.

***P3a. Description:** (Describe resource and its major elements. Include design, materials, condition, alterations, size, setting, and boundaries)
 This is an extremely simple storage warehouse constructed of 13-inch solid brick walls with a wood-framed bowstring truss roof system. The rectangular massed building measures 97 feet long x 72 feet wide for approximately 7,000 square feet. The bricks are set in a running bond with a bond course every five rows. There is one large overhead door opening on the west elevation. In 1984 the building was being used for wine storage. In 1994 the building was being leased by Select Steel Inc. In 2007, the building was being used by a masonry supply operation.

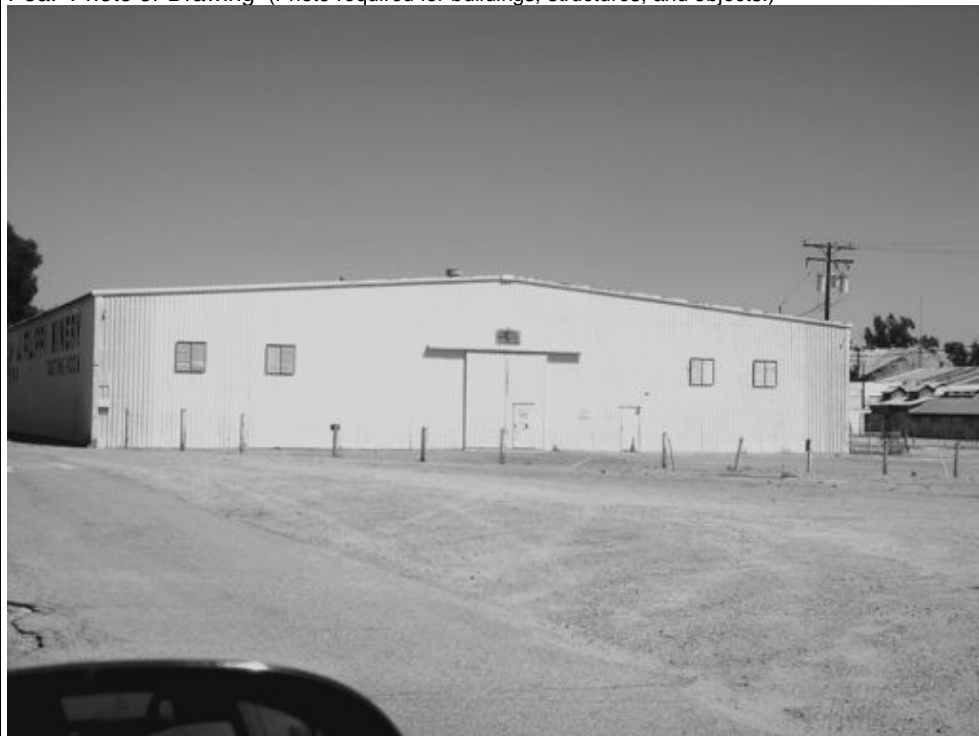
P5b. Description of Photo: (View, date, accession #) View looking east, July 2007.

***P3a. Description:** (Describe resource and its major elements. Include design, materials, condition, alterations, size, setting, and boundaries) This is a moderate sized, one-story, metal framed industrial type storage building with corrugated metal siding and low-pitched gable roof. The building sits on a concrete foundation and has approximately 13,200 square feet of space.

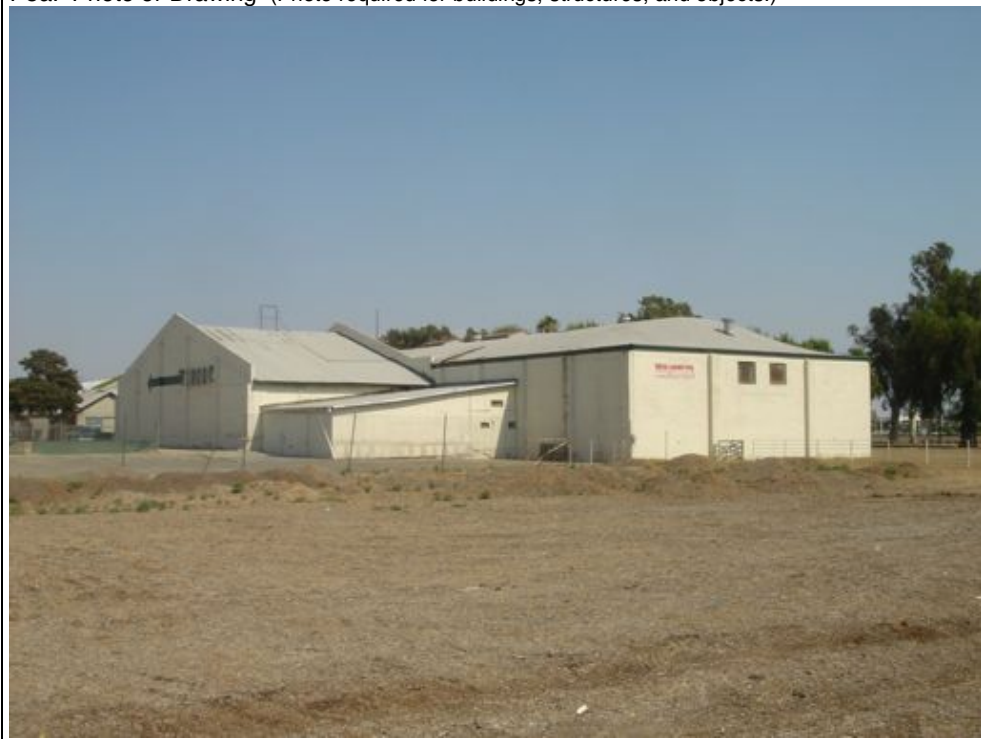
P5b. Description of Photo: (View, date, accession #) View looking southeast, July 2007.

The main section of this 1920 Warehouse has dimensions of 78 feet x 151 feet and is of brick construction with brick buttresses, a concrete foundation, and a composition roof with a curved "gymnasium-style" [bowstring truss arch] dome to it. The west wall has two slightly arched windows high over a bricked-up large doorway flanked by two high windows that have also been bricked-up. A large metal rolling door on the east side is the main entrance. A corrugated metal addition to the south (left) has dimensions of 15 feet x 80 feet with two large wooden doors and four six-light medium height windows. The corrugated metal shed roof slopes to the south. Another addition to the north has dimensions of 44 foot x 115 foot, corrugated metal walls and roof, and a single small door. A smaller 19 foot x 32 foot addition with corrugated metal walls and shed roof extends to the east (right). The northern wall of both of these additions was originally a 100 foot x 200 foot concrete block ware house, but has been demolished, leaving only the common wall. The main building was originally used as a warehouse for the winery but is now used for general storage. The addition to the north was originally a bottling shop and is also now used for general storage.

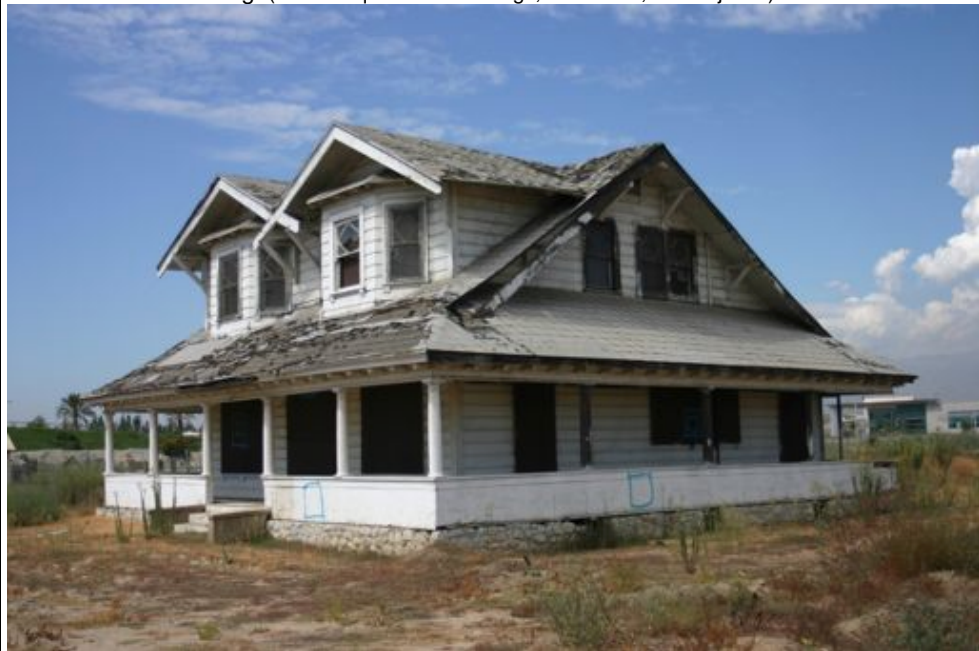
P5b. Description of Photo: (View, date, accession #) View looking northwest, Sept 2008.

***P3a. Description:** (Describe resource and its major elements. Include design, materials, condition, alterations, size, setting, and boundaries) This is a 1 ½-story residence that appears to have been built around the beginning of the 20th century. It has stylistic attributes of the Queen Anne and Shingle residential houses in a Vernacular interpretation. The main massing of the building is a wide gable roof structure with the gable roof on an east/west axis. To enlarge the amount of space on the second floor, two large gable roof dormers, that are connected in the middle to each other project from the southern roof slop. Under the gable roof of each dormer there is a hip-roofed cant bay window that has a double hung wood sash window on each side of the bay. The top sash of each rectangular window in the bay has a large wood sash diamond pane with smaller triangular panes at each corner. The bottom sash is a single pane. The bay windows sit on an extension of the roof plane, and this plane forms one side of a secondary roof that encircles the east, south, and west elevations and forms a roof for the deep veranda on the ground floor. The veranda roof is supported by classical columns that sit on a solid porch railing. Large brackets are used to support the roof edges on the upper level while decorative trimmed rafter tails support the veranda roof edge. The entire building sits on a large fieldstone and cement foundation and concrete steps lead to the front (south) entrance. Except for the exterior wall of the north elevation on the first floor, the entire building is clad in a wide shiplap siding. The north wall is covered with vertical boards. There is a brick chimney with a corbelled cap on the west elevation. The centrally placed front door has ¾ sidelights. Besides being the original manager's house, it was used by the foreman of the cooperage shops, and later as a restaurant.

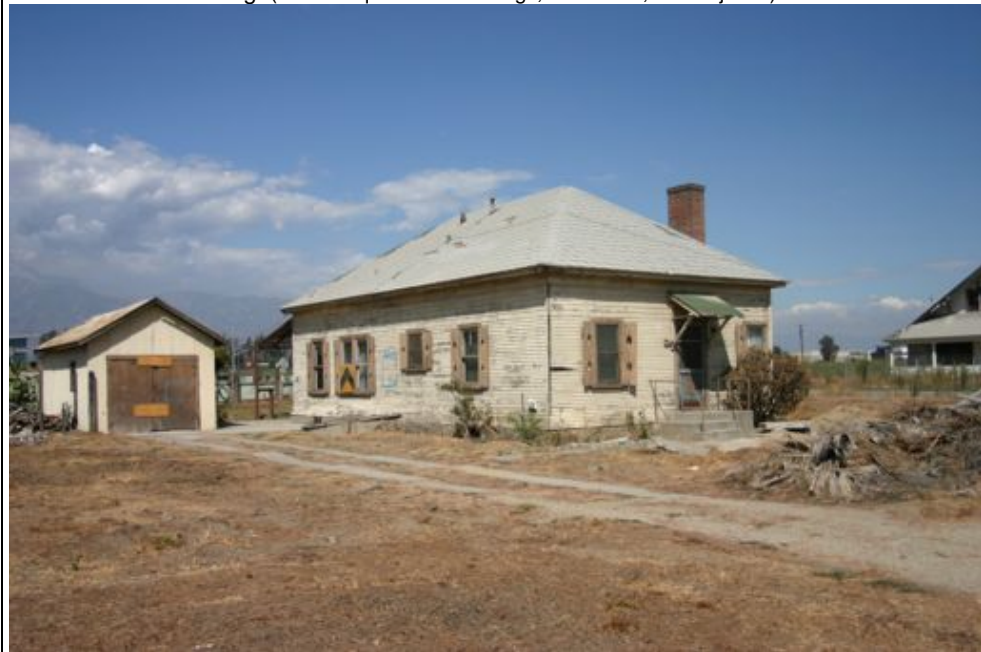
P5b. Description of Photo: (View, date, accession #) View looking northeast, Sept 2008.

***P3a. Description:** (Describe resource and its major elements. Include design, materials, condition, alterations, size, setting, and boundaries) Except for the lack of the added gable roof covered porch this house is very similar to Building 31 (P36-016286). They are both slightly larger than the other hipped roof cottages that were designed by architects Morgan, Walls & Morgan, who drew the plans for 20, 4-room, wood-frame bungalows to be erected at Guasti for the Italian Vineyard Company. This appears to be one of the small residences designed in a Vernacular Craftsman style. The rectangular massed house measures approximately 46 feet long x 28 feet wide, and has 1/1 wood frame double-hung sash windows. It is clad in narrow clapboard with plain corner boards and the roof on the main block is hipped and has closed eaves. The front door is centrally located and is covered by a shed roof awning supported by wood brackets. The house also has a red brick exterior chimney on the east elevation and decorative cut-out shutters still remain on this building. A small, gable roof, single-car garage is an associated feature and is located at the northwest corner of the house.

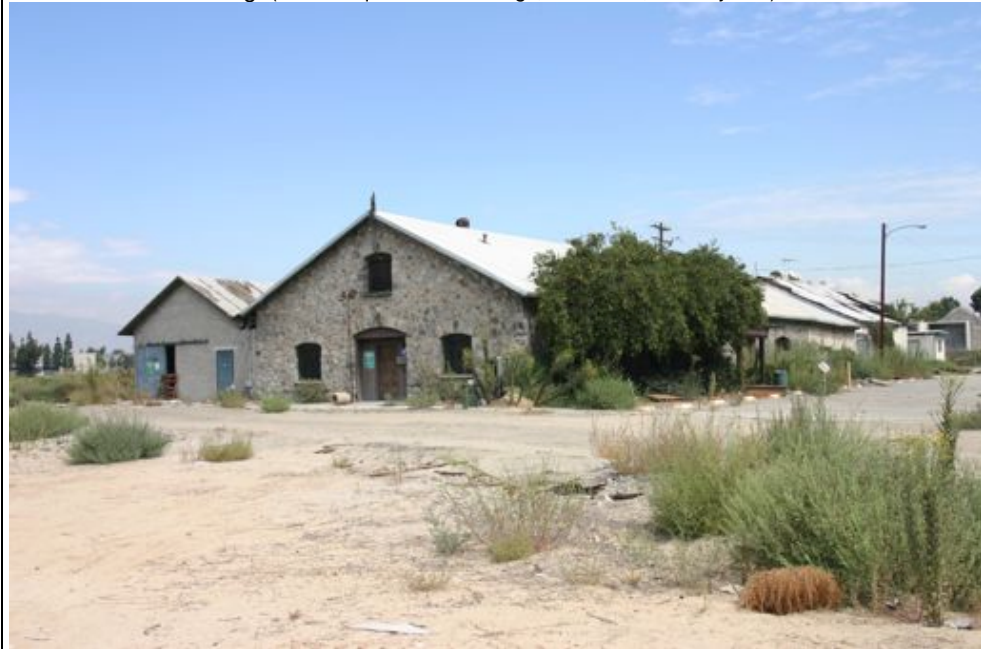
P5b. Description of Photo: (View, date, accession #) View looking northeast, Sept 2008.

***P3a. Description:** (Describe resource and its major elements. Include design, materials, condition, alterations, size, setting, and boundaries)
 This building is an amalgamation of several buildings serving different functions. The rectangular massed fieldstone building which forms the core for this structure measures approximately 64 feet wide x 158 feet long. The main block has a medium pitched gable roof. Original entrances and windows are still evident on the west and south elevations. The wood doors, windows and gable end vent, are set in deep segmental arched openings. There are two separate gable roof buildings that were attached to east elevation of the stone warehouse. The immediate building is exactly the same dimensions as the stone building, while the building at the east end is slightly larger and is constructed of wood frame with clapboard siding. Both buildings were clad with metal siding. Running along the entire length of the north elevation of the stone warehouse is a smaller and more narrow gable roof warehouse-type building. The north extension has concrete brick on the west elevation, but the rest of the building appears to be metal siding over a wood frame. On the saddle of the roof ridge sit two large ventilators, and a smaller ventilator sits on the apex of the ridge just to the west. There had been an extension of the north warehouse block on the east elevation that measured 32 feet x 54 feet. (It had been removed by September 2008.) These buildings used to house a coopers shop, barrel manufacturing shop, a wine tasting sales room and visitors center.

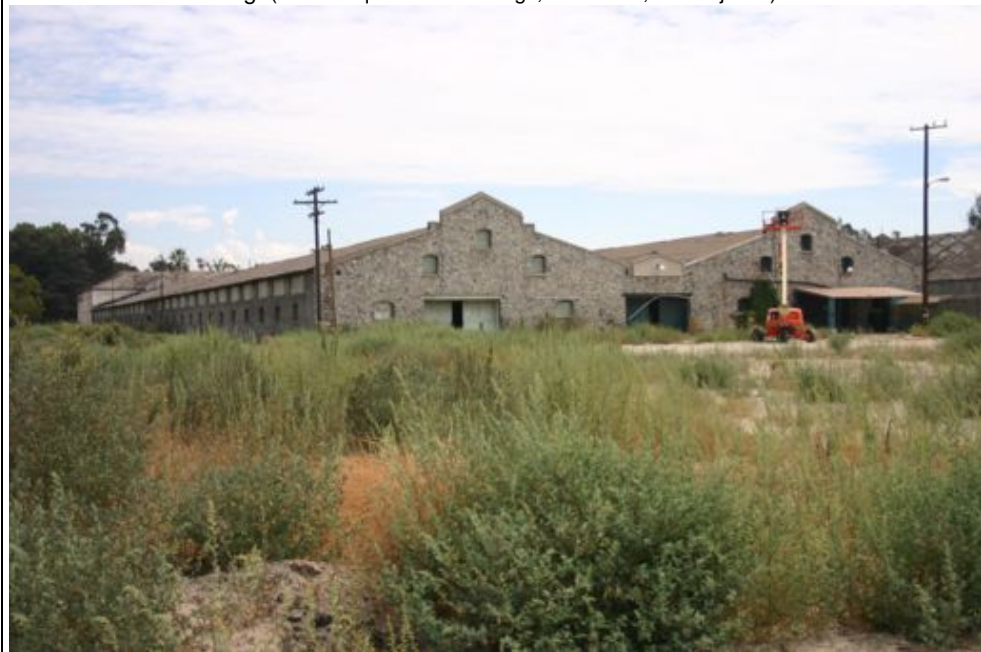
P5b. Description of Photo: (View, date, accession #) View looking southeast, Sept 2008.

This building has three distinct construction dates; the large double gable fieldstone warehouse is estimated to have been constructed in 1904, and the large brick and concrete addition on the east end of the building was added in 1932 to serve as a loading dock and storage area. The fieldstone building is 146 feet wide x 404 feet long. The loading dock addition measures 146 feet wide x 80 feet long. Both this building and Building 54 were extensively damaged by fire in July 1916 and only the fieldstone walls were left standing. (Los Angeles Times July 4, 1916. page 15.) All of the almost 90 redwood tanks that were contained in the building and used for fermenting the wine were destroyed. When the building was reconstructed may have been when the height of the building was increased with poured concrete walls increasing the height of the fieldstone walls. Inserted in the new wall space were window/vent openings that provided additional ventilation to the building interior. The new addition at the east end of the building was of reinforced concrete and brick infill construction with a bowstring truss roof. The railroad spur line ran to this end of the large building.

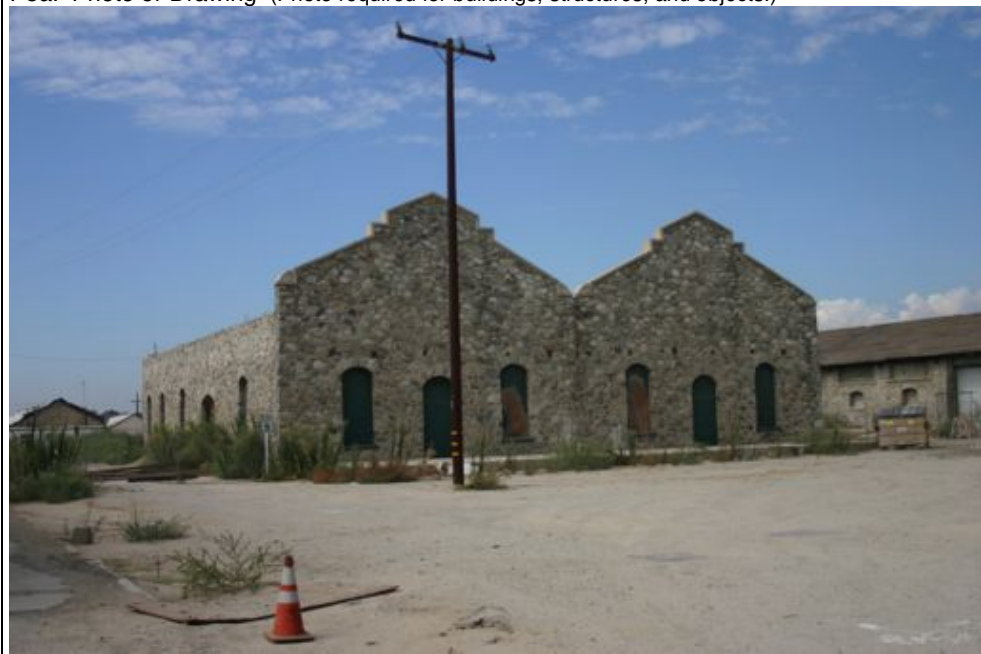
P5b. Description of Photo: (View, date, accession #) View looking northwest, September 2008.

***P3a. Description:** (Describe resource and its major elements. Include design, materials, condition, alterations, size, setting, and boundaries)
 This building was almost destroyed by fire. Only the stone walls remaining standing from what was one of the main distillery buildings. The section remaining measures approximately 70 feet wide by 50 feet long. The fieldstone section was only one-third of the building total size before the fire.

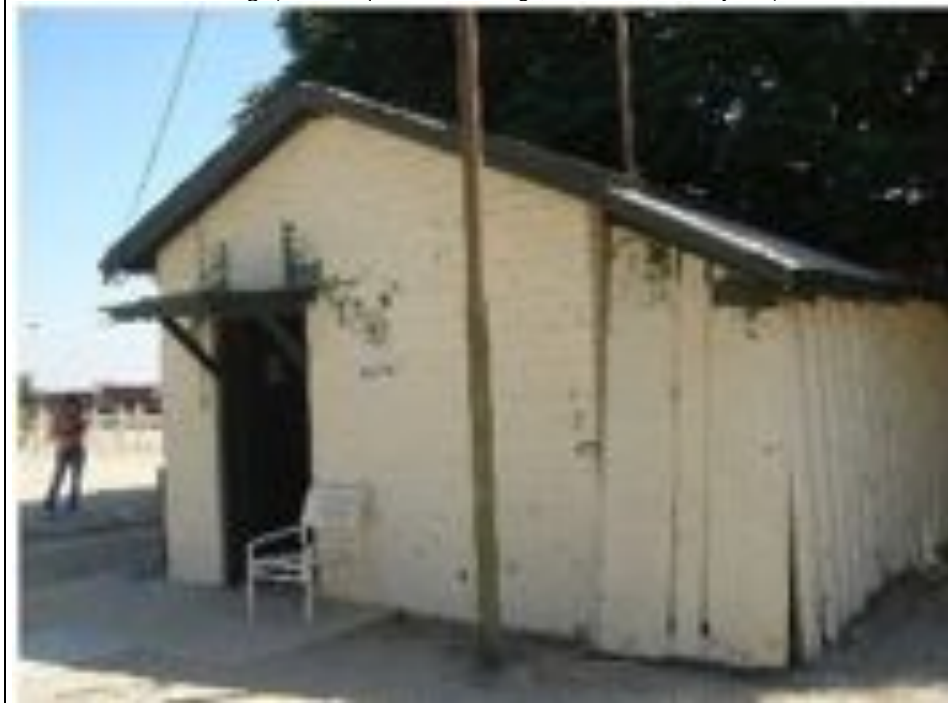
P5b. Description of Photo: (View, date, accession #) View looking southeast. February 2007.

***P3a. Description:** (Describe resource and its major elements. Include design, materials, condition, alterations, size, setting, and boundaries) The scale house had dimensions of 13 feet wide x 21 feet long and set on a concrete pad foundation. The walls were constructed of 8 inch concrete block and the building had a gable roof set on a north/south axis. The Fairbanks scales were sub-level and the weigh bed measured 10 feet wide x 45 feet long. The scales could hold up to 80,000 pounds.

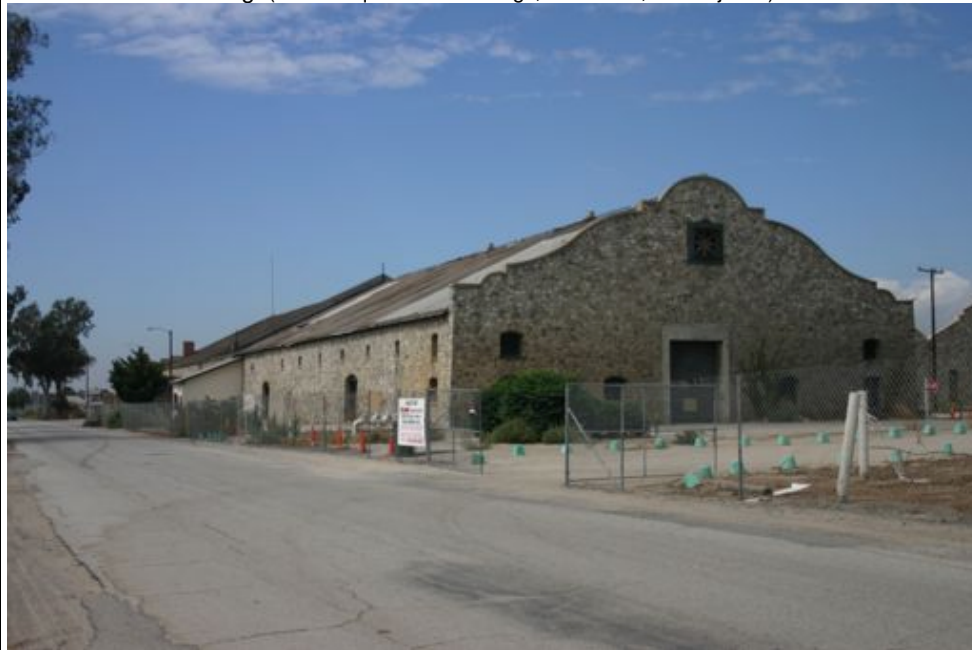
P5b. Description of Photo: (View, date, accession #) View looking northwest. September 2008

*P3a. Description: (Describe resource and its major elements. Include design, materials, condition, alterations, size, setting, and boundaries)
 This 55,000 square foot warehouse constructed of fieldstone and cement mortar has walls which are 16 feet high and up to 3 feet thick. A basement area runs under the building and is approximately 16,000 square feet. The medium-pitched gable roof is constructed of wood frame. The windows and doors in the fieldstone building are set within the thick walls and have segmental arches. The front elevation is that facing south and Guasti Road and a 20 foot wide by 50 foot long section projects from the main block of the winery with a curvilinear Mission style parapet. It contains some of the offices for the winery and shares space with a branch of the U.S. Post Office. The fieldstone building has taller walls on the east end than on the west end. The west end may have been added or altered after the fire in 1916 which totally gutted this and Building 50 (Los Angeles Times, July 4, 1916.) At the far west end of the building, a large concrete brick shipping dock building unit was added in the 1930s or 1940s. Along the exterior of the north side of the warehouse, there are still remnants of the railroad spur that picked up wine and grape products for distribution around the United States. Inside the building is the large steam engine plant that produced the power for the machinery inside the building before electrical power became practical.

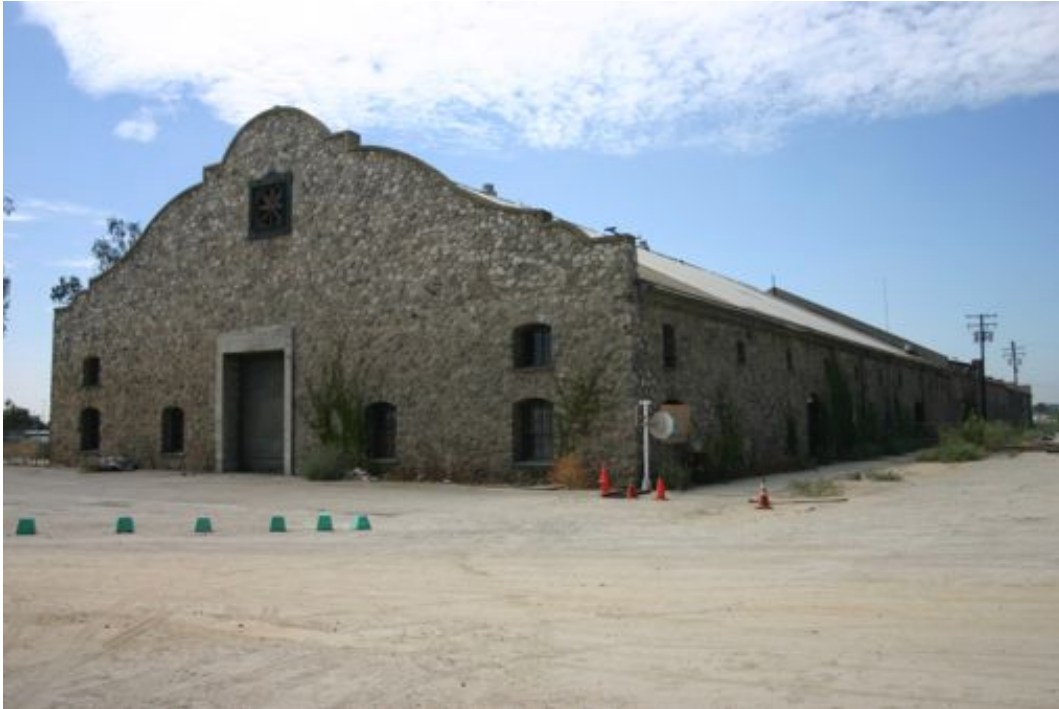
Building 54, north elevation, east end of building, view looking southwest, September 2008.

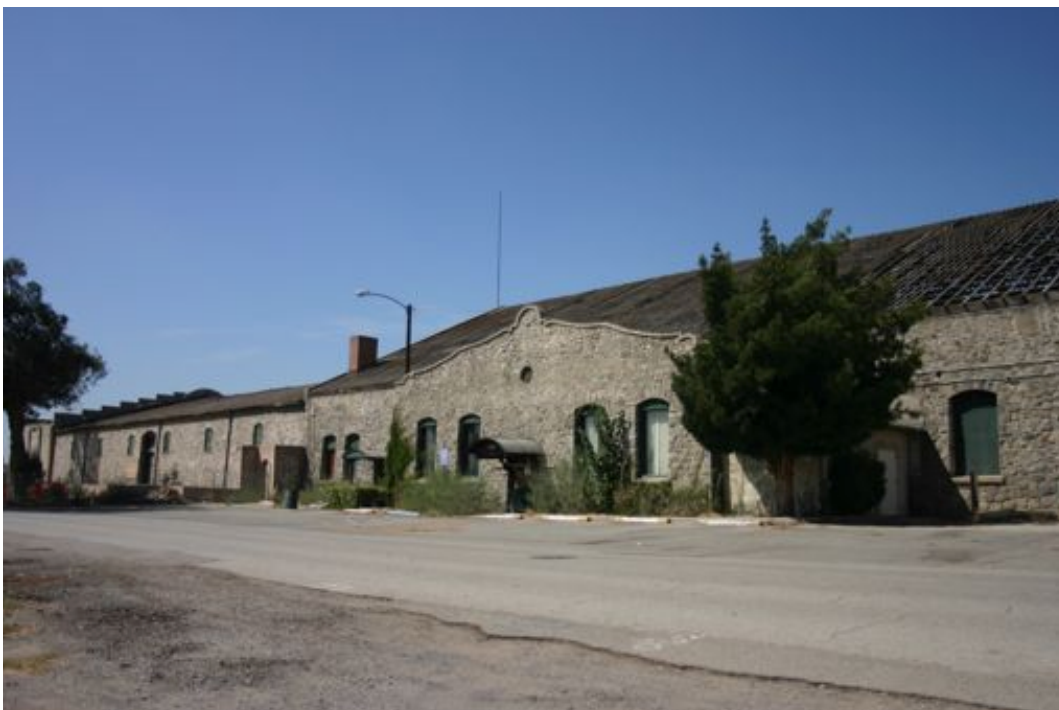
Building 54, south elevation, mid-section of the building, view looking northwest, September 2008

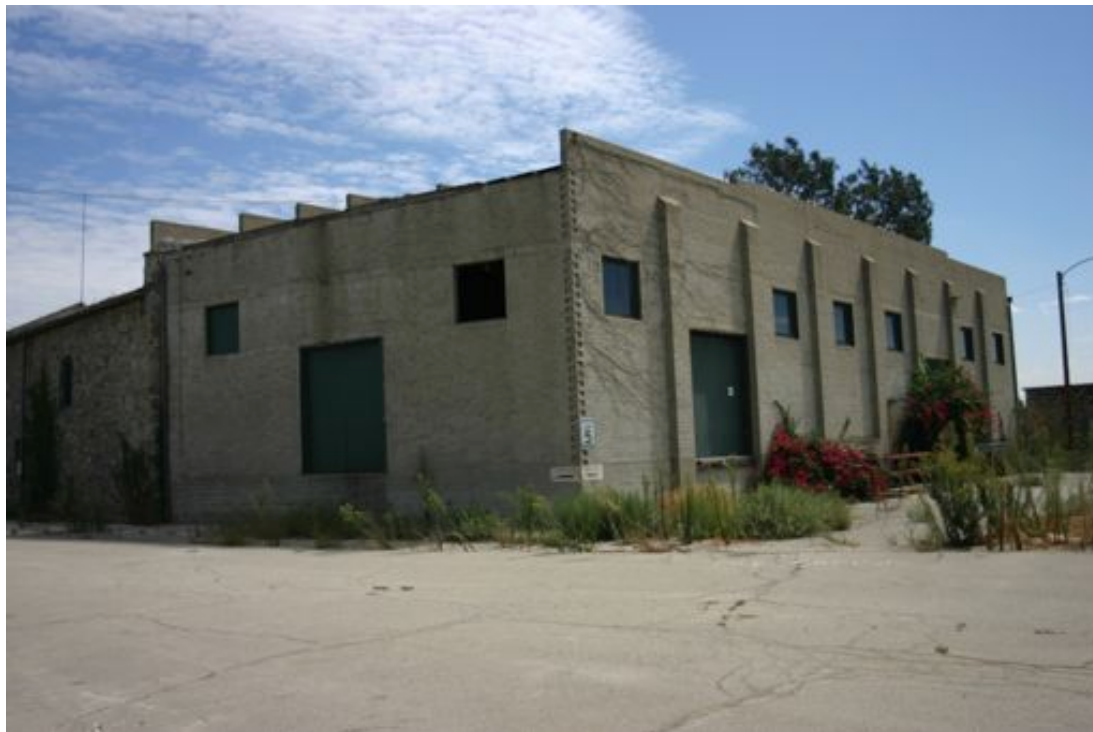
Building 54, north and west elevation, west end of building, view looking southeast, September 2008.

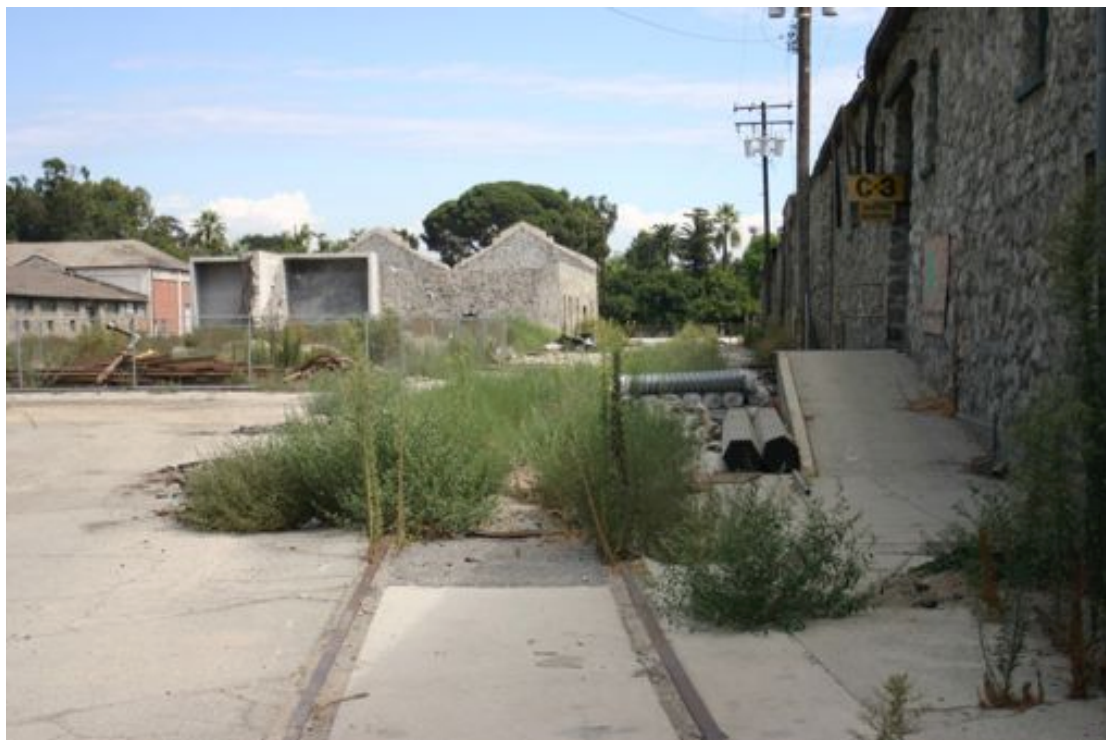
Last section of railroad spur line that ran along the north side of Building 54.
Photo looking east, September 2008.
