**PRELIMINARY GEOTECHNICAL SITE ASSESSMENT
AND REPORT REVIEW AND UPDATE
SUBAREA 29 SPECIFIC PLAN AMENDMENT – PLANNING AREAS 30 - 34
SW AND SE CORNER OF EUCALYPTUS AND HAVEN AVES
ONTARIO, CA**

January 28, 2022

21-1464-01

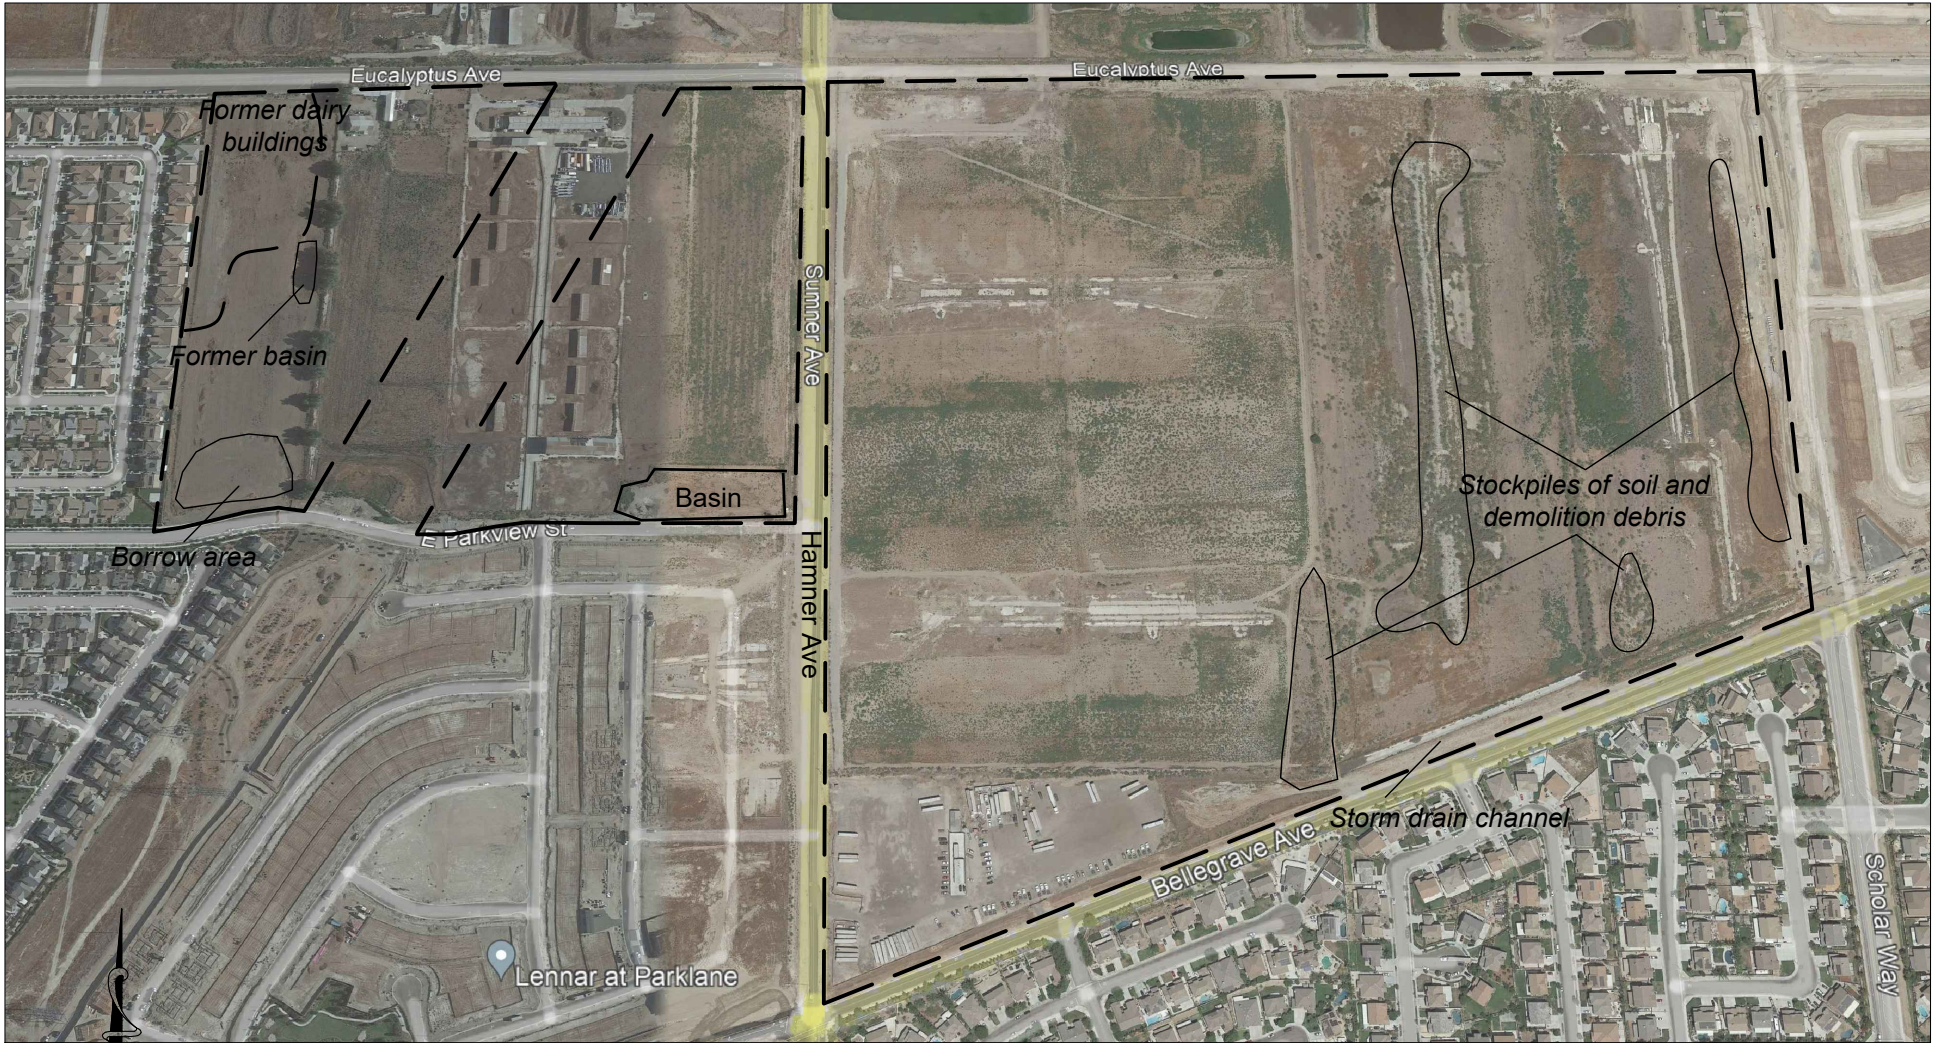
Site Reconnaissance Map

Scale: 1"= 500'
Source: Google Earth, 2021

During our site reconnaissance it was observed that the surface of PA 30 that has been cleared of the former dairy structures and has a thin layer of loose artificial fill and alluvium across its surface and small amounts of concrete, wood and other debris most likely from the demolition at the site. Surficial conditions at PA 31 are similar to those indicated in the LGC report since the dairy at that site has not yet been demolished. Stockpiles of soil and concrete debris were also observed in PA’s 33 and 34, again associated with the demolition of the former dairies.
